FPOL2001-6 HARVEY BEACH JETTY

ATTACHMENT 1 - Harvey Beach Jetty – Fixed Timber Structure Inspection

**Project:** Condition Inspection  
**Structure:** Harvey Beach Jetty  
**Location:** North Fremantle  
**Client:** City of Fremantle  
**Date:** 15<sup>th</sup> January 2020

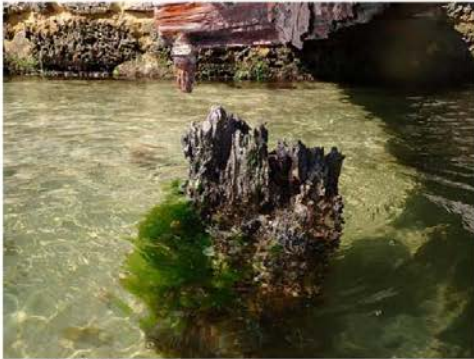
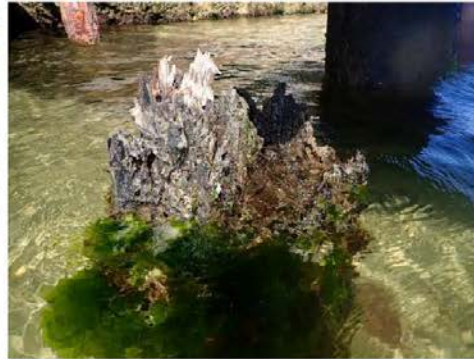
| PILE 1A PARTICULARS | | | |
|---|---|---|---|
| Overview | <ul style="list-style-type: none"> <li>Pile 1A was observed to have failed at the intertidal zone due to severe wood rot and marine borer.</li> <li>Due to the failure of the pile, the pile cap circumference measurement and intertidal probing could not be achieved during the inspection.</li> <li>The pile condition at seabed appeared to be in fair condition and considered suitable for pile splicing.</li> <li>Pile 1A is in need of immediate repair/replacement.</li> </ul> | | |

*Pile 1A Failure*

*Pile 1A Failure (1)*

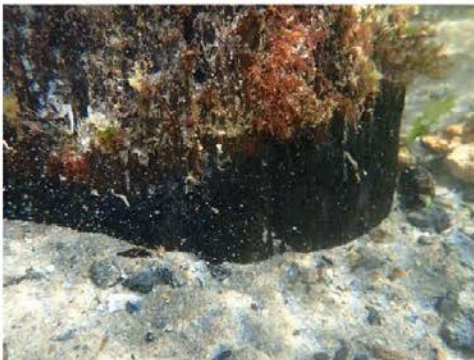
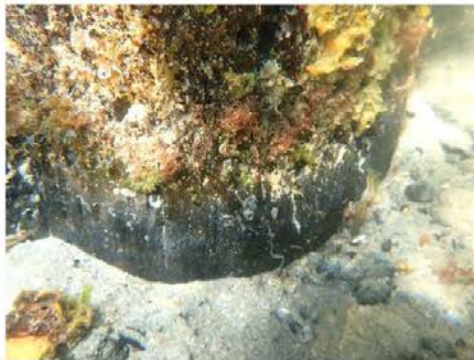
*Pile 1A seabed condition*

*Pile 1A seabed condition (1)*

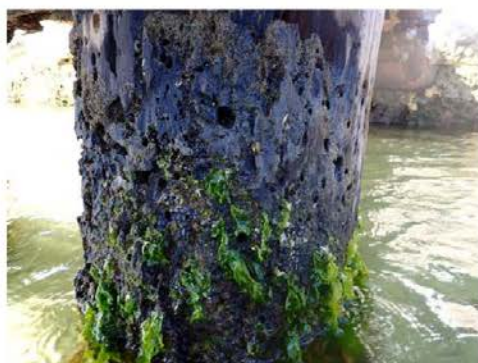
| PILE 1B PARTICULARS | | | |
|---|---|---|---|
| Overview | <ul style="list-style-type: none"> <li>Pile 1B was observed to be in very poor condition at the intertidal zone due to severe wood rot, splitting and marine borer.</li> <li>Large holes were observed in the pile as a result of severe wood rot and measured up to 180mm in depth.</li> <li>The pile condition at seabed appeared to be in fair condition and considered suitable for pile splicing.</li> <li>Pile 1B is in need of immediate repair/replacement.</li> </ul> | | |

*Pile 1B poor condition*

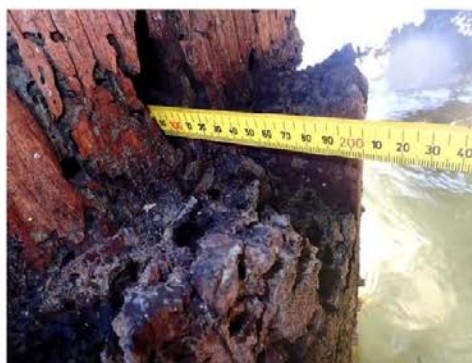
*Pile 1B severe wood rot*

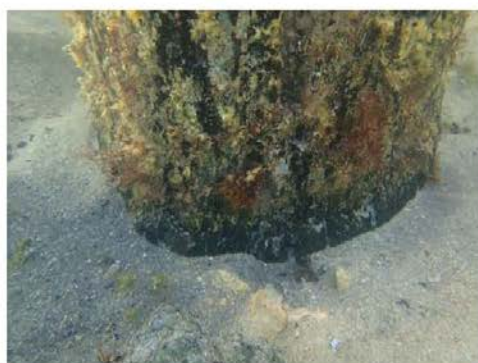
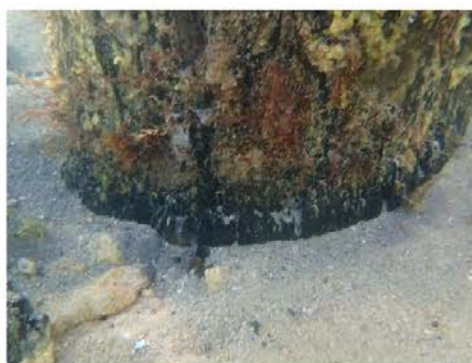
*Pile 1B seabed condition*

*Pile 1B seabed condition (1)*

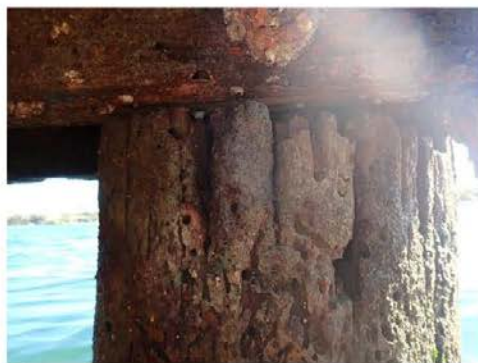
| PILE 2A PARTICULARS | | | |
|---|---|---|---|
| Overview | <ul style="list-style-type: none"> <li>Pile 2A was observed to be in poor condition at the intertidal zone due to severe wood rot, splitting and marine borer.</li> <li>Significant splitting at the pile cap was observed and measured up to 120mm in depth.</li> <li>The pile condition at seabed appeared to be in fair condition and considered suitable for pile splicing.</li> <li>Pile 2A is in need of immediate repair/replacement.</li> </ul> | | |

*Pile 2A poor condition*

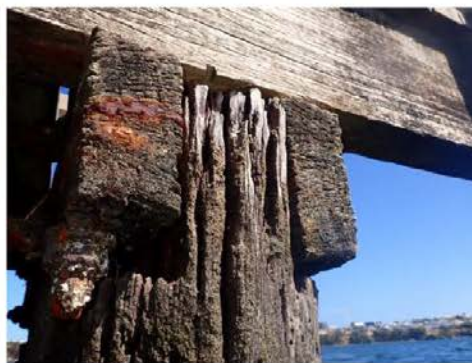
*Pile 2A severe splitting*

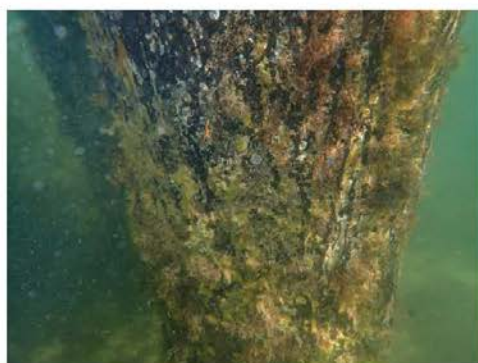
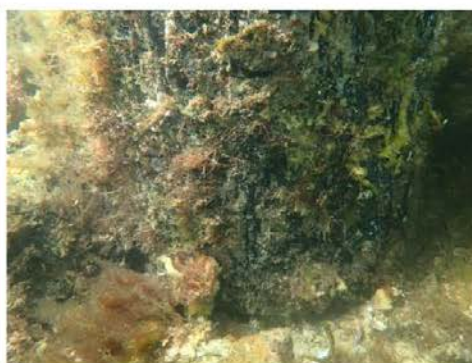
*Pile 2A seabed condition*

*Pile 2A seabed condition (1)*

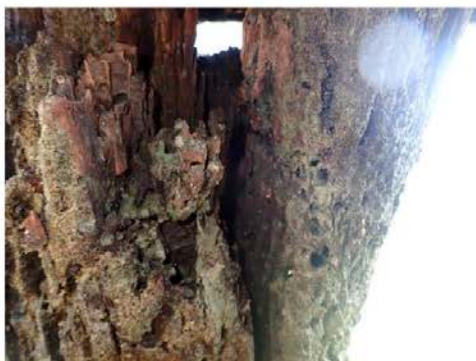
| PILE 2B PARTICULARS | | | |
|---|---|---|---|
| Overview | <ul style="list-style-type: none"> <li>Pile 2B was observed to be in poor condition at the intertidal zone due to severe wood rot, splitting and marine borer.</li> <li>Significant splitting and wood rot at was observed at the pile cap and was penetrating through the entire pile thickness.</li> <li>The pile condition at seabed appeared to be in fair condition and considered suitable for pile splicing.</li> <li>Pile 2B is in need of immediate repair/replacement.</li> </ul> | | |

*Pile 2B poor condition*

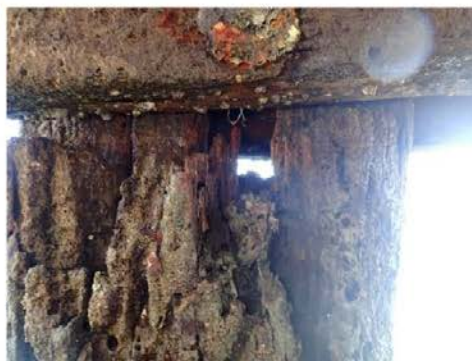
*Pile 2B severe splitting and rotting*

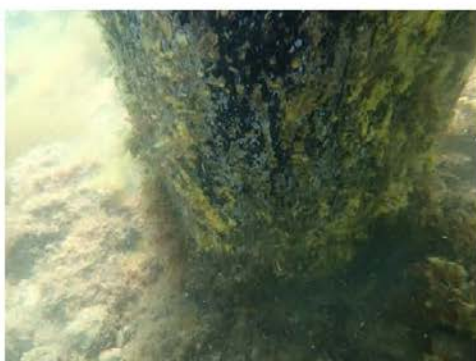
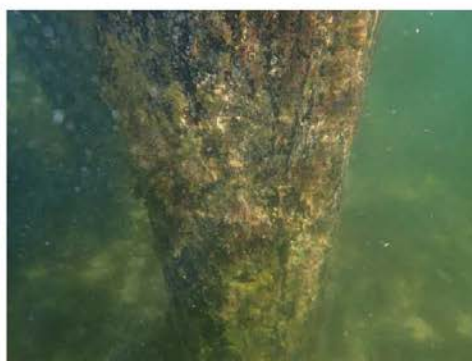
*Pile 2B seabed condition*

*Pile 2B seabed condition (1)*

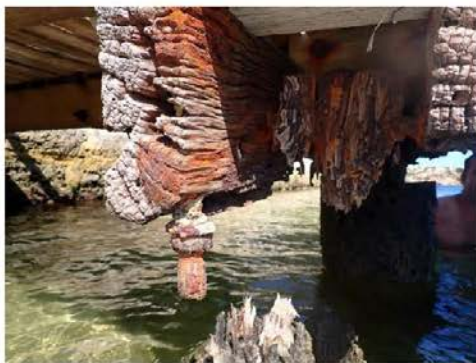
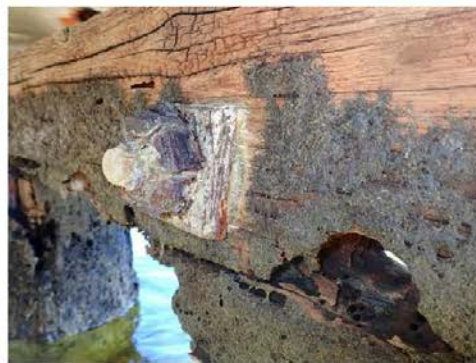
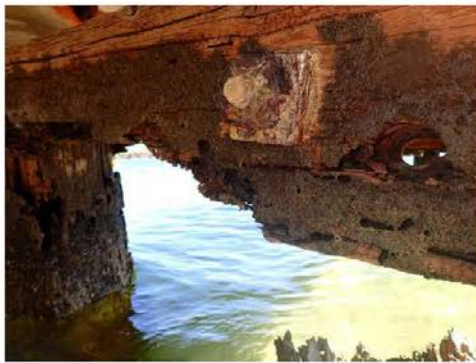
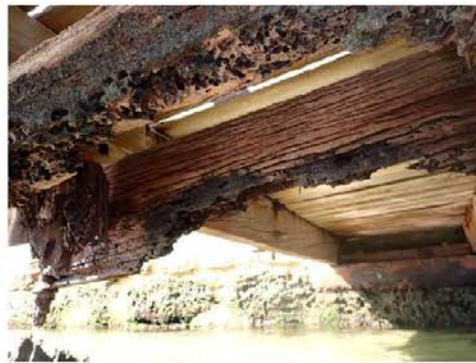
- Two (2) timber headstocks were in position at Bent One (1). These headstocks spanned between pile 1A and 1B.
- Both headstocks were in poor condition due to significant wood rot, splitting and marine borer.
- All fixings connecting the headstocks to the piles were observed to be in poor condition subject to significant corrosion and are in need of replacement.
- The headstocks at Bent One (1) both have a condition rating of seven (7) and are in need of immediate replacement.

*Bent one headstock condition*

*Bent one headstock and fixing condition*

*Bent one headstock condition (1)*

*Bent one headstock condition (2)*

- Headstocks;** The headstocks are to be replaced. These can be replaced with I-Beam welded to the new piles or like for like Structural Jarrah dependant on the City's aesthetic preference. Any headstock installed is to be adequately protected from the deleterious marine environment.
- Whalers;** Whalers 1A and 1B are to be replaced with like for like structural jarrah.
- Ladder;** Jetty ladder bottom rung to be replaced and made safe.
- Decking and Handrails;** Sections of decking/handrails subject to significant splitting and deemed unsafe to be replaced. Proud fixings associated with the decking/handrails are to be recessed into the timbers.
- Fixings;** All fixings subject to significant corrosion be replaced.
- End Grains;** All exposed timber end grains be treated to prevent further moisture entering causing splitting.

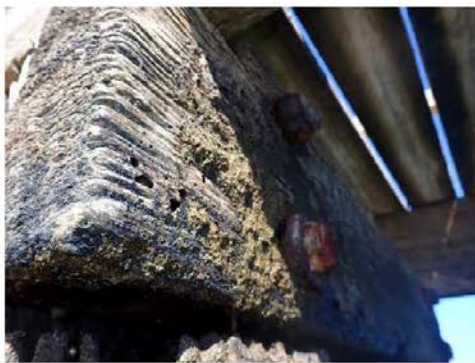
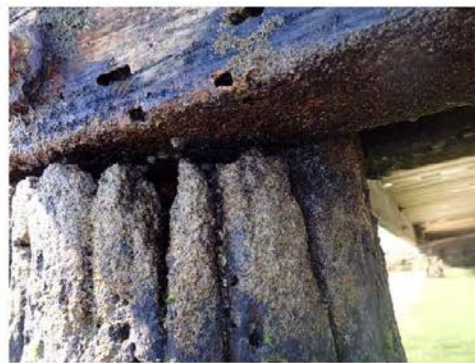
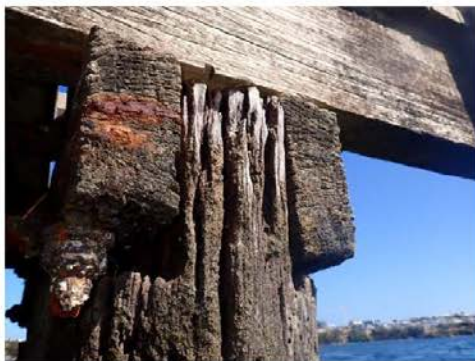
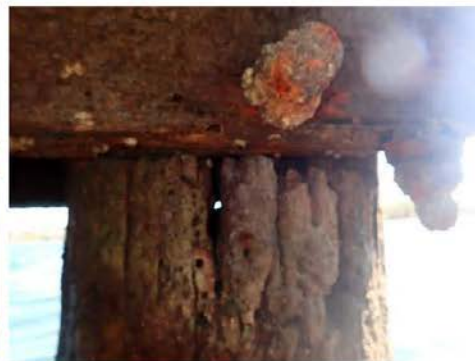
- Two (2) timber headstocks were in position at Bent Two (2). These headstocks spanned between pile 2A and 2B.
- Both headstocks were in poor-average condition due to apparent wood rot, splitting and marine borer.
- All fixings connecting the headstocks to the piles were observed to be in poor condition subject to significant corrosion and are in need of replacement.
- The headstocks at Bent Two (2) both have a condition rating of six (6) and are in need of replacement.

*Bent two headstock condition*

*Bent two headstock condition (1)*

*Bent two headstock condition (2)*

*Bent two typical fixing condition*

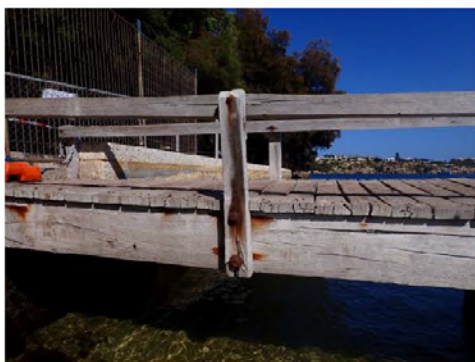
- Whaler 1A spanned between shore and Bent One (1) and was observed to be in an overall poor-average condition.
- The failure of Pile 1A on Bent One (1) has resulted in Whaler 1A being subject to significant stress. Subsequently, stress cracking can be observed in multiple locations on both the external and internal faces of the whaler.
- Whalers 1A and 1B are joined by a timber splice plate above the Bent One (1) on the internal side of the whaler. As the splice plate is small in length, fixings have been installed too close to the end of the whalers and splice plate causing the timbers to split at the end grain.
- All fixings associated with Whaler 1A were observed to be in poor condition subject to significant corrosion and are in need of replacement.
- Whaler 1A has a condition rating of five (5) and is recommended to be replaced.

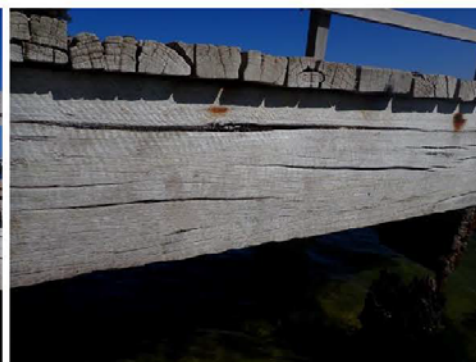
Stress cracking external face

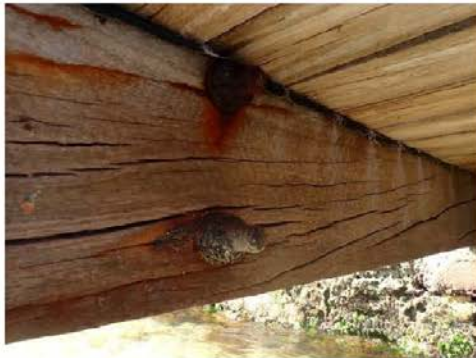
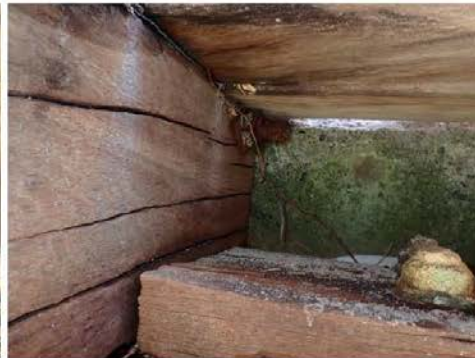
*Stress cracking internal face*

*Stress cracking internal face (1)*

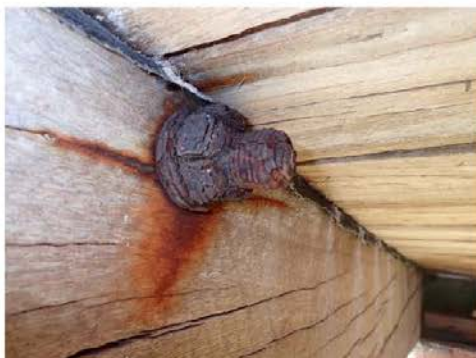
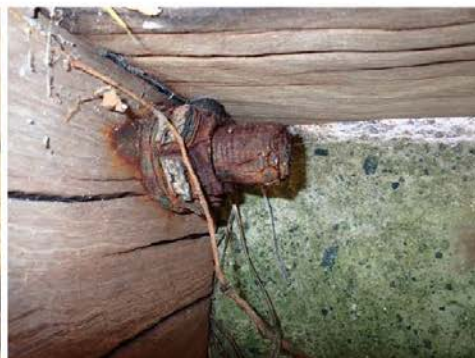
*Typical fixing condition*

*Typical fixing condition (1)*

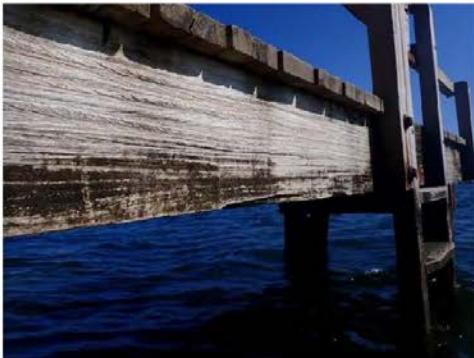
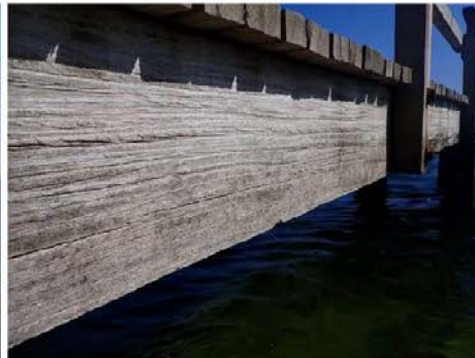
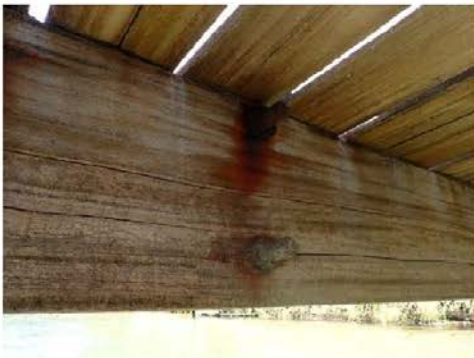
- Whaler 1B spanned between Bent One (1) and Bent Two (2) and was observed to be in average-good condition.
- Whaler 1B was subject to minor defects only predominantly in the form of small splits.
- All fixings associated with Whaler 1B were observed to be in poor condition subject to significant corrosion and are in need of replacement.
- Whaler 1B has a condition rating of three (3), it is recommended the end grains be treated to prevent further splitting.

*Whaler 1B*

*Typical external face condition*

*Typical internal face condition*

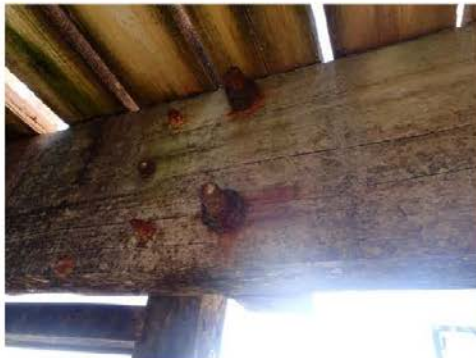
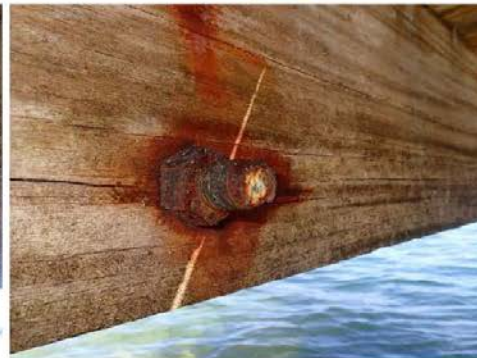
*Typical fixing condition*

*Typical fixing condition (1)*

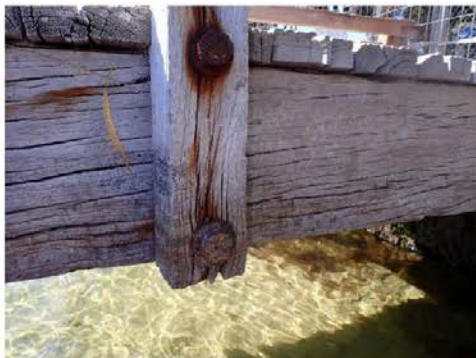
- Whaler 2A spanned between shore and Bent One (1) and was observed to be in an overall poor-average condition.
- Similar to Whaler 1A, the failure of Pile 1A on Bent One (1) has resulted in Whaler 2A being subject to significant stress. Subsequently, stress cracking can be observed in multiple locations on both the external and internal faces of the whaler.
- Whalers 2A and 2B are joined by a timber splice plate above the Bent One (1) on the internal side of the whaler. As the splice plate is small in length, fixings have been installed too close to the end of the whalers and splice plate causing the timbers to split at the end grain.
- All fixings associated with Whaler 2A were observed to be in poor condition subject to significant corrosion and are in need of replacement.
- Whaler 2A has a condition rating of five (5) and is recommended to be replaced.

*Whaler 2A*

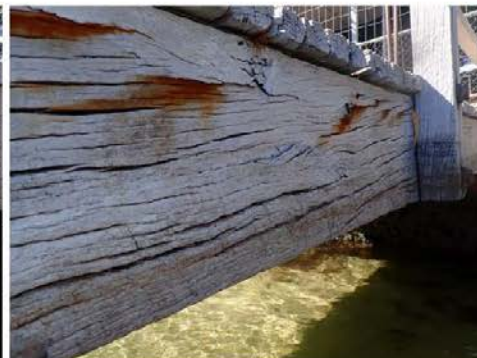
*Stress cracking external face*

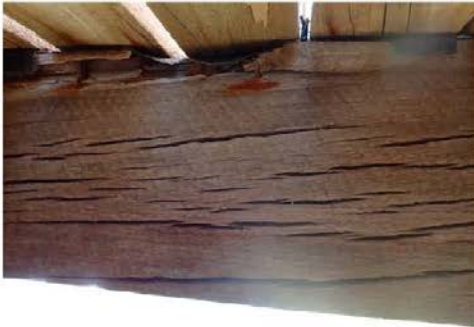
*Stress cracking internal face*

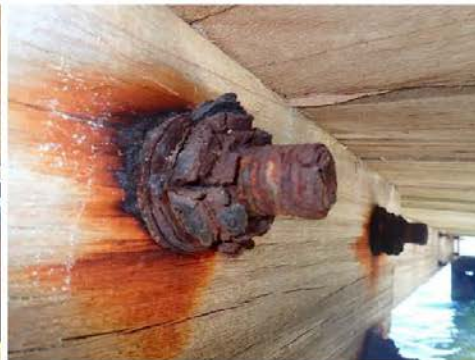
*Typical fixing condition*

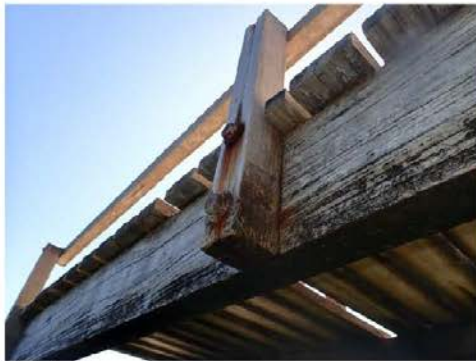
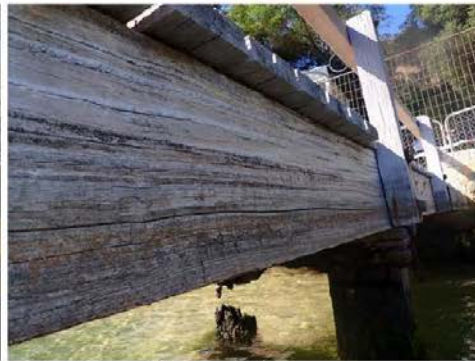
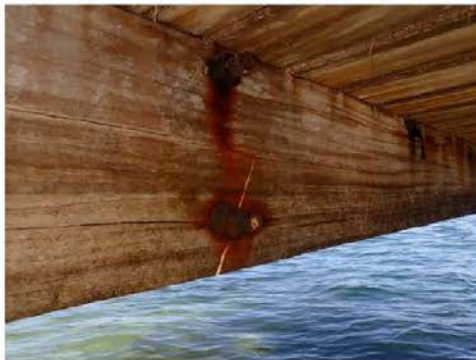
- Whaler 2B spanned between Bent One (1) and Bent Two (2) and was observed to be in average – good condition.
- Whaler 2B was subject to minor defects only predominantly in the form of small splits.
- All fixings associated with Whaler 2B were observed to be in poor condition subject to significant corrosion and are in need of replacement.
- Whaler 2B has a condition rating of three (3), it is recommended that the end grains be treated to prevent further splitting.

*Whaler 2B*

*Typical external face condition*

*Typical internal face condition*

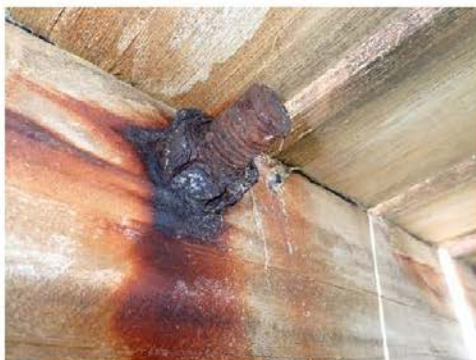
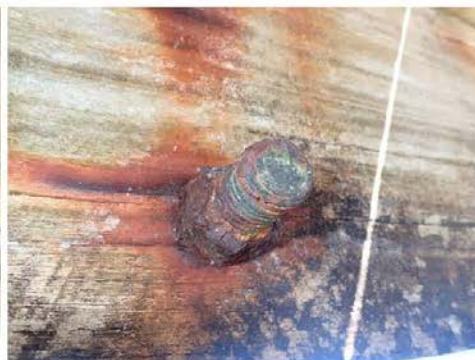
*Typical fixing condition*

*Typical fixing condition (1)*

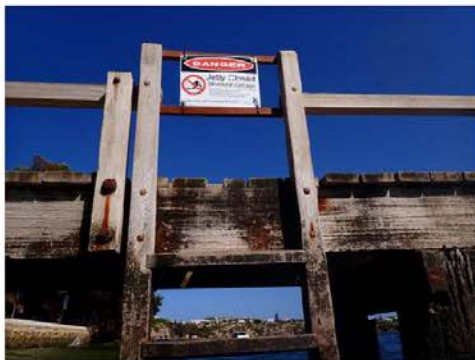
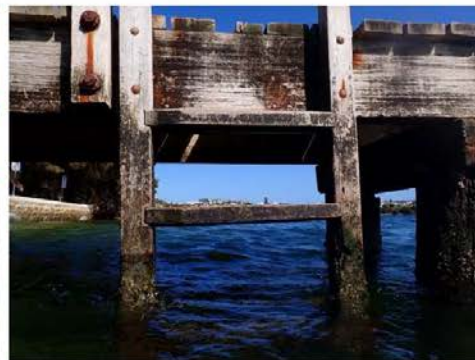
*Jetty Ladder above waterline*

*Jetty Ladder at waterline*

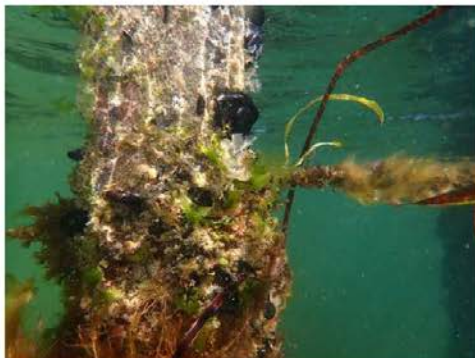
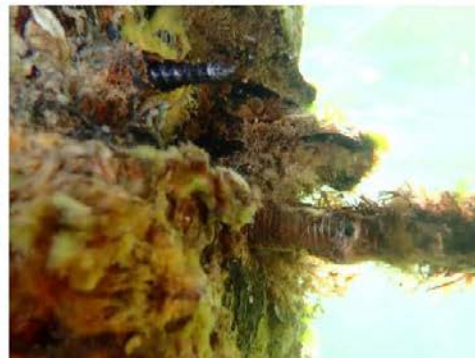
- The ladder was secured to whaler 2A and observed to be in average condition due to minor wood rot and splitting.
- The ladder's bottom rung is missing; however, coach bolts remain in position and are a hazard.
- All fixings associated with Ladder were observed to be in fair condition subject to minor corrosion and are in need of corrosion treatment.
- The Ladder has a condition rating of six (6) it is recommended that at a minimum the bottom rung is replaced, and the fixings have the corrosion treated.

*Jetty Ladder missing rung*

*Jetty Ladder exposed coach bolts*

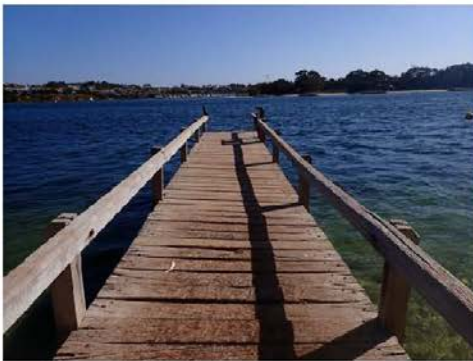
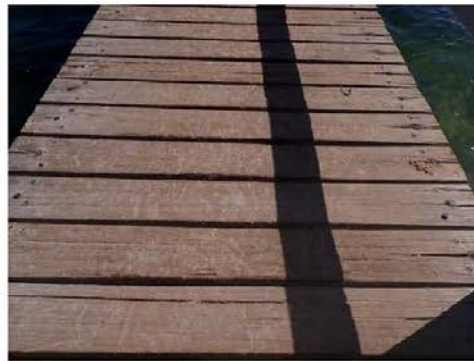
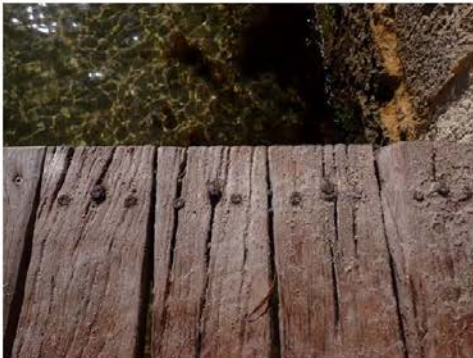
- The decking timbers were observed to be in an overall fair condition.
- Timber splitting was apparent on all decking timbers and appeared to be a result of a combination of: No end grain sealing resulting in moisture entering the timbers and; in some instances, the fixings are positioned too close to the end of the decking timbers causing splitting.

*Decking condition*

*Decking condition (1)*

*Typical splitting*

- The decking timbers have a condition rating of four (4), at minimum it is recommended that the end grains be sealed in effort to prevent further timber splitting, however, ultimately the timber decking will need replacing in the short to medium term (within 5 years). Any proud fixings are to be made recessed into the decking. Timbers with significant splitting are to be replaced immediately.

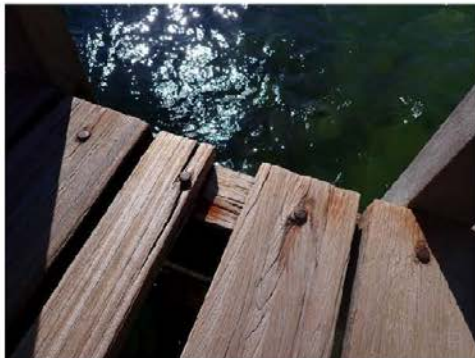
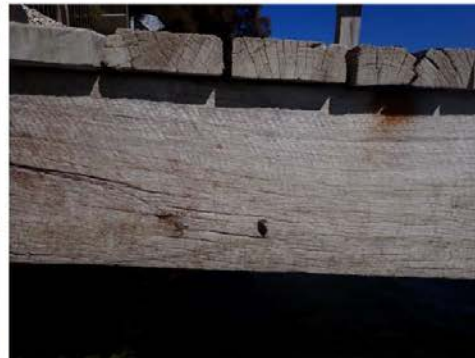
*Typical decking timber in need of replacement*

*Typical end grains untreated*

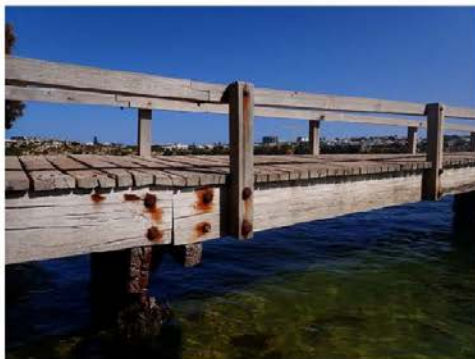
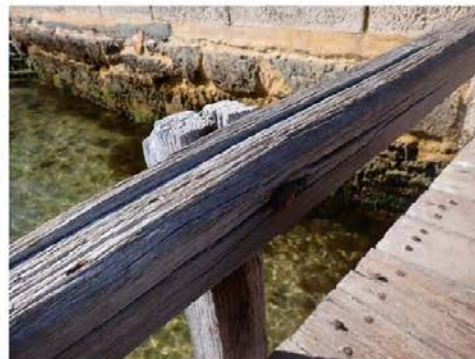
- The hand railing on the jetty was observed to be in an overall fair condition.
- Timber splitting was apparent on all hand railing components and appeared to be a result of a combination of: No end grain sealing resulting in moisture entering the timbers and; in some instances, the fixings are positioned too close to the end of the timbers causing splitting.
- The fixings associated with the decking timbers were generally in poor condition due to corrosion and are need of replacement.
- The handrails have a condition rating of five (5), it is recommended that all end grains be treated, and multiple sections be replaced, however ultimately ALL handrails will need replacing in the short to medium term (within 5 years).

*Handrail conditions*

*Handrail Timber splitting*

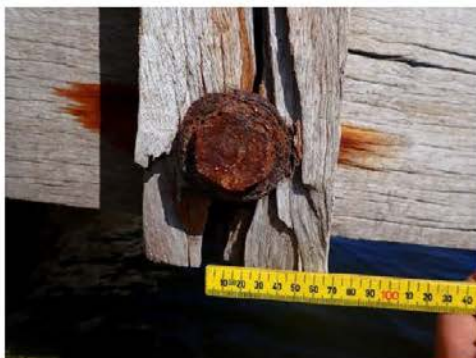
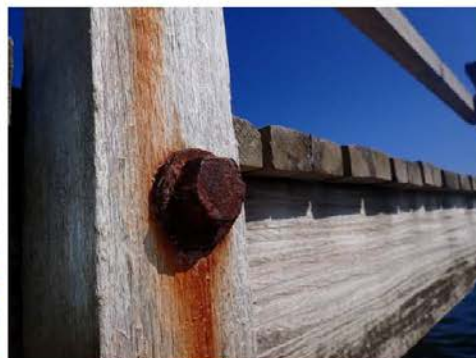
*Handrail fixing condition*

*Handrail fixing condition (1)*
