**PC2307-01 - HERBERT STREET, NO. 21 (LOT 23), NORTH FREMANTLE –
DEMOLITION OF EXISTING SINGLE HOUSE AND INCIDENTAL
STRUCTURES (JZ DA0127/23).**

Structural Integrity Report

Property Address: 21 Herbert Street North Fremantle 6159

Asbestos Inspection and Condition Report

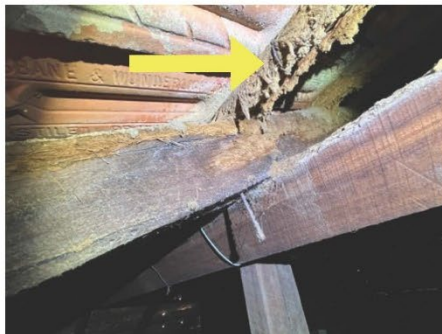
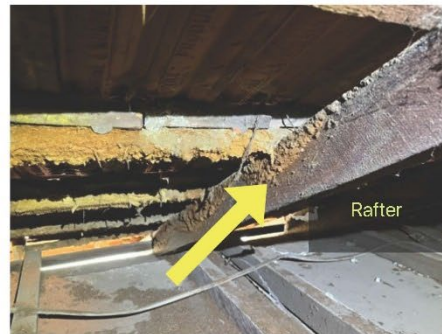
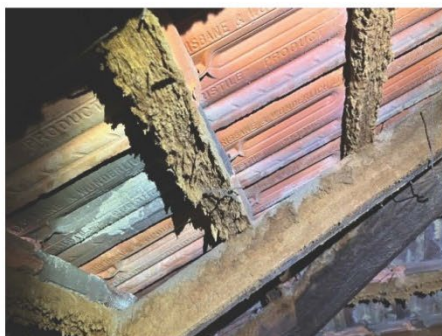
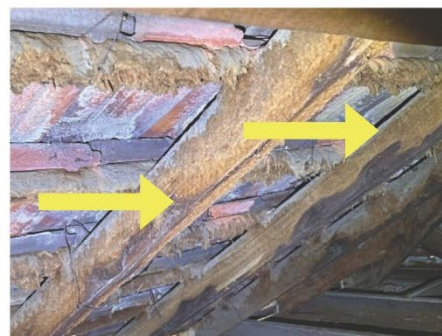
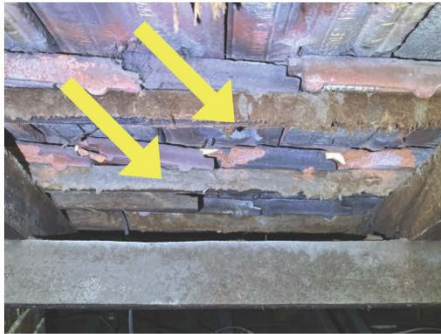
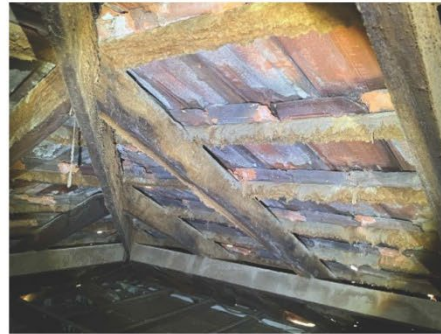
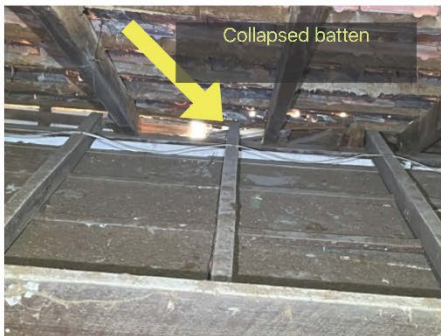
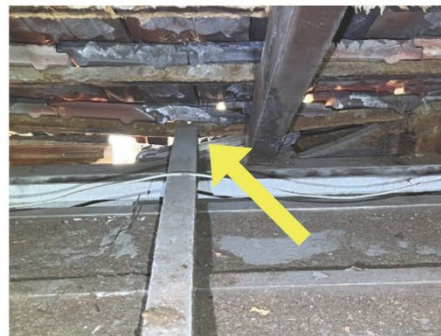
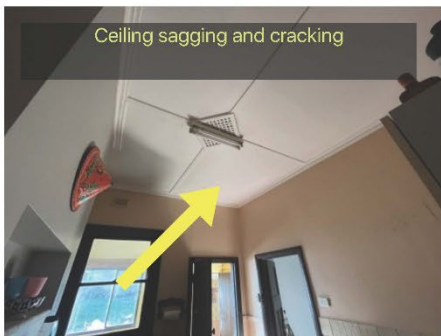
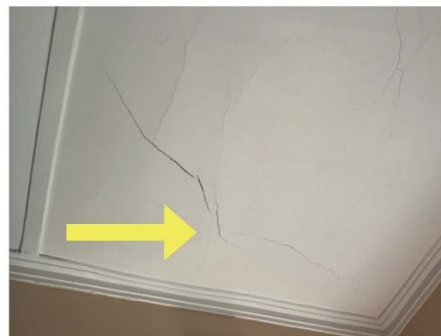
Safety Hazard 1.01

Location: Roofspace

Finding: Chemical Delignification - Compromised Roof structure

At the time of the inspection advanced stages of Chemical delignification were observed in the roof structure.

Chemical delignification is the chemical breakdown of lignin. Lignin is the “glue” that keeps wood fibres together.

Some of the roof battens have already collapsed due to the deterioration of the timber. This was also evident in the roof rafters which impacts the structural integrity of the roof.

When the tile battens collapsed the possibility of roof tiles falling through the ceiling becomes a safety concern. As can be seen in the photos the condition of some of the ceilings are also very poor.

Replacement of the roof is advised as chemical delignification is not treatable and the condition not reversible.

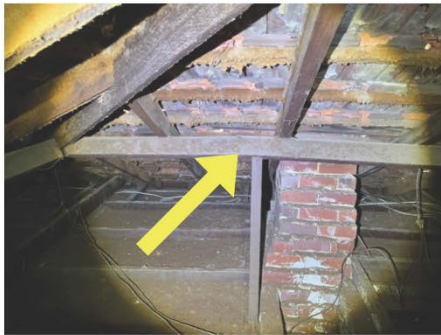
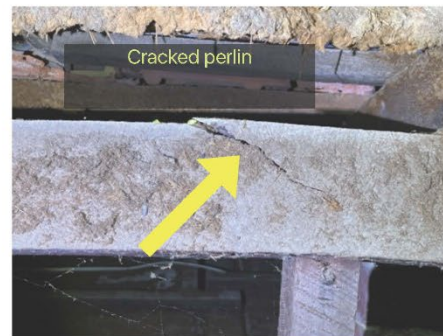
Major Defect 2.01

Location: Roofspace

Finding: Cracked Purlin or beam

At the time of the inspection a cracked purlin was observed.

Purlins are horizontal members that are supported by struts. The purpose of purlins is to provide intermediate support for the roof. The struts transfer the load from the struts to either a load-bearing wall or a specially designed joist. A purlin is considered a structural member and crucial to ensure the structural integrity of the roof.

Immediate consultation with a roof plumber or registered builder is advised regarding the repair or replacement of the purlin.

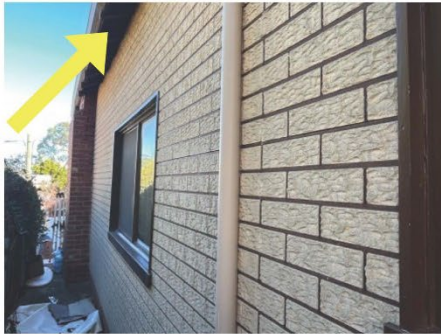
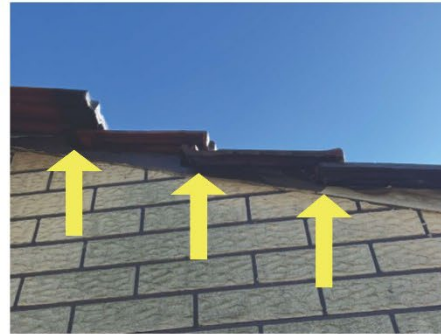
Minor Defect 3.01

Location: Roof exterior

Finding: Roof tile slippage

At the time of the inspection roof tile slippage was evident. This is a secondary defect caused by the poor structural integrity of the roof.

Complete roof replacement is advised.

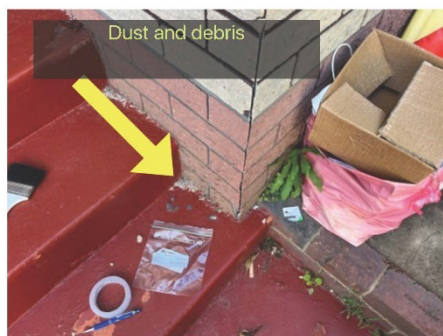
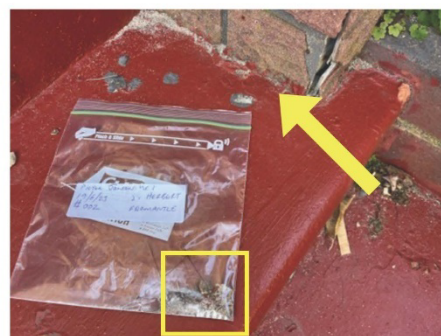
ACM - Urgent and Hazardous Condition 1.01

Several forms of artificial or fake brick 'look' cladding materials contain asbestos. At the time of the inspection, the observable areas of the cladding appear to be subject to damage and deterioration and/or points of attachment or fixings appear to be in an unsealed condition.

Damaged and deteriorated ACMs have a higher probability of releasing airborne asbestos fibres creating a significant health safety risk.

A Sample was taken from debris found on the entrance steps for lab analysis to confirm the presence of asbestos. The debris comes from the deteriorating fake brick cladding.

Deteriorating cladding were evident all around the property. See associated photos for more details. The results from the lab tested positive for asbestos. Chrysotile Asbestos and Amosite Asbestos were detected.

Immediate consultation with a Licensed Asbestos Removal firm and registered builder is highly recommended.

No works should be carried out to the ACM or associated building elements without further specialist advice.

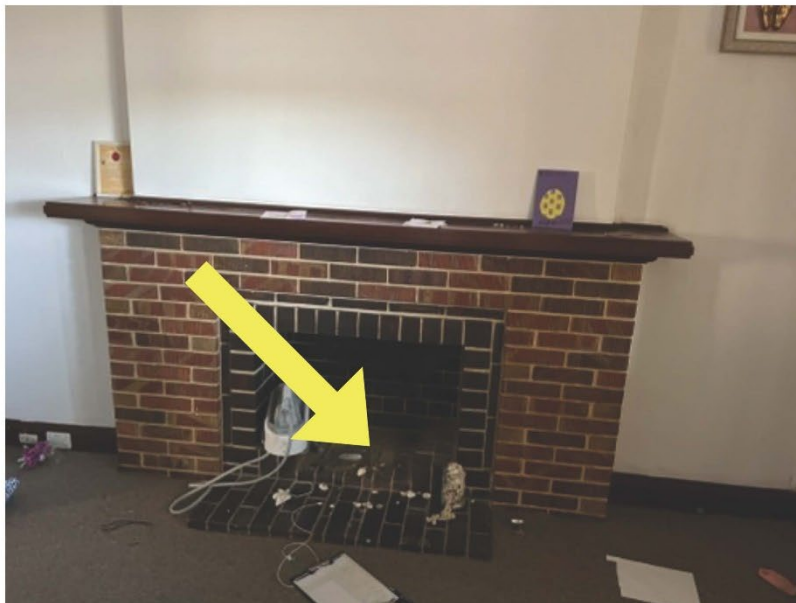
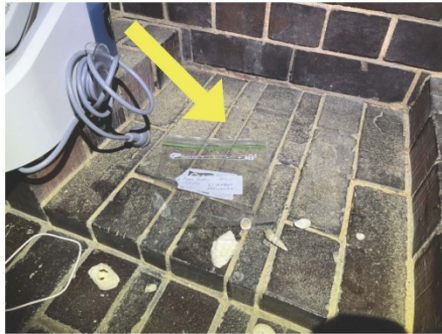
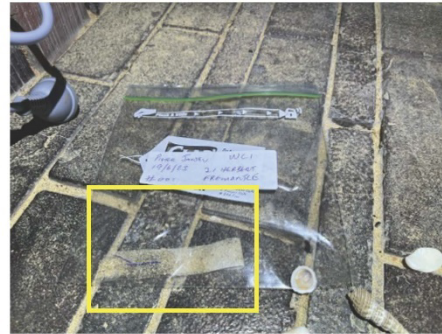
The rendering inside the chimney of the fireplace is suspected to contain asbestos. Asbestos were used in and around fireplaces for it's excellent heat resistant properties. The rendering is in a deteriorating state and in poor condition.

A sample were taking for analysis to determine the presence of asbestos. The lab results returned negative for asbestos.
