Additional information

Planning Committee

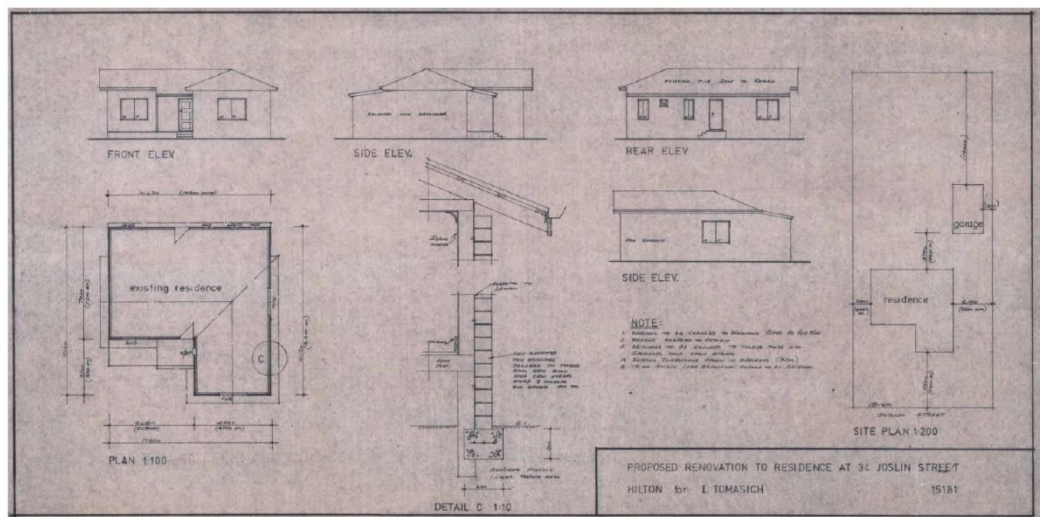
Plan for installation of brick veneer and aluminium windows, 1981, Property file, City of Fremantle Archives.

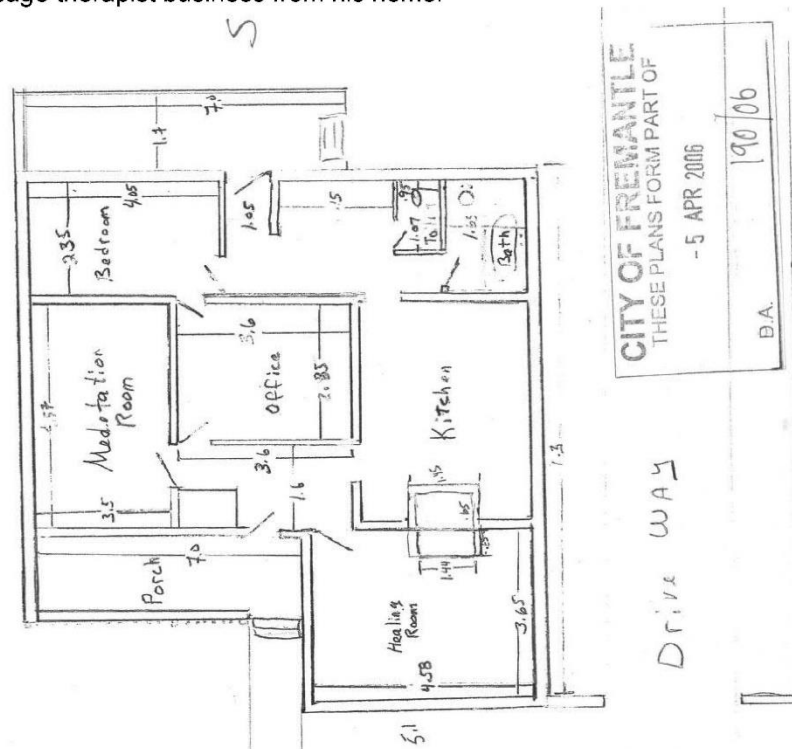
34 Joslin Street remained in the ownership of Robert Smith until 2021 when it was sold on his behalf by the Public Trustees due to his ill health. By this time the property was vacant and had fallen into disrepair. A fence was erected around the property to prevent public access due to concerns about public safety.⁸

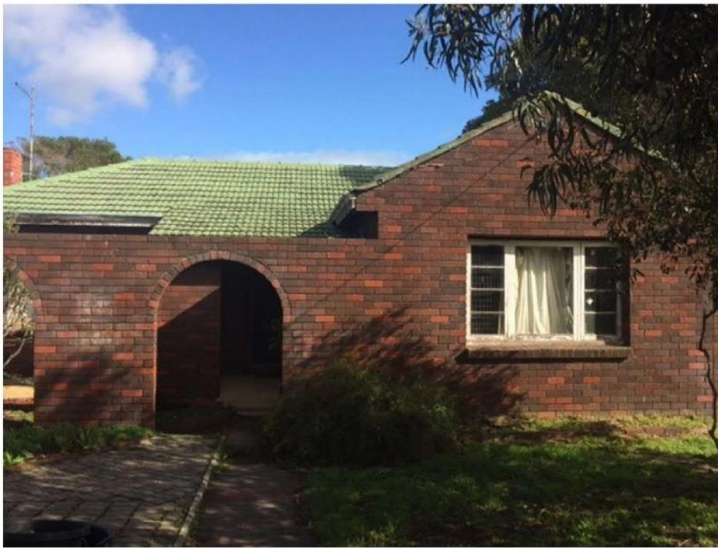
Street elevation, 93 Collick Street showing 1970s brick veneer cladding, original timber framed windows and courtyard wall with original porch and hip and gable roof beyond, August 2020

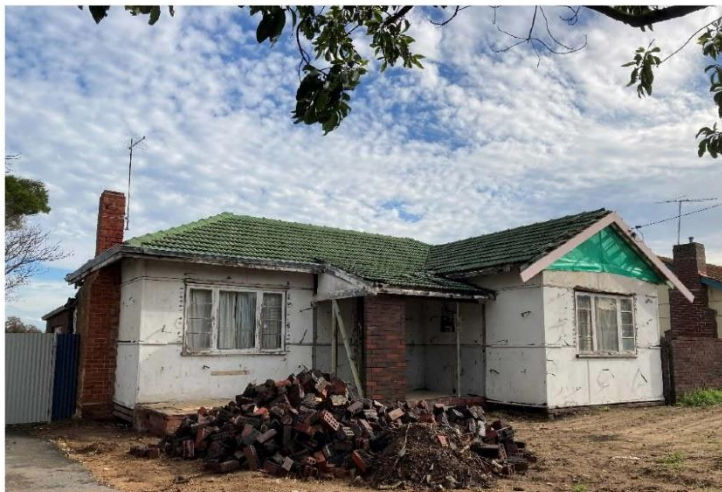
93 Collick Street following the removal of the 1970s brick veneer cladding to reveal the largely intact original Hilton house, June 2021. The brick tie straps were fixed to the face of the original external wall cladding.

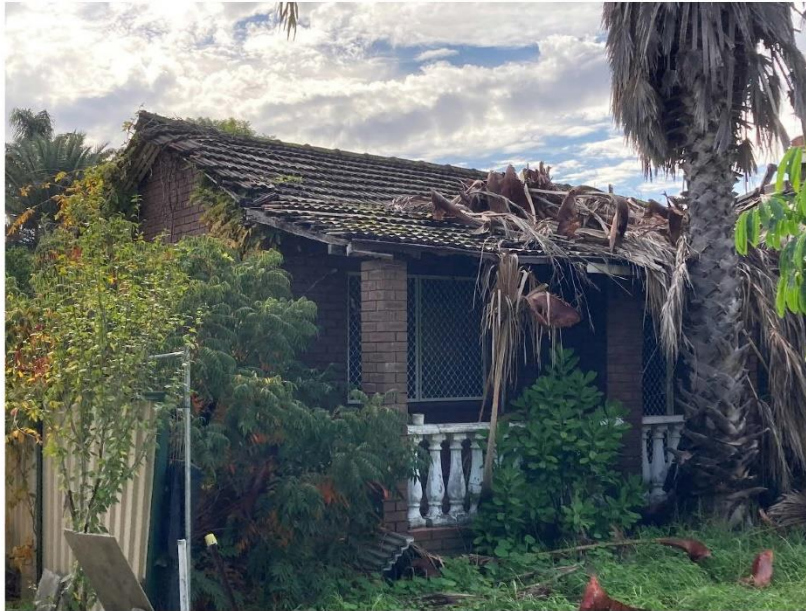
PHOTOGRAPH 1 Joslin Street elevation (south) showing deteriorated roof trims, eaves and bowing and collapsing section of roof.

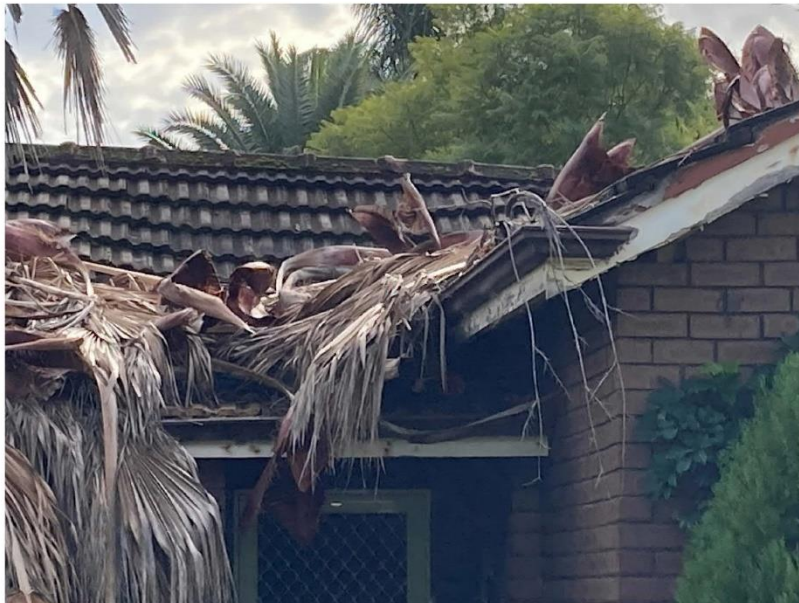
PHOTOGRAPH 2 Detail of collapsing section of roof above front entry hall

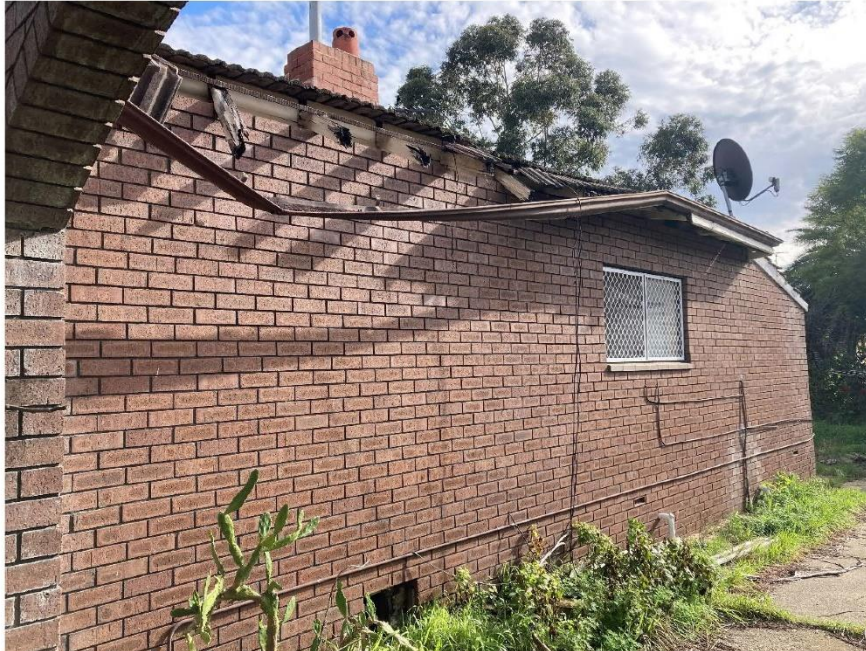
PHOTOGRAPH 4 – East elevation showing deteriorated gutter and collapsing eaves. Note sub-floor access hole to base of wall and the original red face brick chimney.

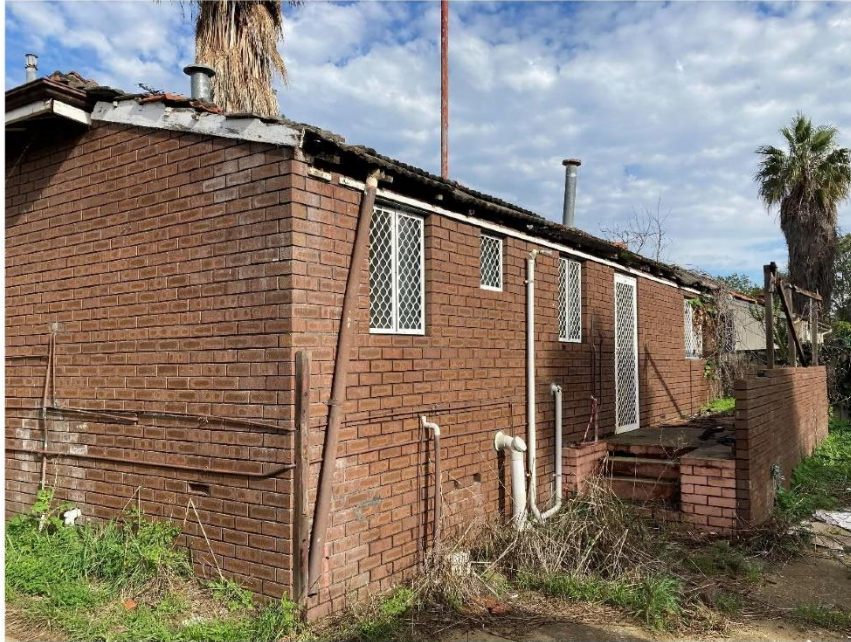
PHOTOGRAPH 5 North-east corner of the house. Note the different character of the bricks to the original rear porch and steps and the later brick veneer addition.

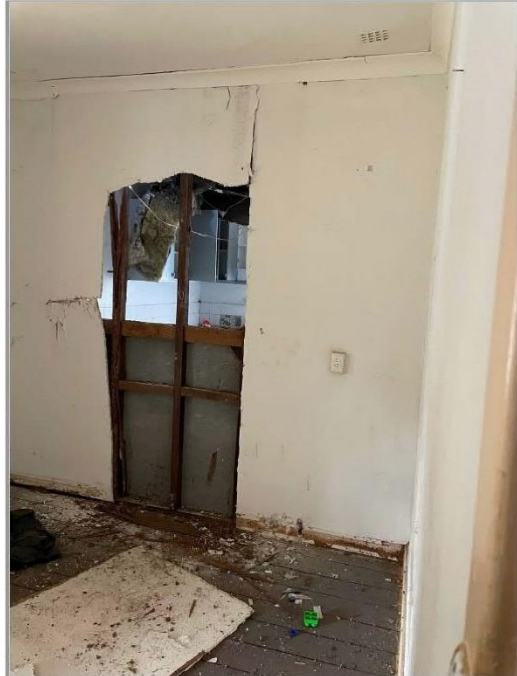
PHOTOGRAPH 11
Bedroom 2. Wall cladding removed to reveal
termite damaged timber wall studs and noggings
to internal wall of house.

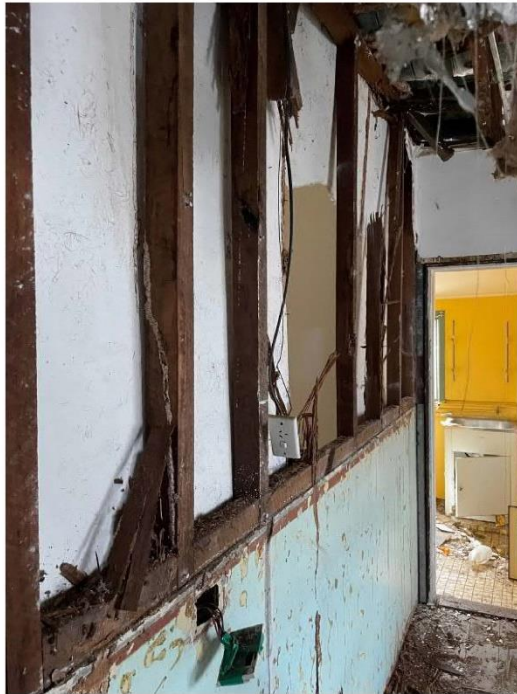
PHOTOGRAPH 12
Kitchen looking toward enclosed rear verandah –
other side of wall shown in photograph 10.
Termite activity in timber wall studs and
collapsing ceilings with termite damaged ceiling
joists.

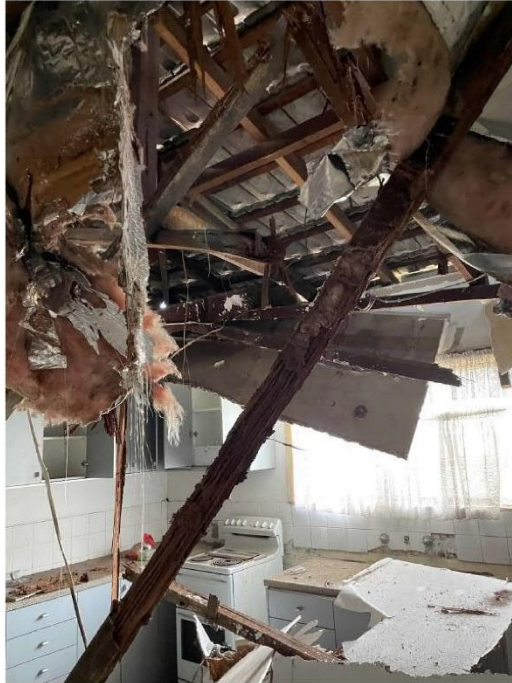
PHOTOGRAPH 13
Kitchen. Collapsing ceiling and termite damaged ceiling joists.

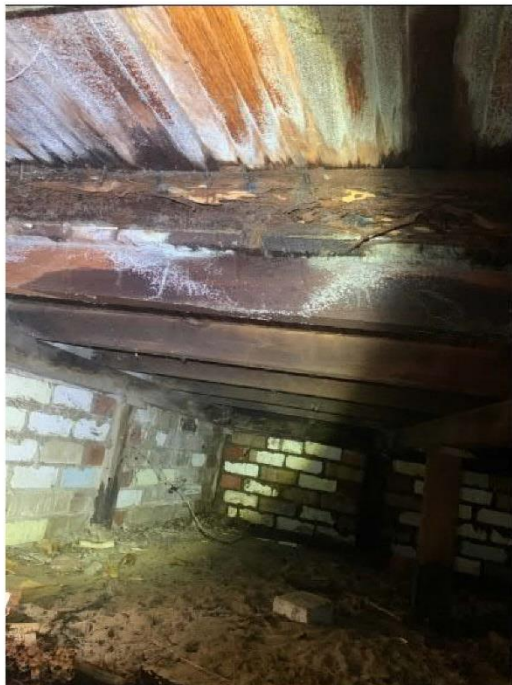
PHOTOGRAPH 14
Sub-floor space (from termite inspection report June 2021). Termite damaged floor joist and extensive white mould fungal wood rot.
