# Additional information

## Planning Committee

Wednesday, 5 May 2021, 6.00pm

**PC2105-1 COMMERCIAL STREET NO.6 (LOT 27), SOUTH FREMANTLE –  
PARTIAL RECONSTRUCTION OF EXISTING SINGLE HOUSE AND  
SINGLE STOREY ADDITIONS AND ALTERATIONS (JL DA0316/20)**

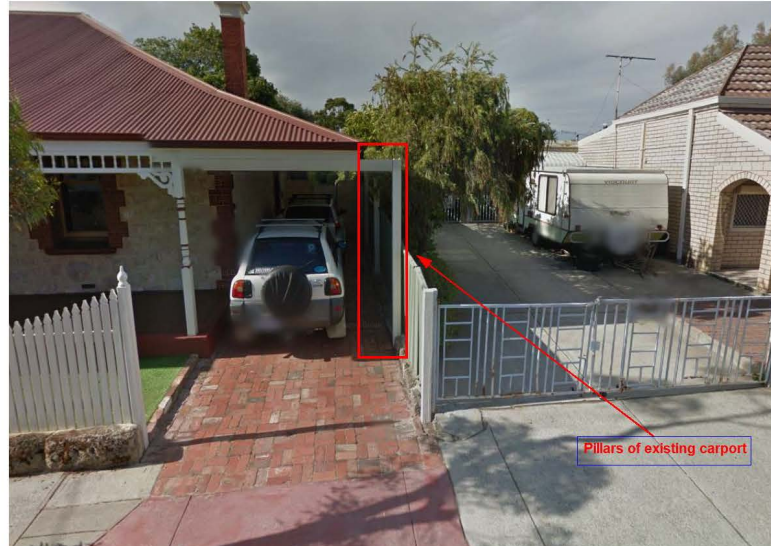
**Image 3:** Carport including posts located on the boundary of adjoining property at 4 Commercial Street.

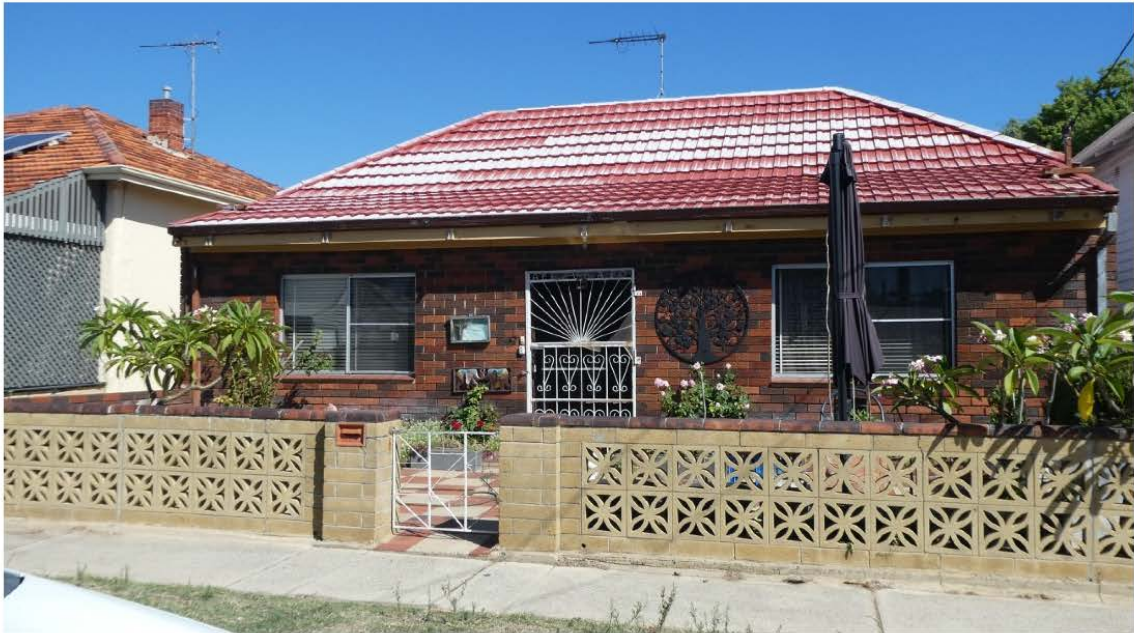
FIGURE 6 15 MCLAREN STREET - FACADE

The property today presents with a variegated red brick facade of symmetrical planform, no verandah and a hipped roof which continues down at a broken pitch to form the roof over the front two small rooms.

The roof is hipped and appears to be the original form. The decramastic cladding dates from the 1960s and is in a failing condition. The original cladding is likely to have been corrugated galvanised iron, laid in short sheets. The verandah canopy will also have been corrugated galvanised iron.

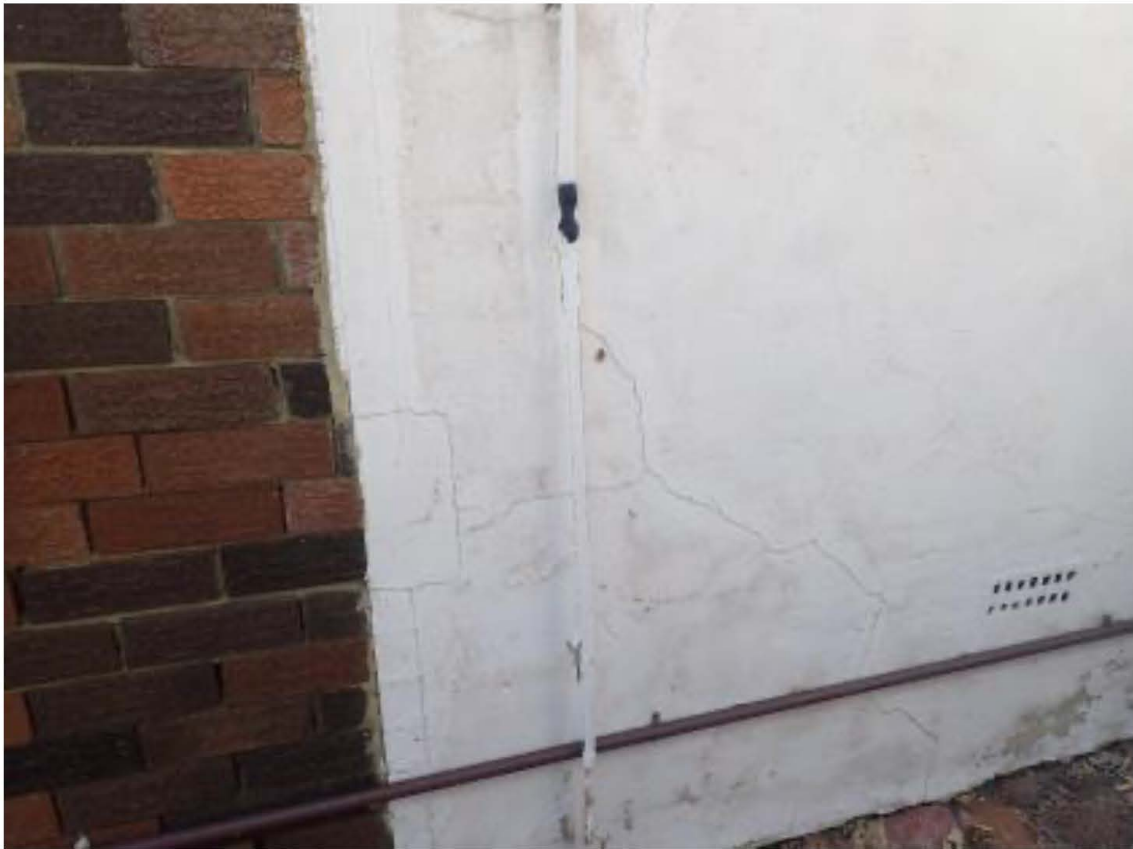
FIGURE 7 CRACK ADJACENT TO BRICK VENEER

The side elevations have been rendered over with a cement render. There is a crack in the render to both the side elevations, approximately one brick width wide and adjacent to the brick veneer. This coincides with the non-original brick cladding to the original frontage of the cottage. It appears that the brick cladding has been affixed to the non-original rendered facade.

The cement render is failing in places to both elevations.

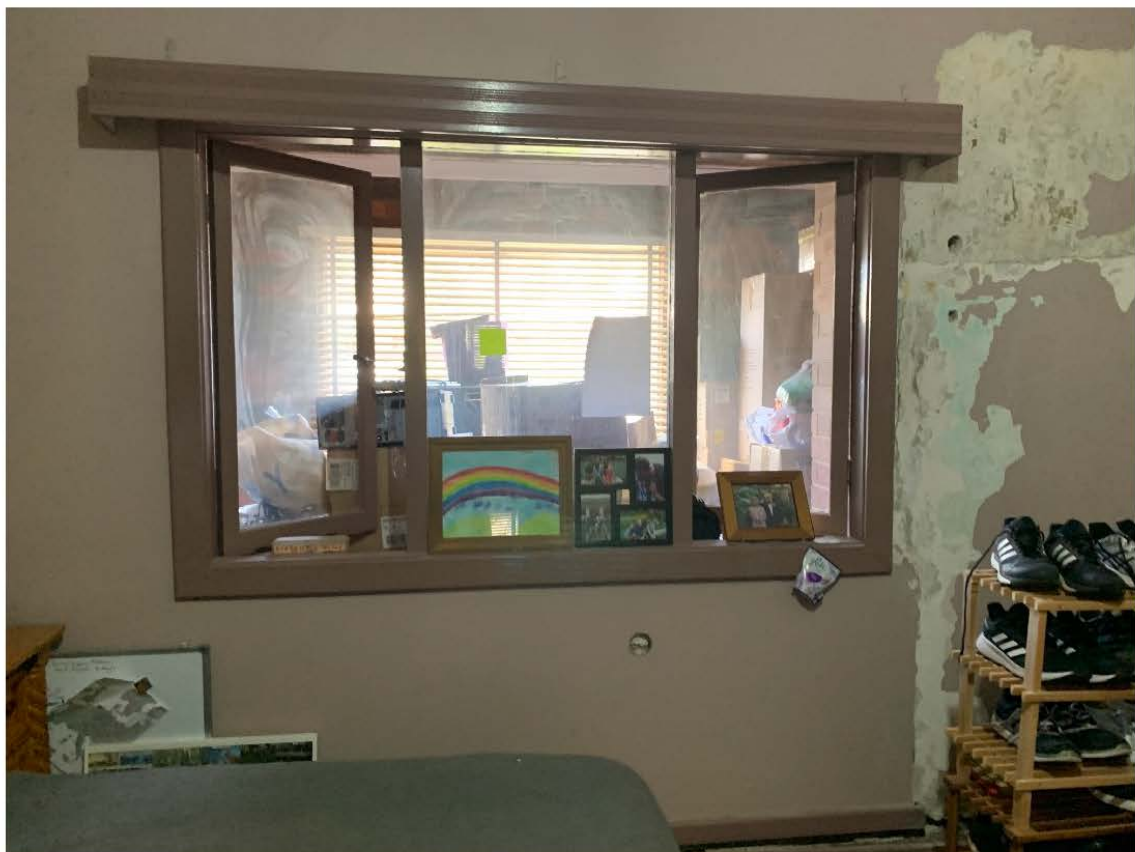
FIGURE 8 REPLACEMENT WINDOWS IN FRONT TWO ROOMS

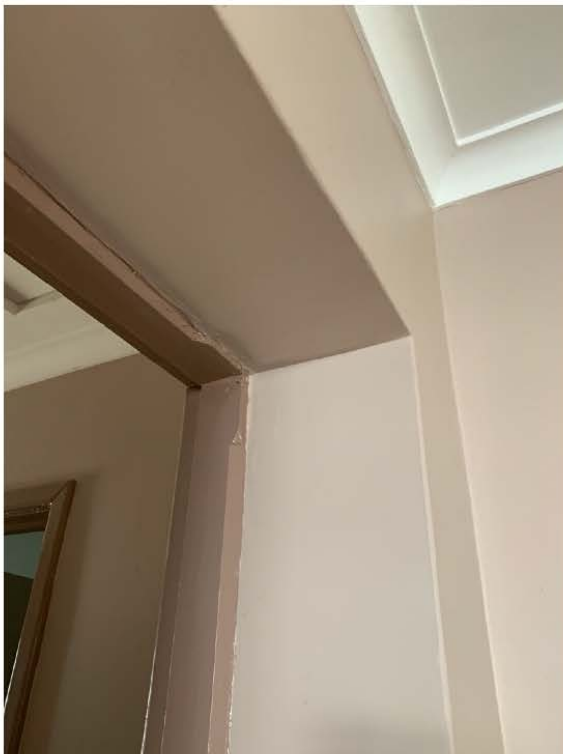
The internal walls are approximately 120mm deep and are of brick construction. The wall between the hallway and lounge (the original rear wall) is considerably deeper and are approximately 250mm deep which would be consistent with limestone construction. The front wall is slightly deeper due to the brick veneer. The walls are lined with a hard render which is definitely cement render in places.

FIGURE 9 WIDTH OF ORIGINAL REAR WALL

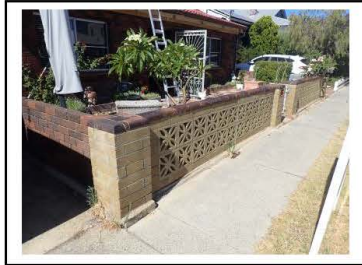
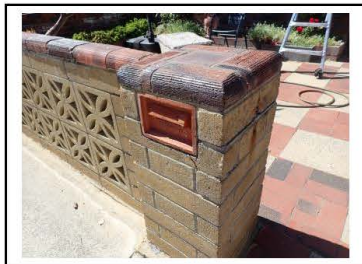
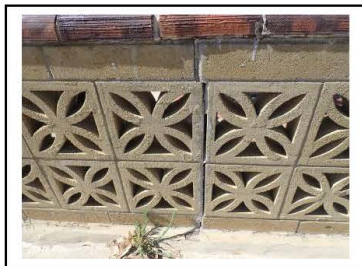
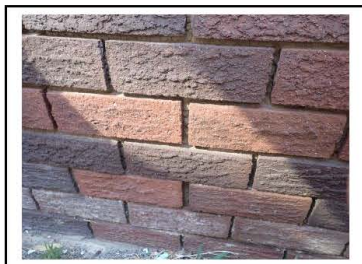
Front boundary walls are around 40-50 years old. Currently stable, however fretting mortar joints and cracking requires attention/repair.

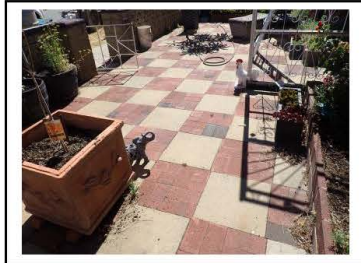
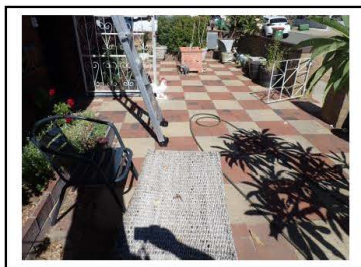
Concrete pavers and slabs  
present as stable and in fair  
condition.

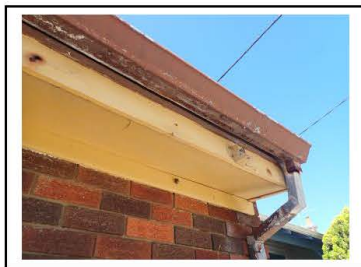
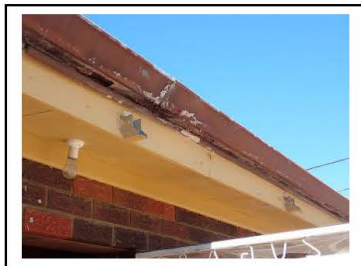
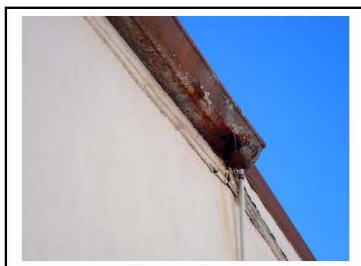
Gutters and downpipes are badly corroded and perforated in multiple areas. Not performing as intended.  
Conducive to Termite attack.

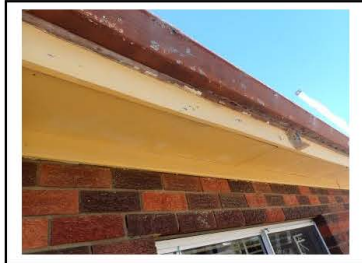
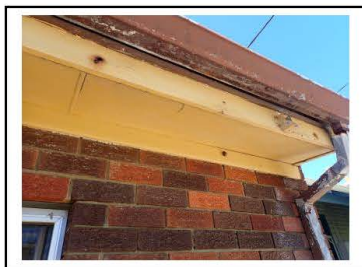
Fascias, trims and eaves  
sheets require painting.

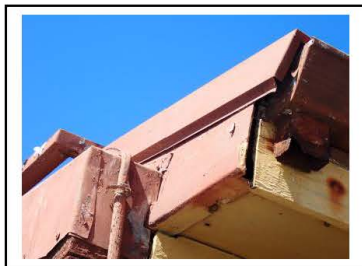
Cover boards to each end are  
possible asbestos containing  
materials.

**SAFETY HAZARD**

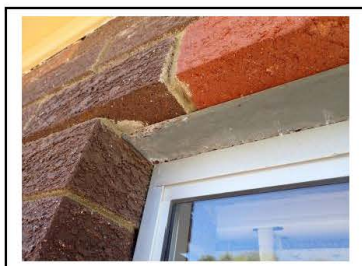
Early/ spot corrosion to lintels.

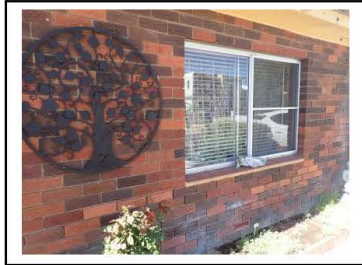
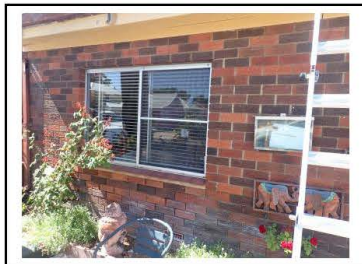
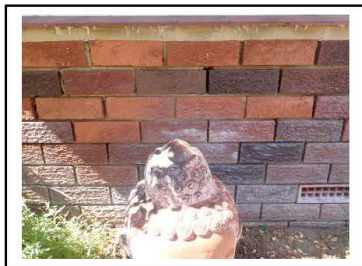
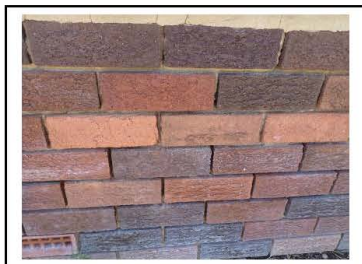
Lean-to addition is built using "Moroccan Leather Barkface" bricks of 230mm solid construction. Aluminium windows are incorporated. Mortar joints are fretting in numerous areas. Multiple spalling bricks also present.

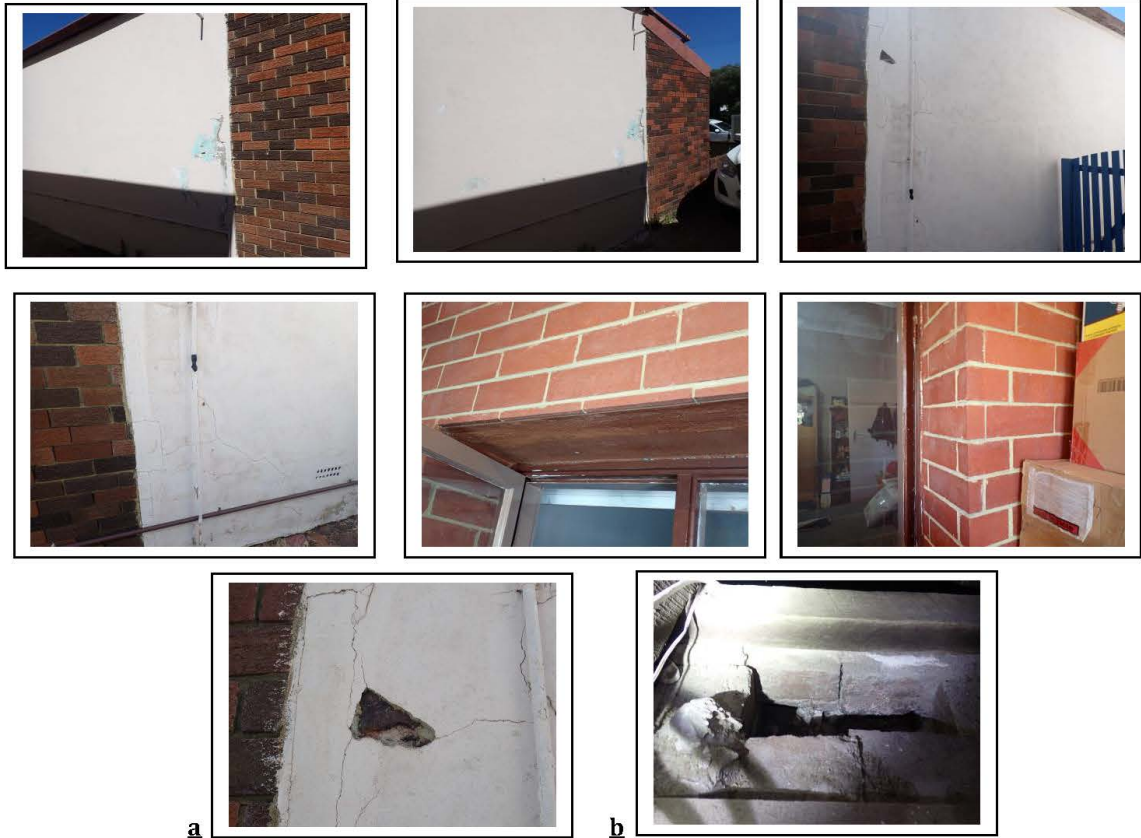
Original exterior walls are thought to date from the 1890's and appear to have been constructed using common/ rough bricks with a rendered finish. This is corroborated by viewing from the damaged area of render and at the top of the walls within the roof loft space. (See pics a & b). A common brick façade has been added more recently, however this has been poorly constructed with bricks cut both horizontally and vertically by more than half their original size. The brickwork is not correctly aligned. Rendered flank walls have bubbling and damaged areas of paintwork consistent with water penetration. There are numerous cracks to render and surfaces are "Drummy" indicating that adhesion to the underlying brickwork has been compromised.

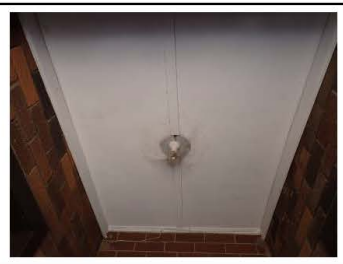
Ceiling boards are possible asbestos containing materials.

**SAFETY HAZARD**

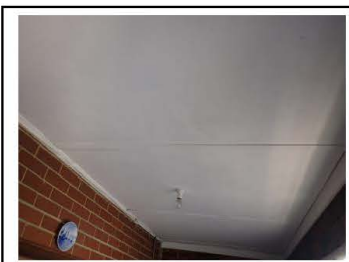
Ceiling boards are possible  
asbestos containing materials.

**SAFETY HAZARD**

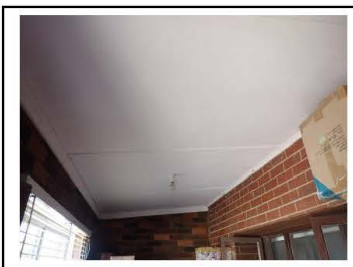
Ceiling boards are possible  
asbestos containing materials.

**SAFETY HAZARD**

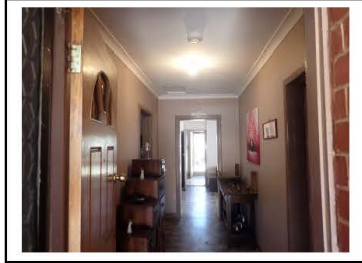
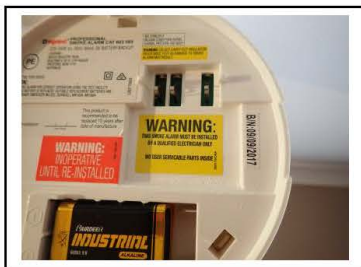
### Room Four: Entrance Hallway

Smoke alarm, hardwired,  
dated: 09/09/2017. Replace  
2027.

- Doors operational – Yes
- Windows operational – N/A
- Some areas of timber floor are “springy”. This often indicates underlying structural damage from fungal decay or Termite attack.

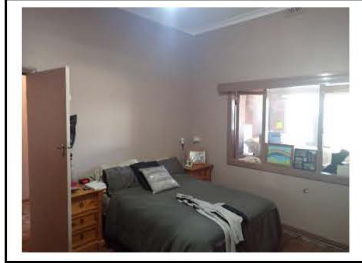
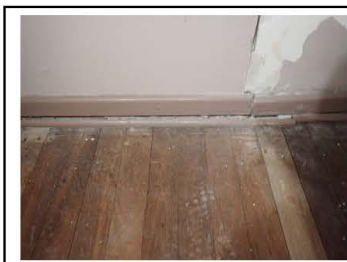
### Room One: Front Bed 1

Timber floor is "springy" in multiple areas and is dropping towards the front wall. Underlying structural damage appears to have occurred.

**MAJOR DEFECT  
(Structural)**

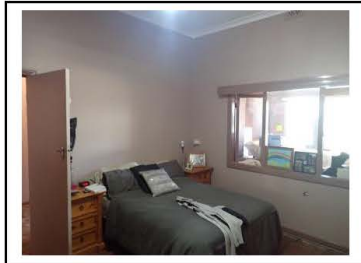
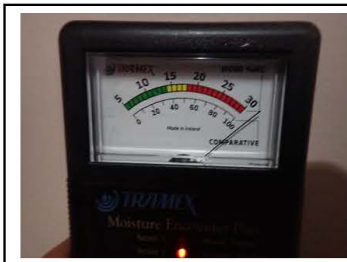
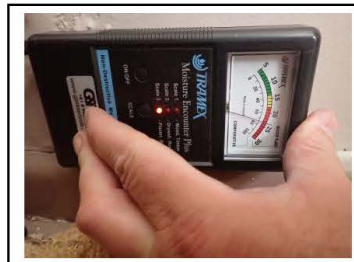
### Room One: Front Bed 1 (Cont.)

Bubbling paint and damaged plaster to both front and rear walls. High moisture readings to base of walls indicating rising damp.

- Doors operational – Yes, however does not latch shut.
- Windows operational – Yes

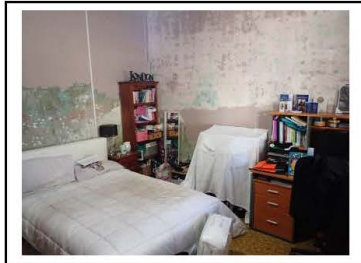
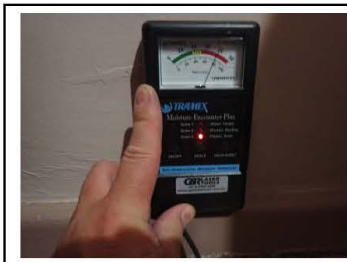
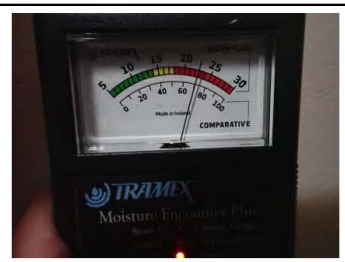
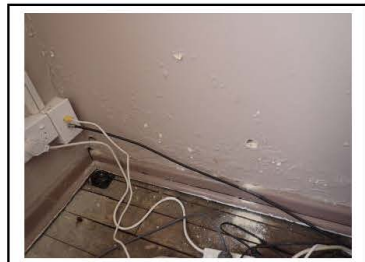
### Room One: Front Bed 2

**Bubbling paint and damaged plaster to both front and rear walls. High moisture readings to base of walls indicating rising damp.**

- Doors operational – Yes
- Windows operational – Yes, however latching handles damaged and not operating as intended and 1x opening binding with frame.
- Some areas of timber floor are “springy”. This often indicates underlying structural damage from fungal decay or Termite attack.

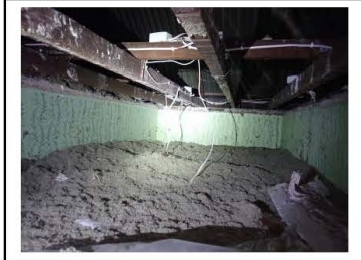
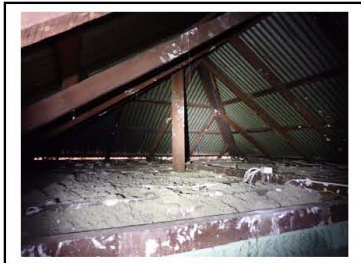
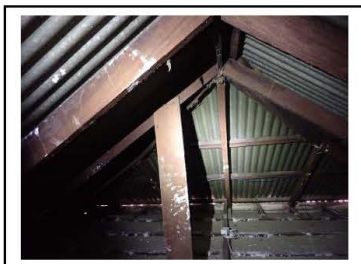
Roof framework presents in fair condition and free of any significant visible defects affecting structural integrity.

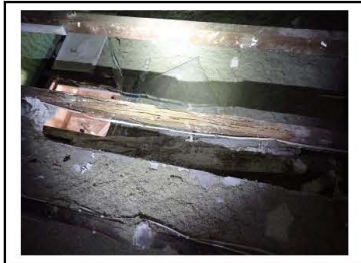
Termite damage to joist.

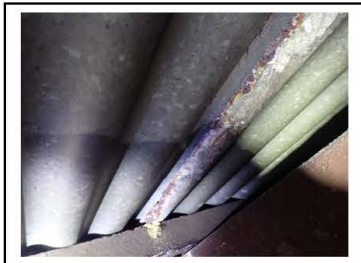
Multiple areas of corrosion to roofing sheets.

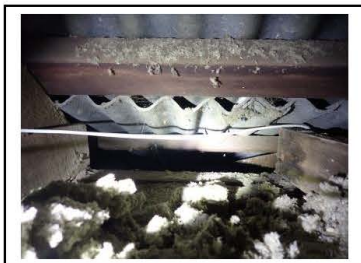
Original roofing sheets over front lean-to structure are possible asbestos containing materials.

**SAFETY HAZARD**

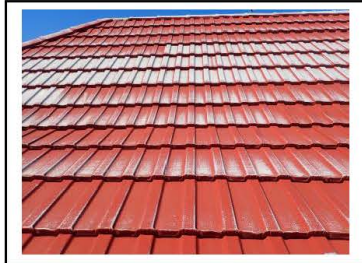
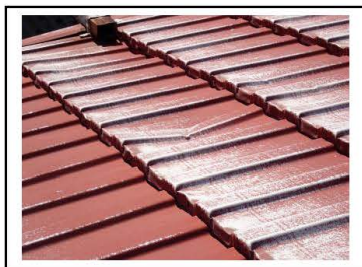
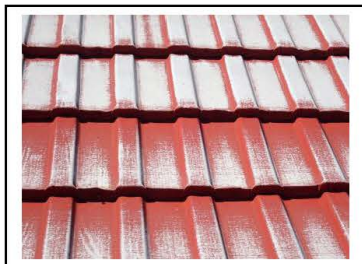
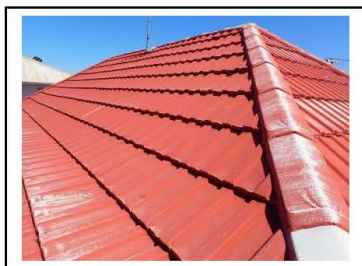
Steel sheet roofing is weathered/ faded and has multiple areas of damage/ denting. Internal corrosion indicates some water penetration.
