# Additional information

## Ordinary Meeting of Council

| Contents | | Page |
|---|---|---|
| FPOL2104-11 | ROUND HOUSE CONSERVATION MANAGEMENT PLAN | 54 |

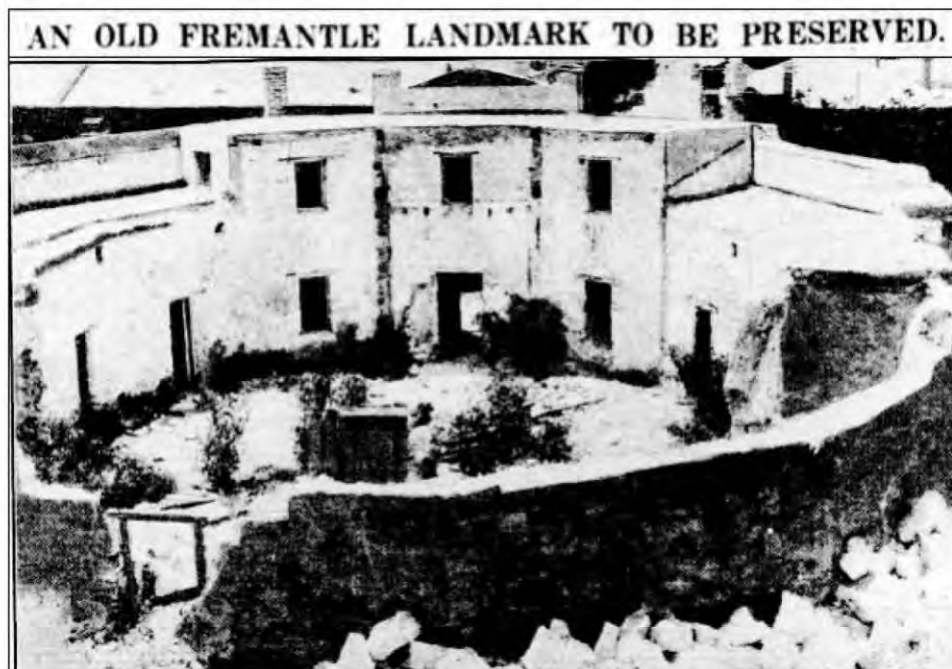
Figure 28: Prior to the repairs April 1929 showing the collapsed wall and loose stones. Courtesy *The West Australian*, 18 April 1929, p. 22.

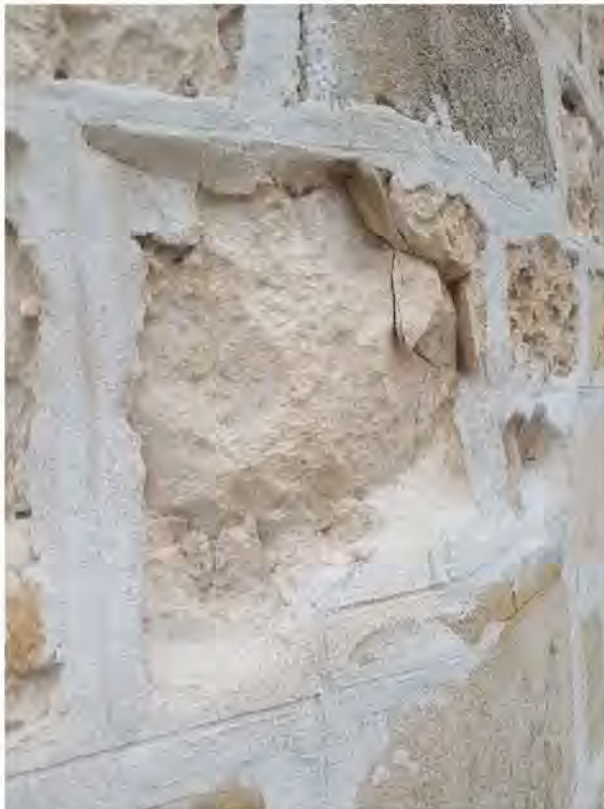
Limestone is susceptible to weathering because it is a porous stone. The cap rock is much less porous than strata stone (found lower down in the rock layers), which is why it was used for the original building, but later works included more porous limestones that are more susceptible to weathering. The porous nature of the stone allows water and salts to get into the stones themselves, increasing expansion and contraction forces and resulting in a breakdown of the stone matrix making the stone more vulnerable to erosion. Wind erosion, water erosion and even damage by people is then more readily developed on the stone surface and the limestone block starts to show signs of pitting, delamination and fretting eventually leading to hollows in the stone. When cement mortars are used with the weaker and more porous stone of limestone this process tends to get accelerated because the mortar holds the water in the stone and creates worse weathering effects as a result.

Figure 28: Limestone block weathering NE external wall

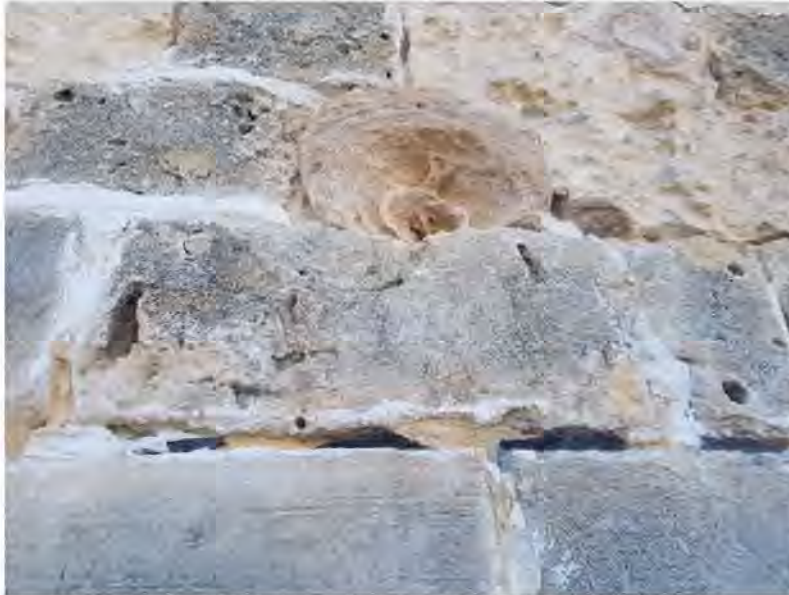
In some cases the natural composition of the limestone formation that makes up the block that was used for construction creates veins and faults through the block that make the masonry more susceptible to spalling. This can be seen in a few locations over the Roundhouse walls where the face of the block has a large cavity created as a result of its natural strata:

Figure 29: Natural strata of limestone block causing cavity in face

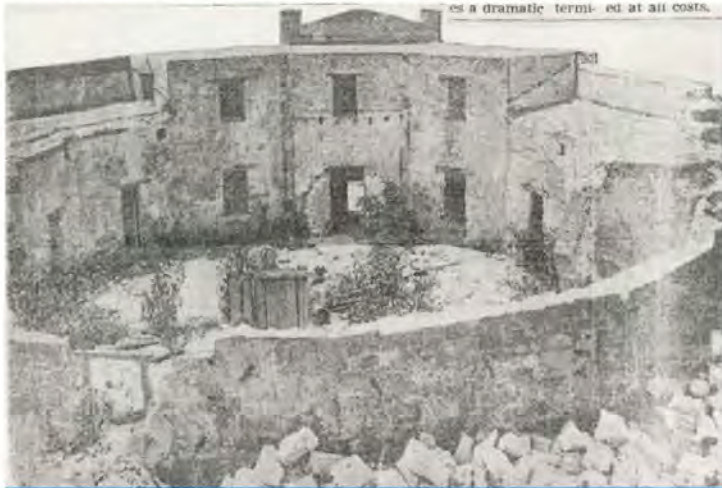
Figure 34: Collapsed wall sections 1929

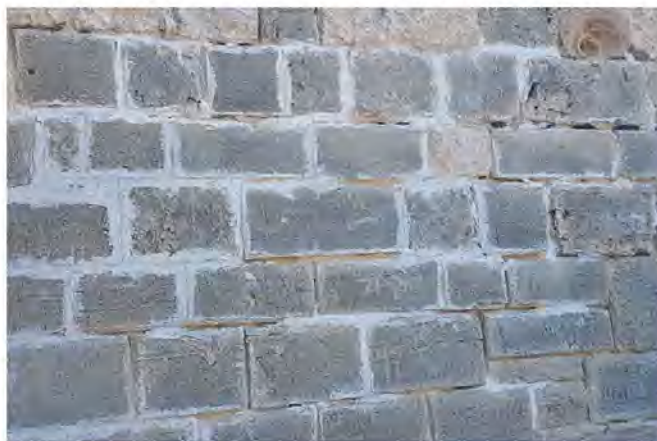
It is evident when inspecting the external walls of the Roundhouse that some of the 2004 mortar re-pointing has already come away. This is particularly evident on the NW side where the mortar joints are back to the previous mortar once more. Now that the 2004 mortar has weathered away in places we can also see what appears to be the remaining cement mortar in the bed joints and perp joints behind meaning that substantially deeper re-pointing will be required to remove the cement mortar from the wall. Because the 1975 works appeared to have included a large amount of replacement facing stone blocks (~100mm thick units), repointing to remove all of the cement mortar will require digging into the mortar joints that full depth. Leaving the cement mortar in the wall and re-pointing over it to a depth of approximately 25mm or so could be a contributing factor to the 2004 mortar having become weak and weathered to the state we see it in today. The cement mortar can trap water in the lime mortar pointing and wash out the lime quicker causing it to become weak.

Figure 37: 2004 re-pointing now weathering from joints

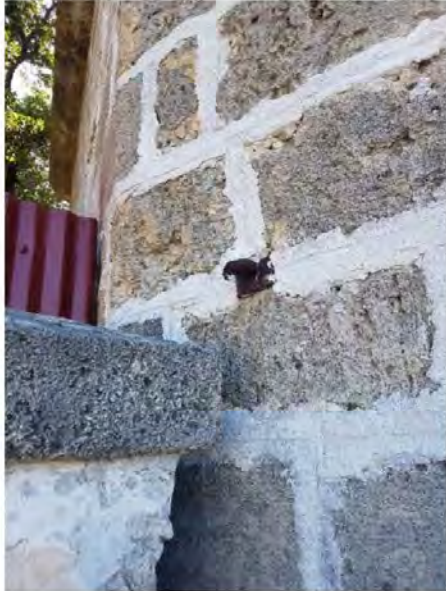
Most steel embedments appear to have been generally removed from the walls, however a few still remain. On the NW and West sides these items are heavily rusted.

Figure 40: Steel embedment for removal - NW side

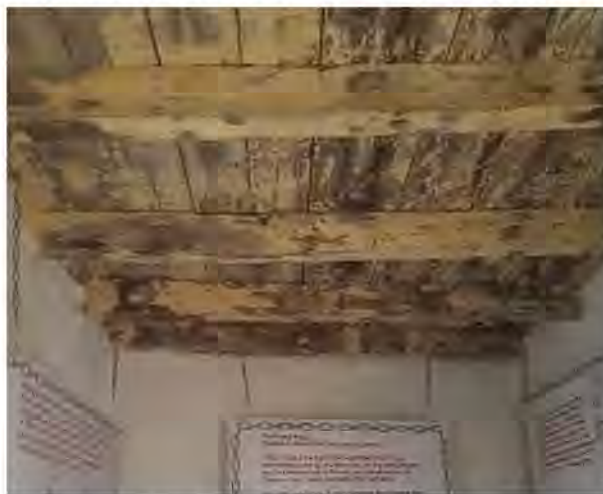
The joists are in reasonably sound condition with only a few minor shakes and splits in them in a couple of locations. They are well bedded into the walls with adequate bearing and no signs of rot or decay.

Figure 45: 1st floor joists

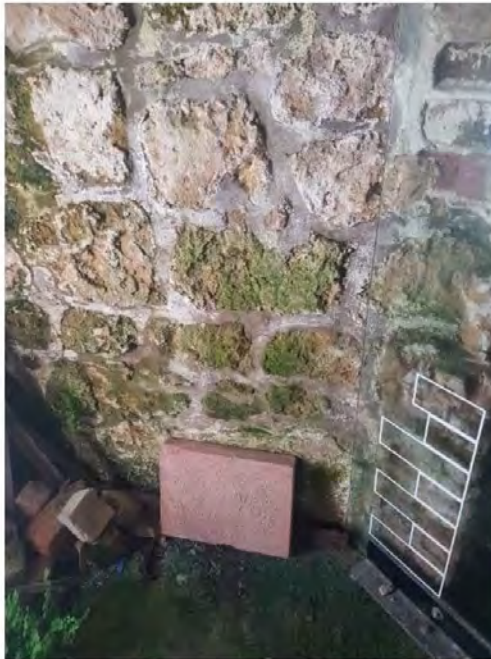
Figure 55: Biological growth on bakehouse walls

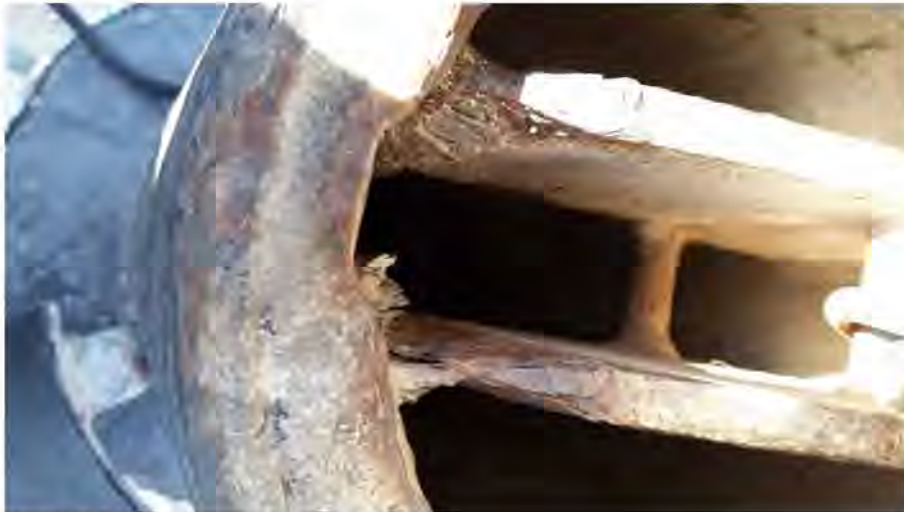
Figure 63: Corroded Pulley plates

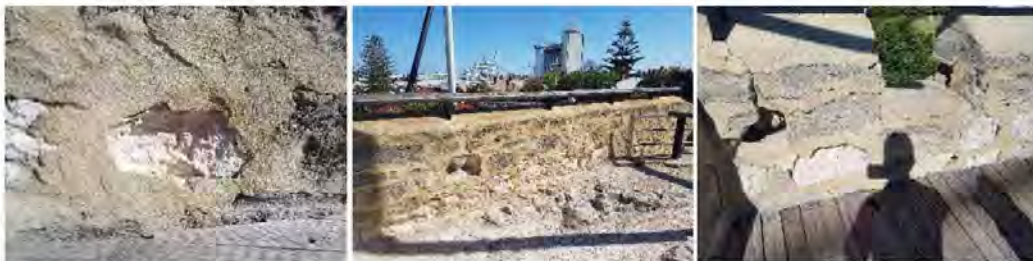
Figure 66: Weathered limestone walls

We recommend that captive head washing is carried out on the Roundhouse annually to reduce the risks of salts and airborne pollutants causing excessive weathering damage to the limestone.

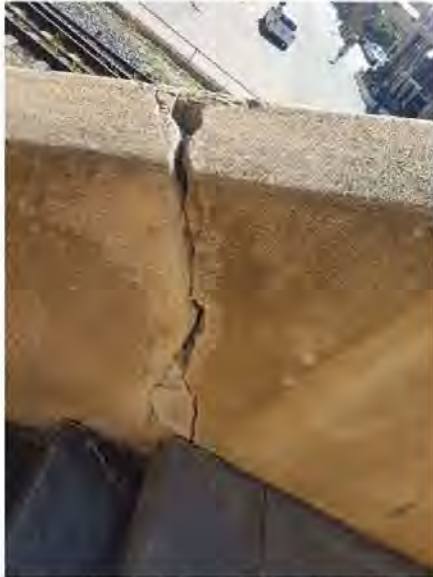
Figure 67: Longstanding, severe, but stable crack to walls of steps

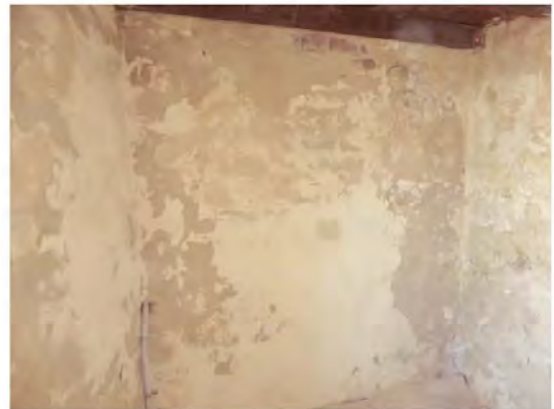
Figure 164: Failing paint and render to west wall Room 13

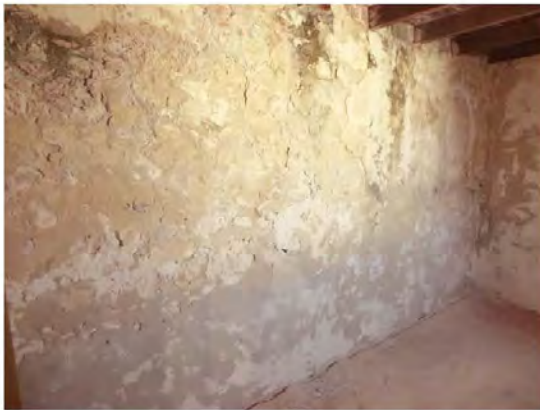
Figure 167: Failing paint and render to west wall Room 15

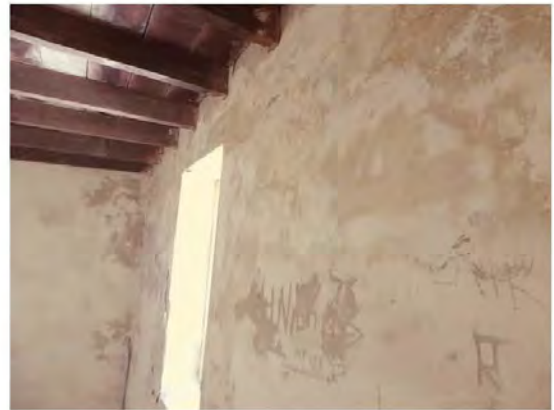
Figure 168: Failing paint and render to west wall Room 15

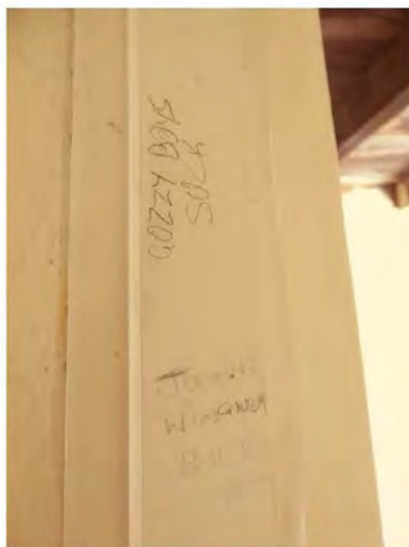
Figure 169: Graffiti

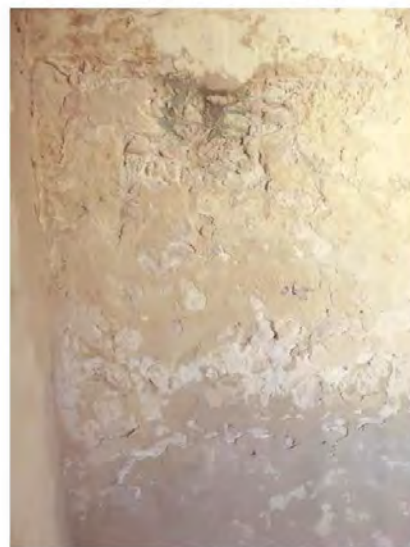
Figure 170: Failing paint and render to west wall Room 15
