# Gilbert Fraser Reserve Precinct Conservation Management Plan

**HOCKING**  
PLANNING AND  
ARCHITECTURE

July 2010

For  
City of Fremantle

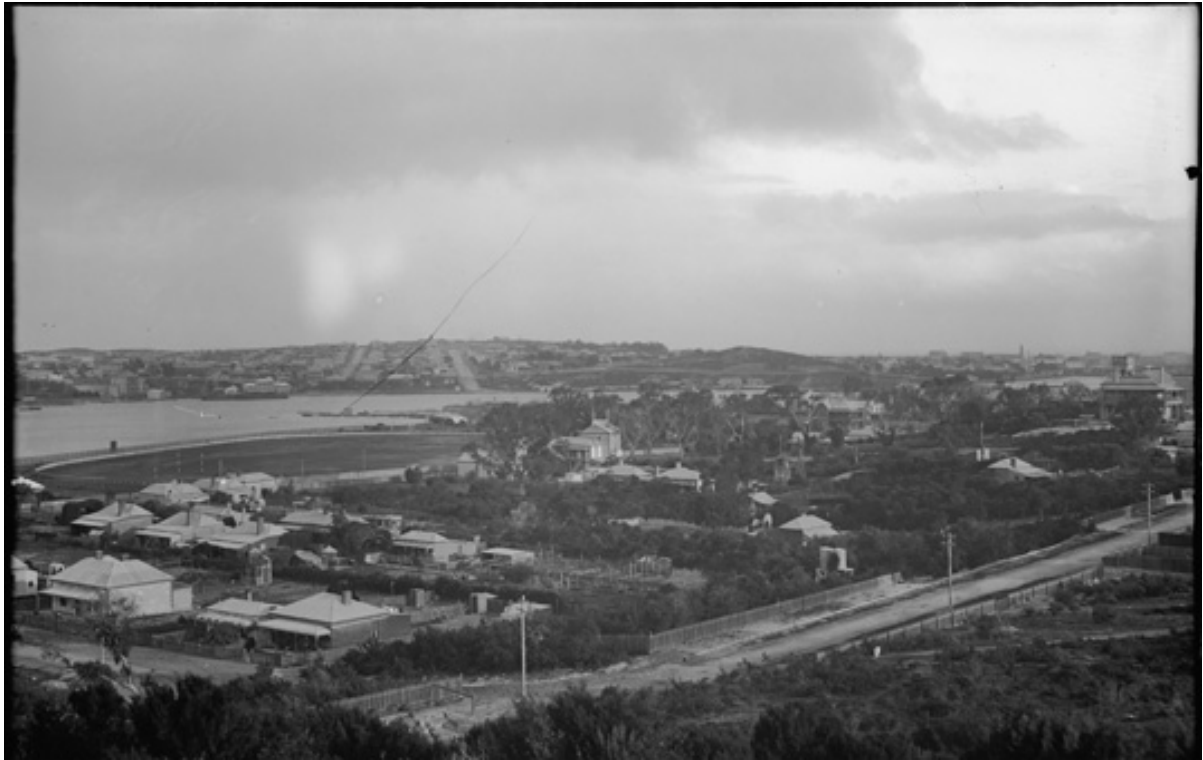
Figure 11 *View of North Fremantle, Reserve in the mid distance, c. 1905*  
Courtesy Batty Library, image 017562PD.

The following image at Figure 11 taken in c.1905 shows the 3-foot picket fence around the oval. Less distinct is the 8-foot picket fence on the boundary of the reserve. The image at Figure 12 shows the detail of the picket fence and the banking on the inside of the fence. The lamps on the poles indicate events were held on the oval in the evening.

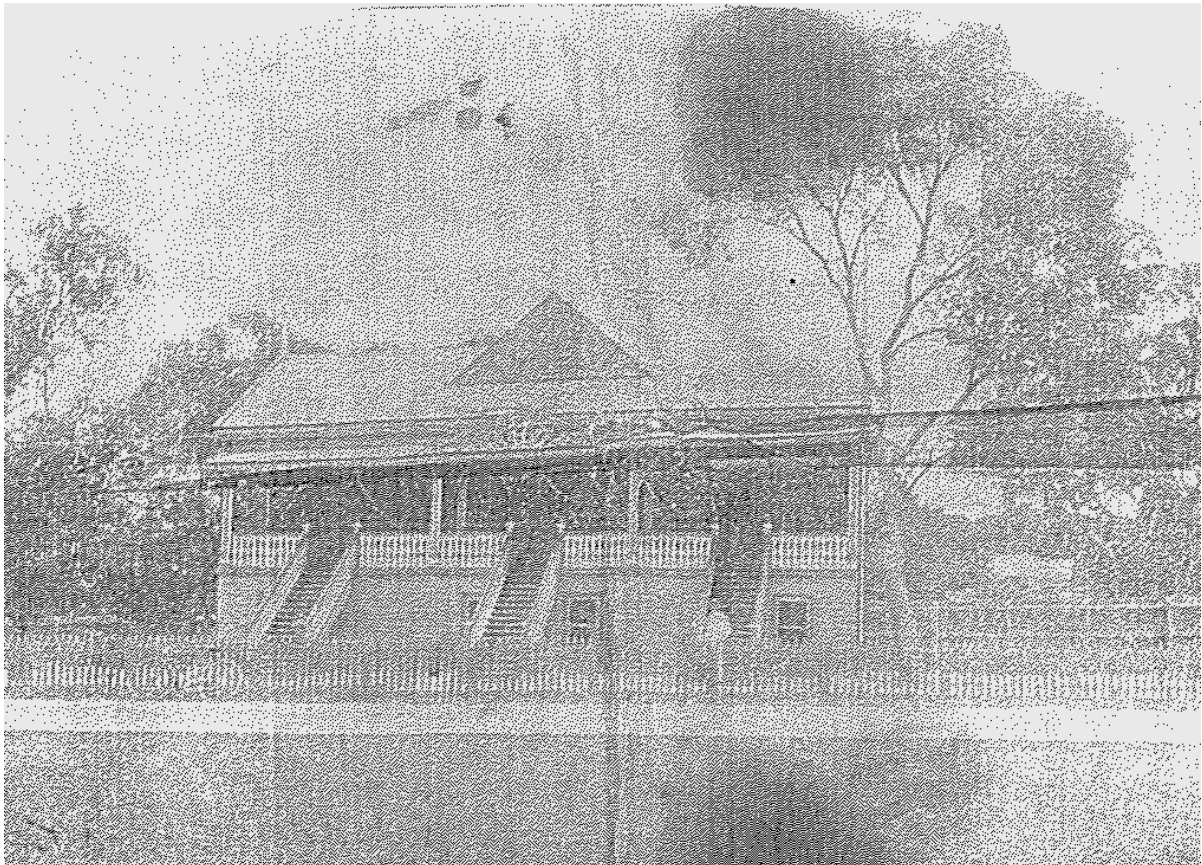
Figure 13 Grandstand (Pavilion) 1901.  
Courtesy Fremantle Local History collection.

The image of the grandstand (Figure 13) shows that the form of the original building was very similar to the current except there are three flights of stairs, and a different roof form with a separate awning structure on the front elevation. The verandah is supported by four uprights on the main elevation whereas currently there are five uprights supporting a gable roof. The following image, Figure 14 dated c.1906 featuring a cricket team, shows the detail of the timber finish of the original stairs and balustrades.

an attempt was made to burn it down. Little damage was done and no further information was found as part of the current research to determine the culprit's identity or motivation.<sup>62</sup> The earliest image of the grandstand shown at Figure 13 is from the 1901 Christmas edition of *The Umpire*.<sup>63</sup>

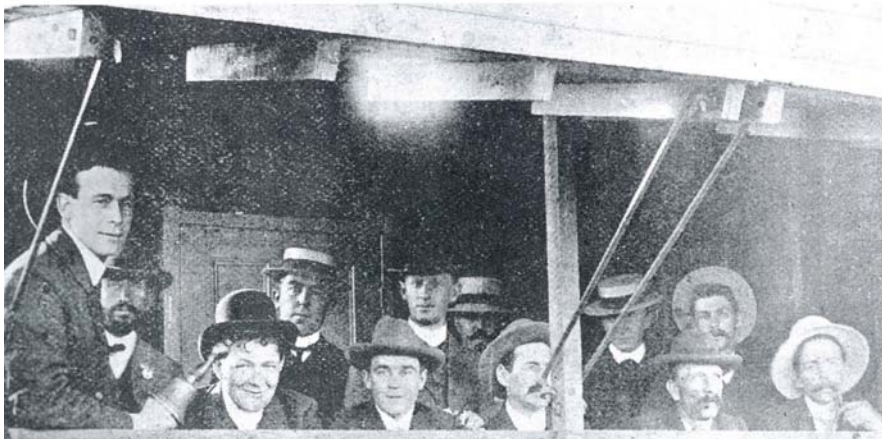
Figure 18 Press Box, c.1906  
Barker, *op.cit.* p. 33.

The reference to a press box in the 1906 description demonstrates the popularity of the game and the ground. The North Fremantle ground was used for the senior metropolitan football matches and the appropriate facilities had to be provided. The press box was located west of the former dressing rooms and an image of the interior of the press box is included at Figure 18.<sup>72</sup>

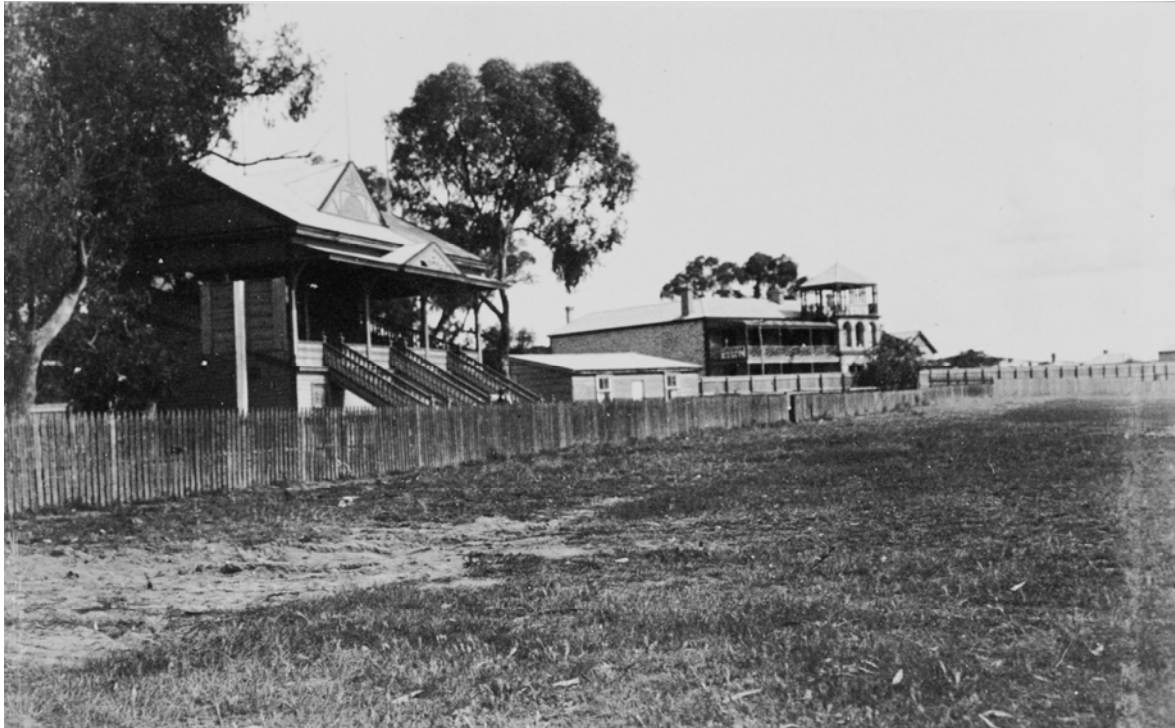
Figure 19 Original Grandstand, dressing rooms and Hotel Gresham, c. 1910  
Courtesy Battye Library, image number 9123B.

Whilst football and cricket continued to be played at North Fremantle Oval in the 1910s it is apparent from the image at Figure 19 that any evidence of the former cycling track did not last long at the oval. As noted earlier the cycling track was removed in 1902.

<sup>79</sup> These change rooms were presumably the rooms under the grandstand or possibly the simple weatherboard building located adjacent to the grandstand shown in the image at figure 19.

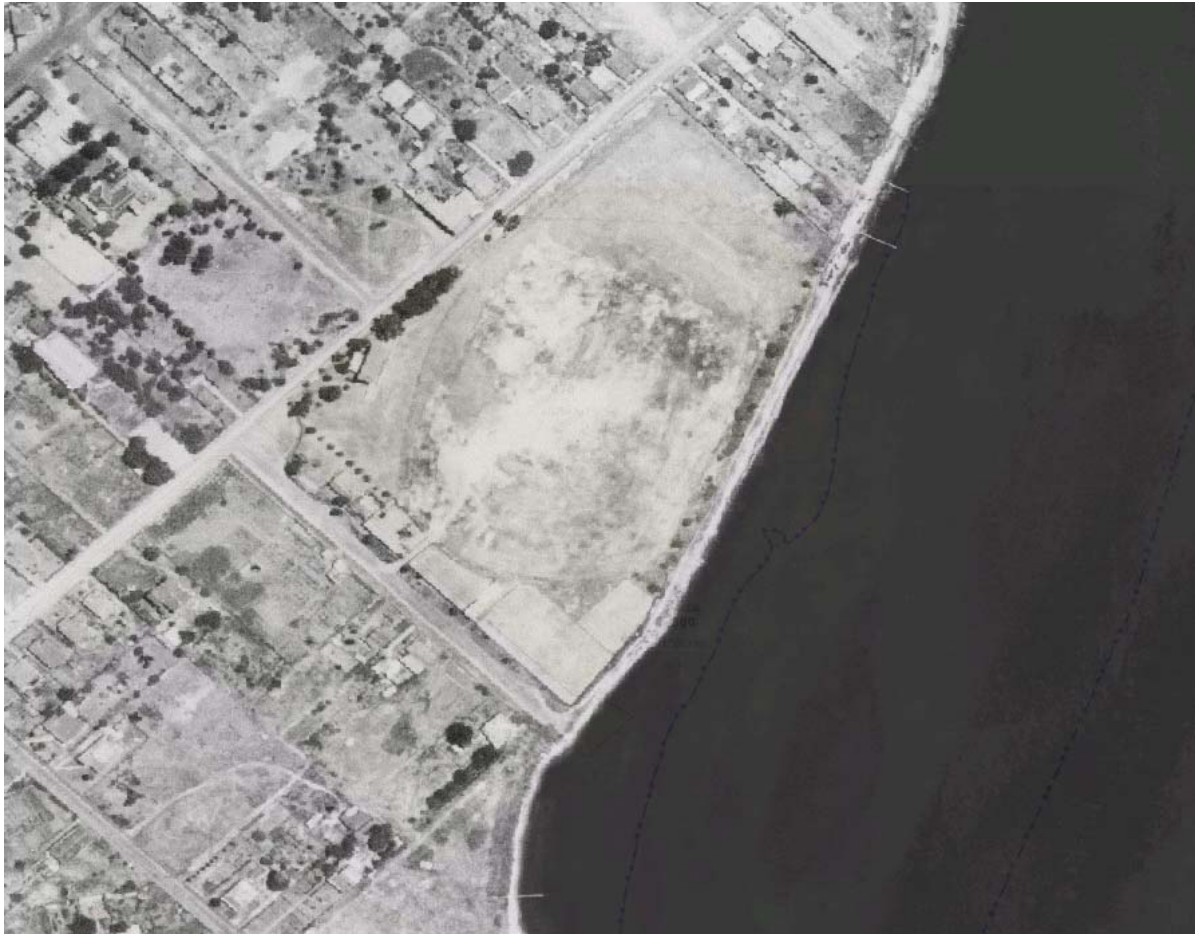
Figure 29 *Aerial Photograph of North Fremantle Recreation Reserve, 1948. Note the tennis courts on the southern corner and evidence of former market gardens on south side of Johannah Street. Courtesy Landgate.*

A seventh court was added in the 1940s. The aerial photograph at Figure 29 dated 1948, shows the location of the tennis courts.

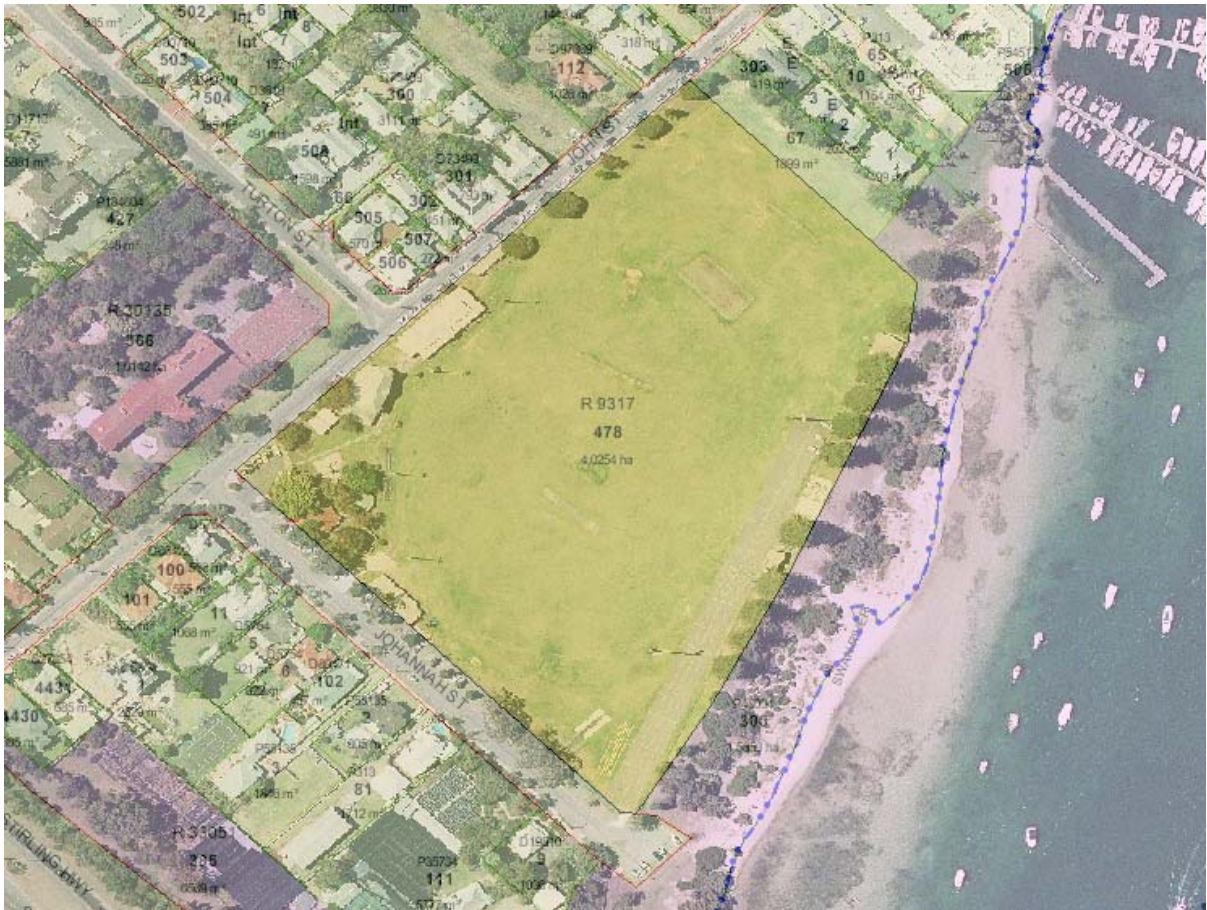
**Figure 41** *Aerial photograph of Gilbert Fraser Reserve Precinct overlaid with boundary, Courtesy Landgate.*  
*The image above shows that there is some discrepancy between the extent of the reserve boundary and what is commonly understood to be part of the reserve. This portion of precinct, lot 67, is owned by the City of Fremantle and maintained by the NFAC. The relationships between the various stakeholders associated with the Gilbert Fraser Reserve Precinct have been varied as the personalities involved have changed. This has had an impact on the extent and nature of responsibilities at different times particularly since the creation of the NFAC in 1989.*

Of note is a fenced portion of the reserve on the northern boundary. This land is not part of the reserve although over the years through continual use the land has been assumed to be part of the reserve. (See Figure 41) The grass on this lot is currently maintained by the leaseholders the NFAC.

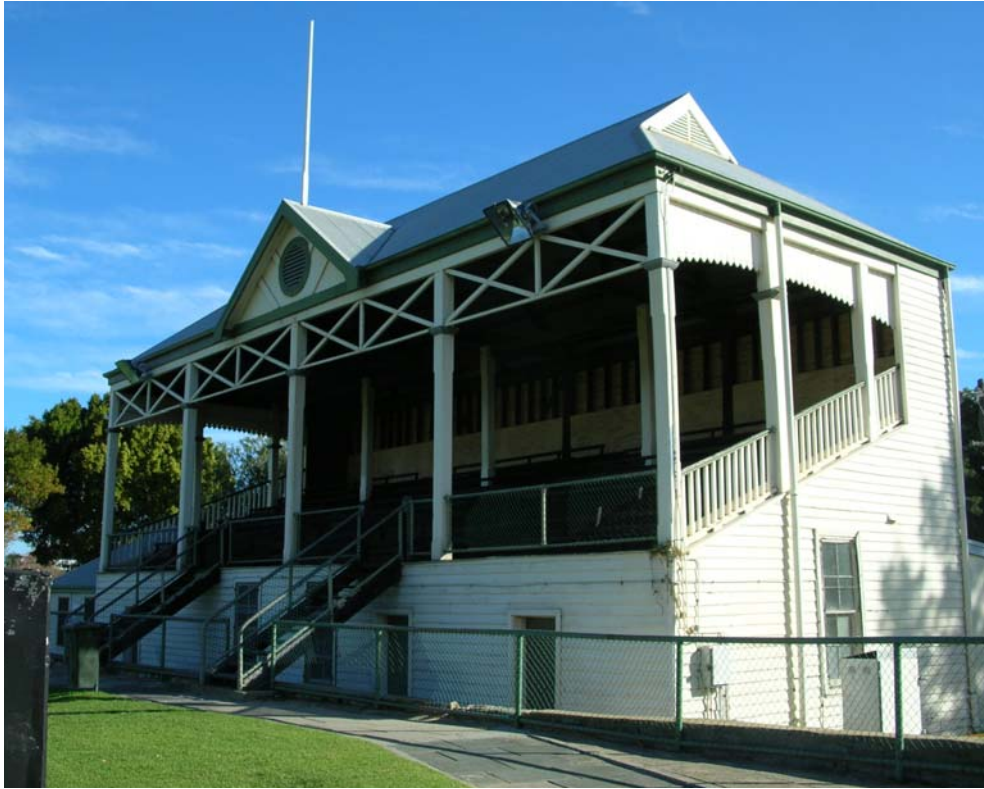
Figure 46 *View of the grandstand from oval.  
Hocking Planning and Architecture, August 2009.*

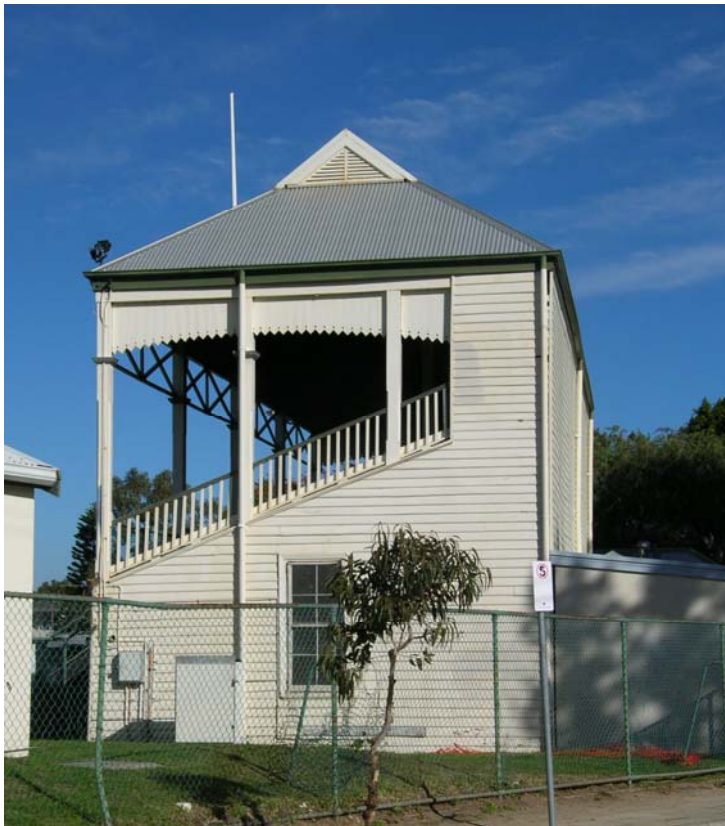
Figure 47 *View of the grandstand from John Street.  
Hocking Planning and Architecture, August 2009.*

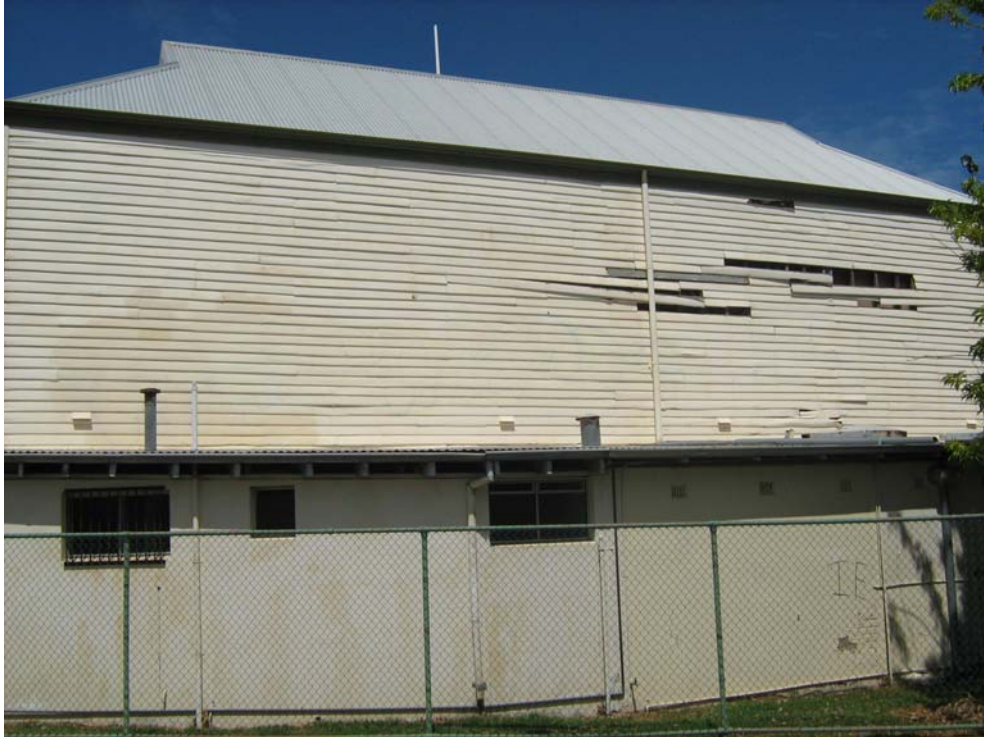
*Figure 48* View of the grandstand (north elevation) prior to conservation work. At the time of inspection, the process of removing sections of termite affected jarrah weatherboard and structural timber were in progress.  
*Hocking Planning and Architecture, August 2009.*

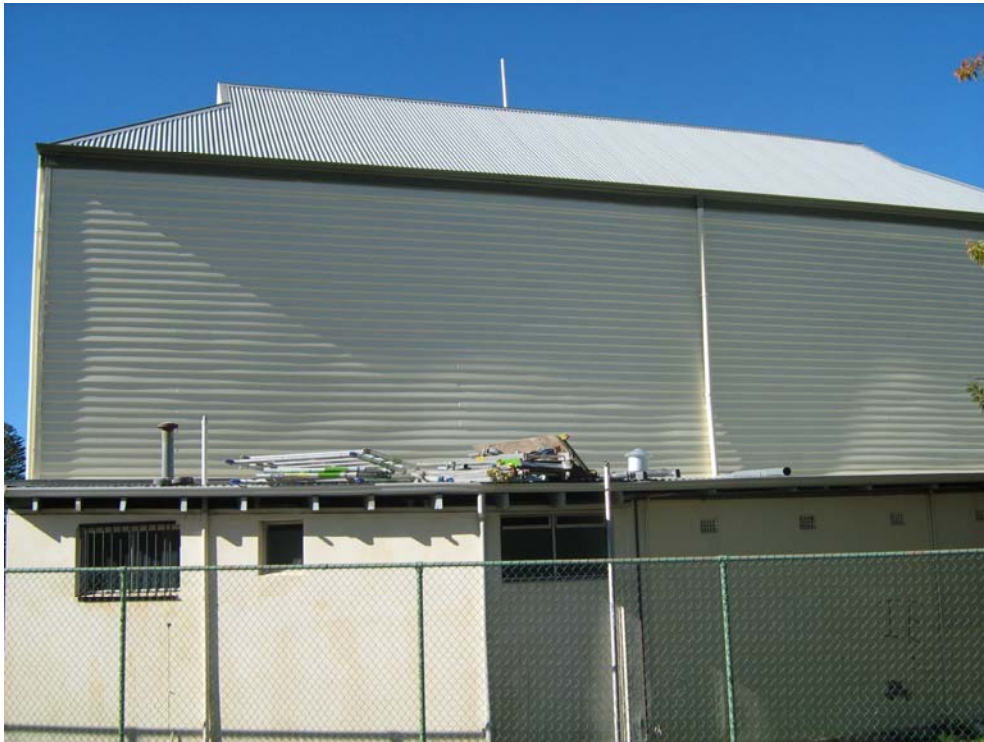
*Figure 49* View of the grandstand (north elevation) after conservation work.  
*Courtesy of City of Fremantle Planning & Development, 2009*

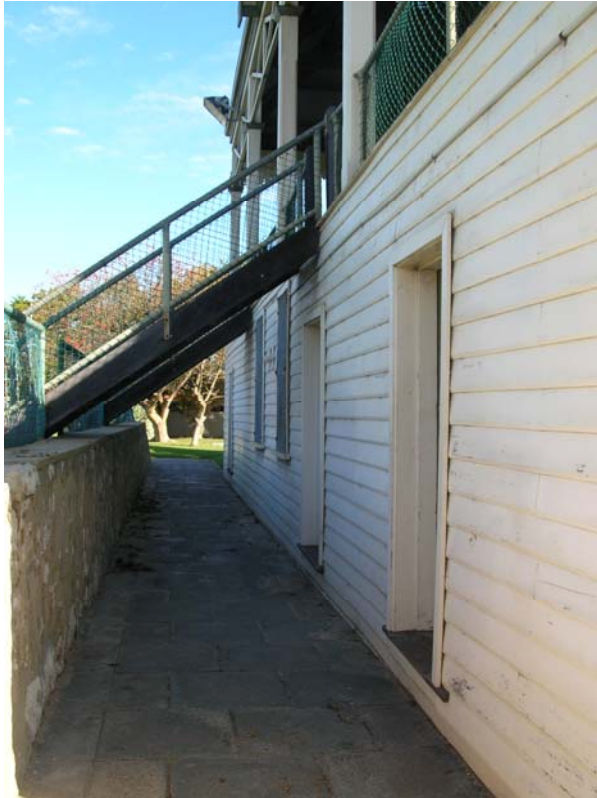
*Figure 50 View of the ground floor level of the grandstand, sunken and concealed behind a limestone retaining wall as the ground level of the oval and surrounding grassed area were elevated over the years.  
Hocking Planning and Architecture, August 2009.*

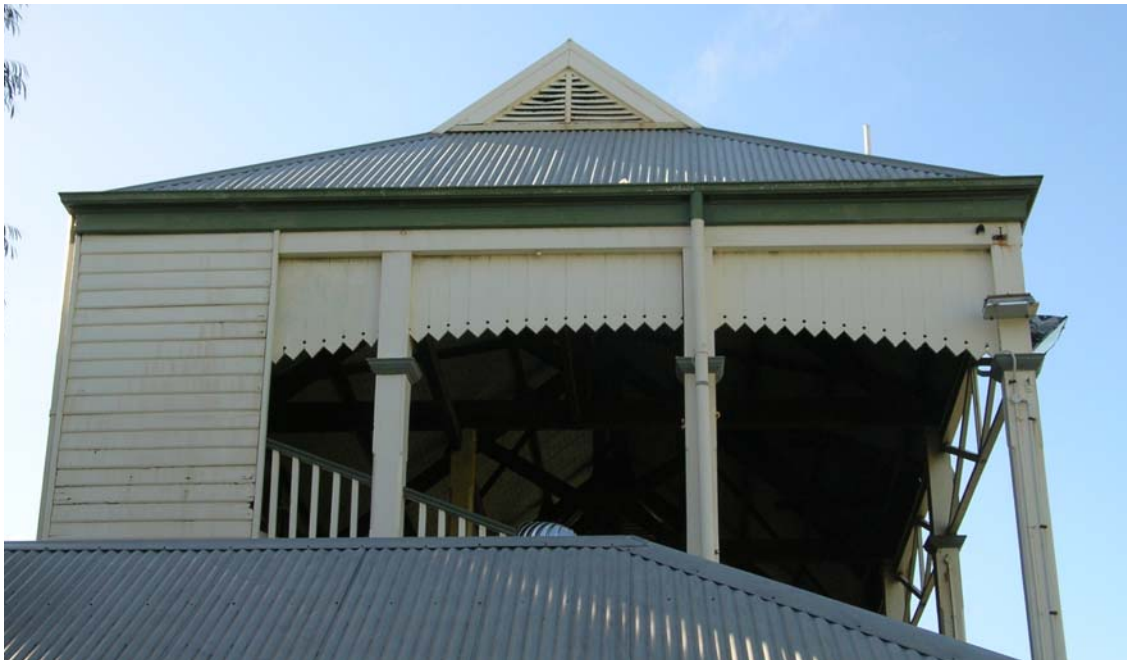
*Figure 51 Timber detailing on the east elevation of the grandstand structure. Corrugated sheet metal roof seen below the pavilion is the southern addition, accommodating an office and storage room.  
Hocking Planning and Architecture, August 2009.*

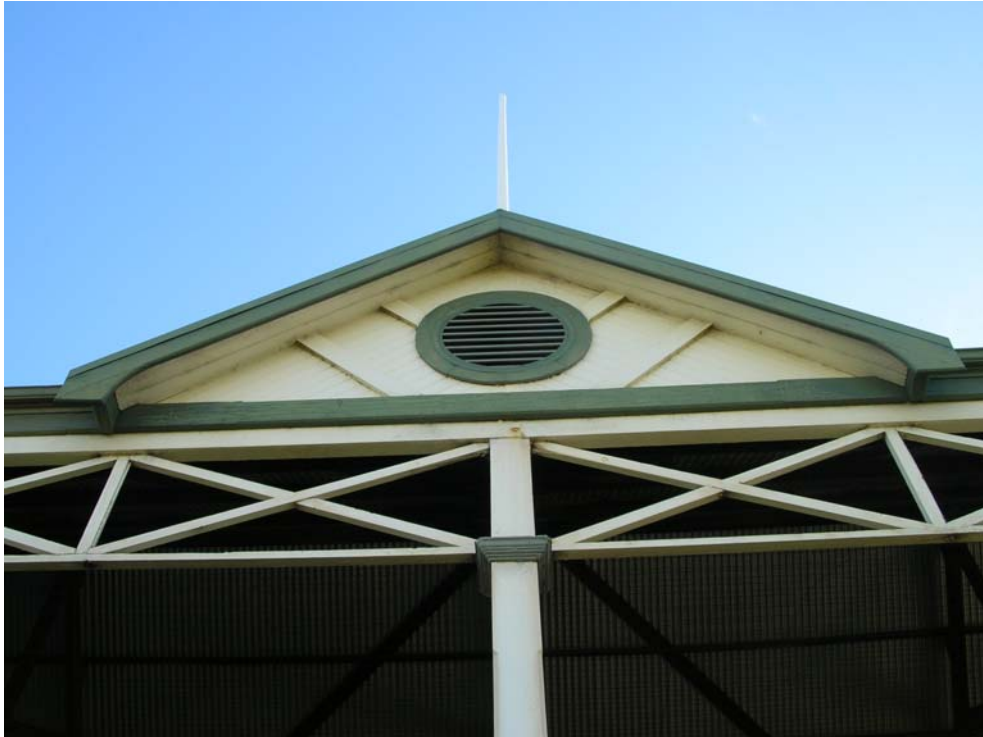
*Figure 52* Detail of gable end on the east elevation.  
*Hocking Planning and Architecture, August 2009.*

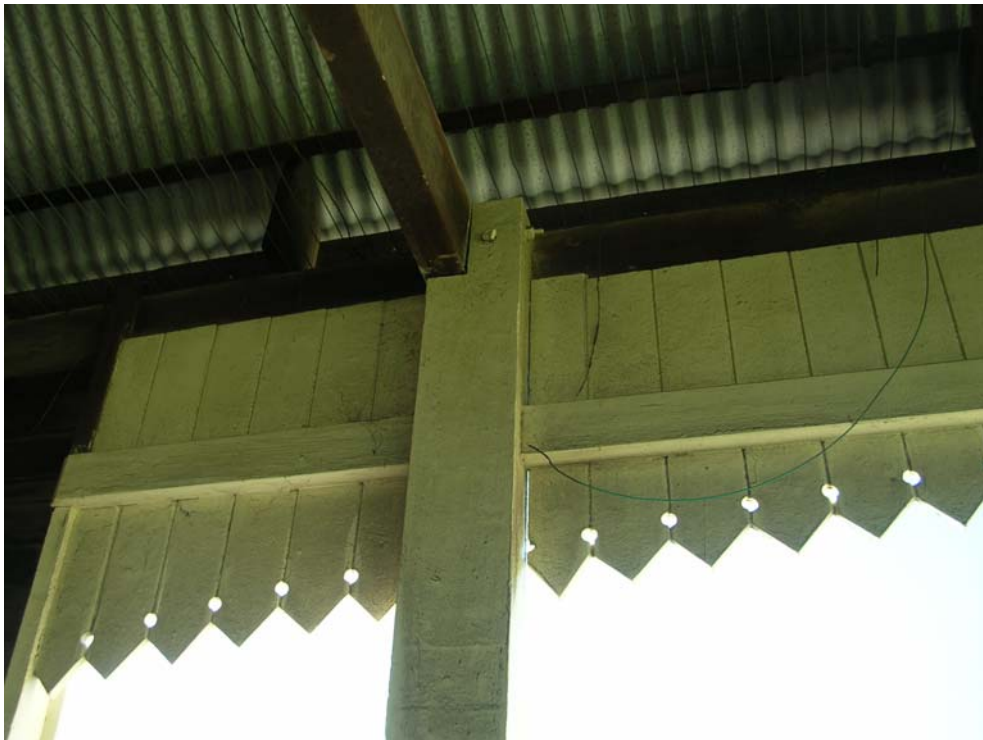
*Figure 53* View detail of timber fascia boards with simple chevron and circle cut-out pattern on the, evident on the north and south elevations of the pavilion.  
*Hocking Planning and Architecture, August 2009.*

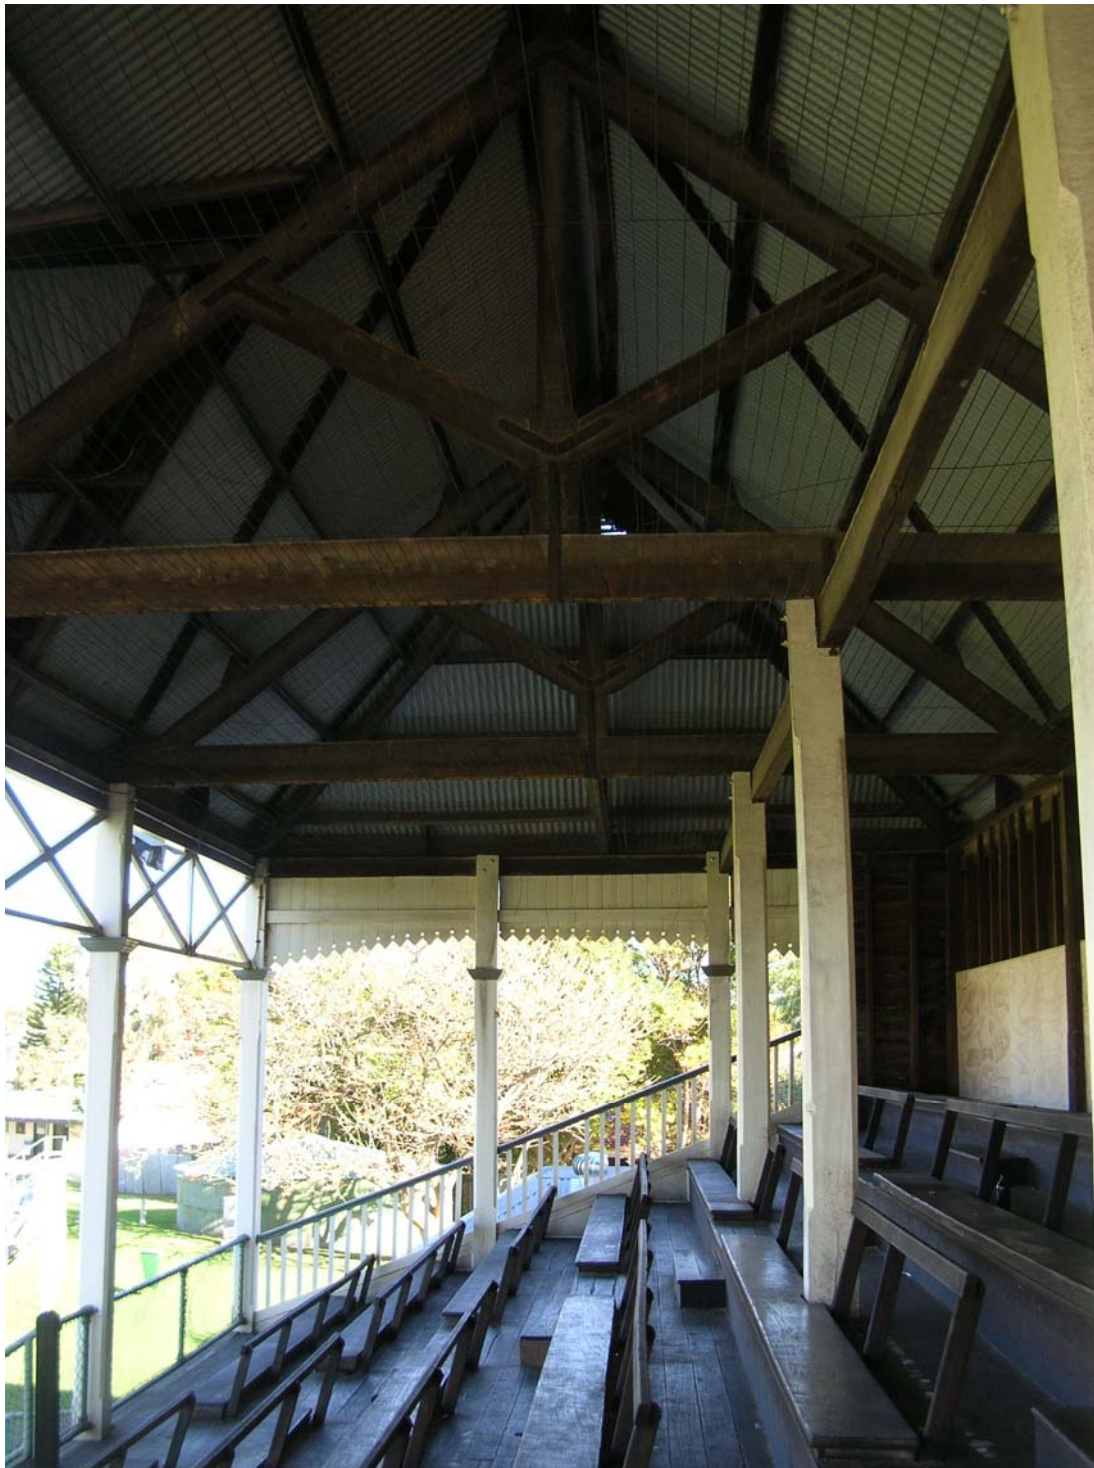
*Figure 54* View of the pavilion. The timber roof, columns and wall structures are in relatively good condition and wearing well. Plywood lining (unpainted) on the internal face of the west wall was put in place during a recent repair and conservation campaign. The lining was subsequently painted to match existing timber structure. *Hocking Planning and Architecture, August 2009.*

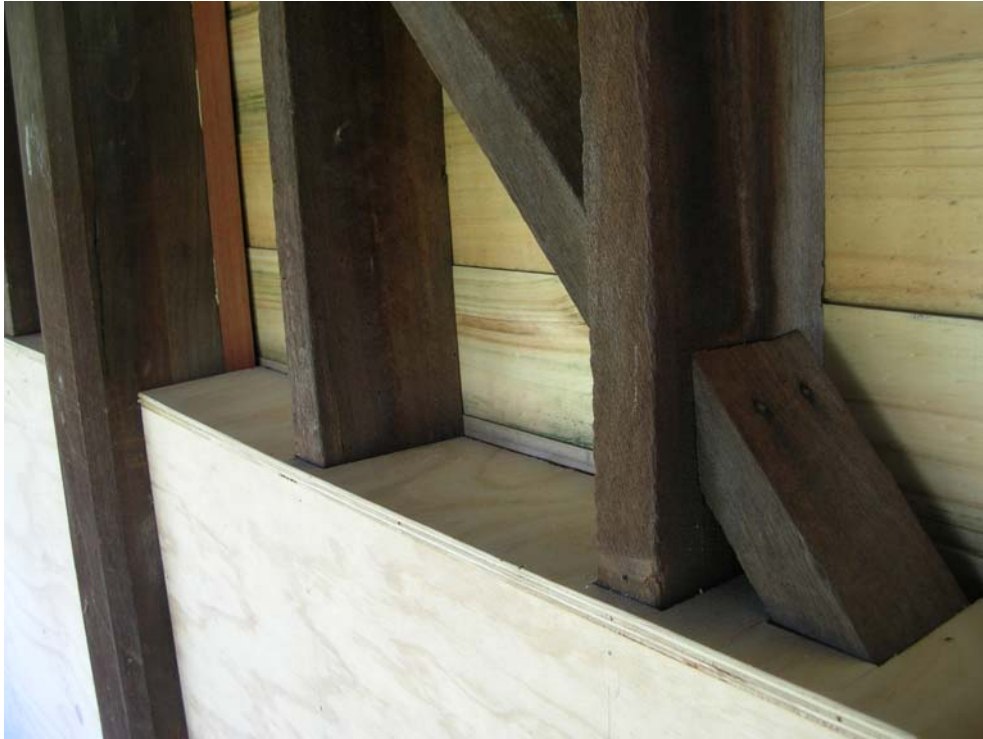
*Figure 55* Detail of plywood lining (during conservation work; unpainted) on the internal face of the west wall. This recent addition created a small 'ledge' along the length of the west wall which may pose future maintenance issues as nesting areas for bird pests. Hocking Planning and Architecture, August 2009.

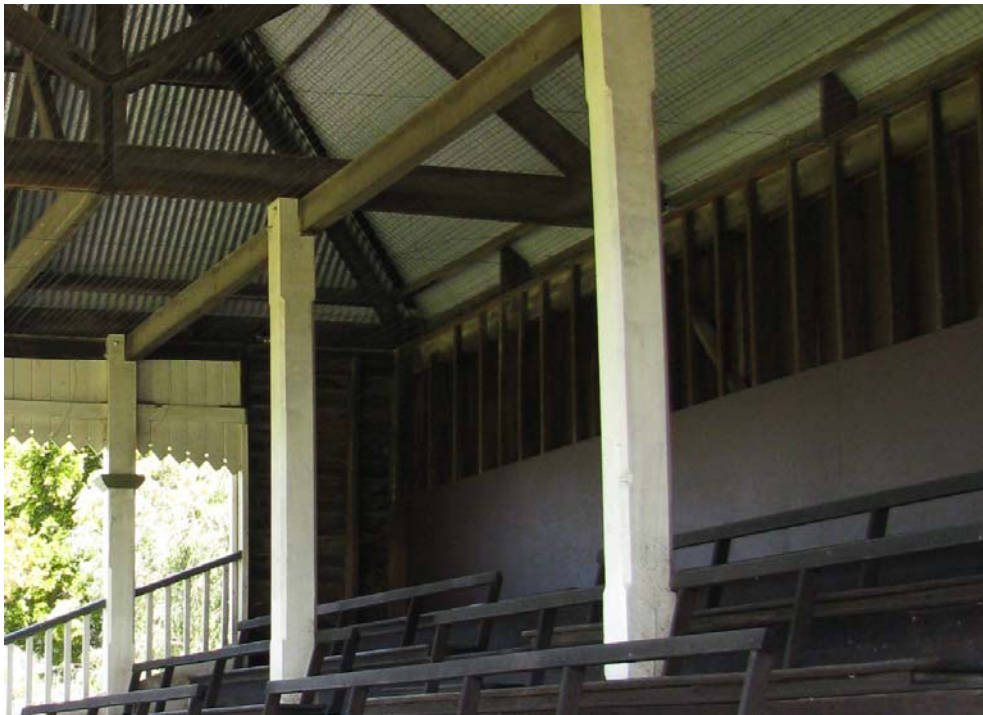
*Figure 56* Detail of plywood lining (after conservation work) painted to match the rest of timber structure. Hocking Planning and Architecture, October 2009.

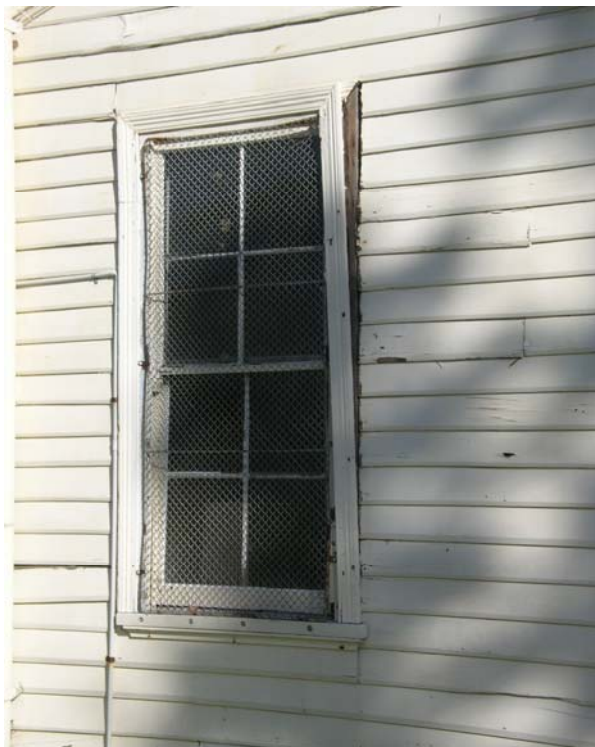
*Figure 58* Detail of double hung sash window on the north elevation. Similar maintenance issues and damage to the window architraves and weatherboards are typically observed around the grandstand.  
*Hocking Planning and Architecture, August 2009.*

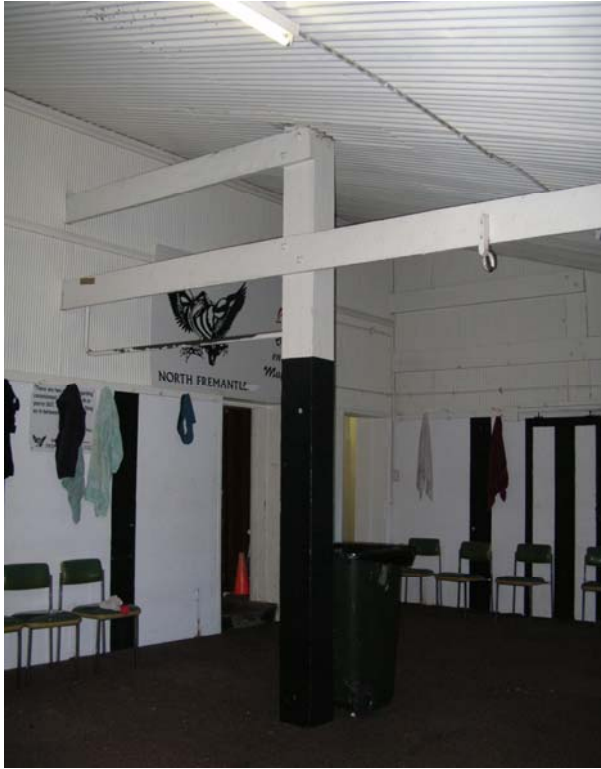
Figure 59 Interior view of the original change rooms below the pavilion. The structural columns carry through to support the roof structure above. Hocking Planning and Architecture, August 2009.

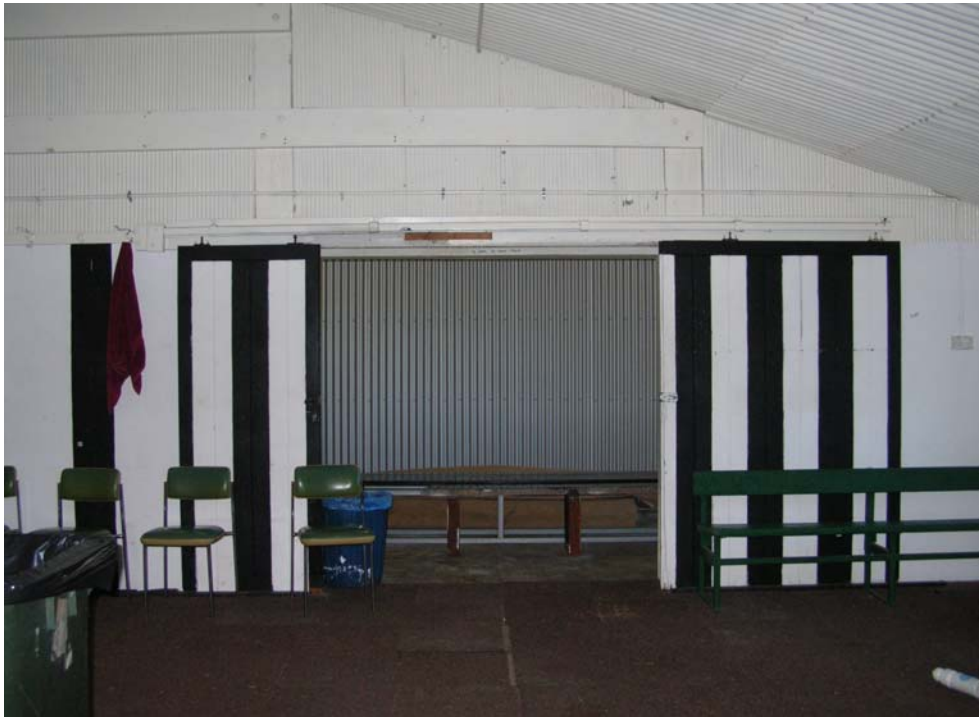
Figure 60 View of the central change room from the southern end change room. The original interiors including, sliding doors between rooms, wall lining and benches re largely intact. However, at the time of inspection, the traditional 'Ripple' corrugated sheet metal lining are being removed and replaced with 'Zincalume Custom Orb' which has larger corrugation profiles. This altered the proportion and general appearance of the original interiors significantly. Hocking Planning and Architecture, August 2009.

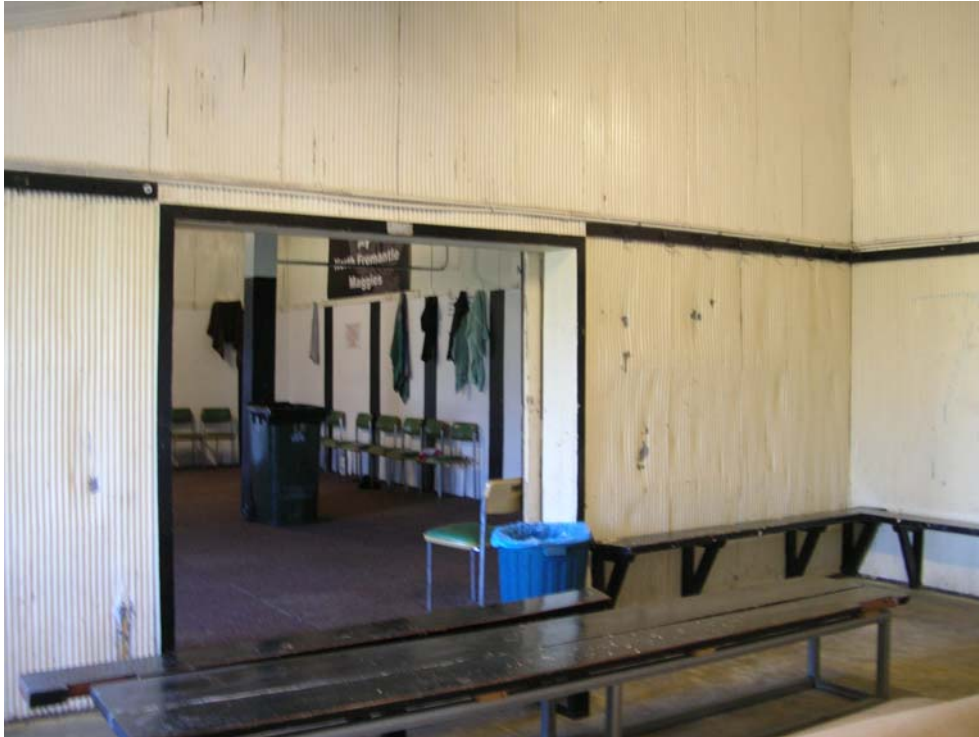
Figure 61 Interior view of the original change rooms. The original lining on the northern wall of this change room has been replaced with new 'Zincalume Custom Orb' wall lining. Hocking Planning and Architecture, August 2009.

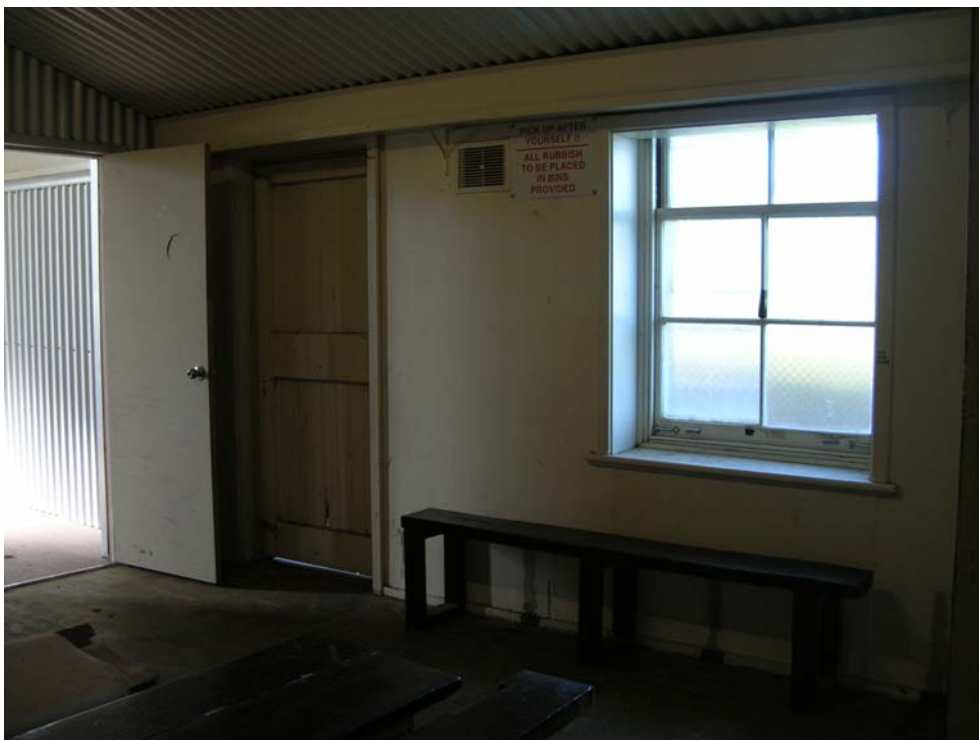
Figure 62 East wall (facing the oval) of the central change room. note lined and raked ceiling, cutting off the head of an existing double hung sash window. It is possible that the ceilings in the change rooms were unlined originally and the full height of the window was accommodated. Hocking Planning and Architecture, August 2009.

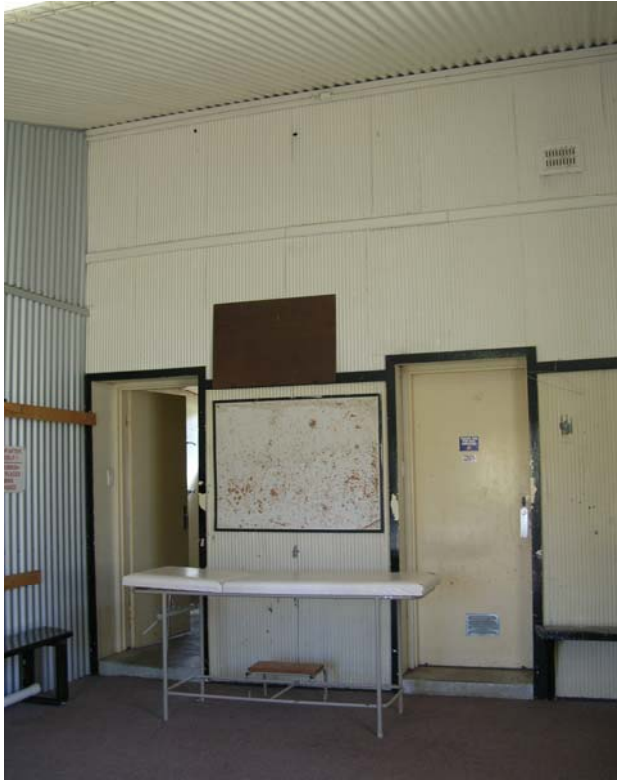
Figure 63 Interior view of the northern end change room. All original wall lining on three elevations, apart from the western wall (as seen in image), have been replaced with 'Zincalume Custom Orb' wall lining.  
Hocking Planning and Architecture, August 2009.

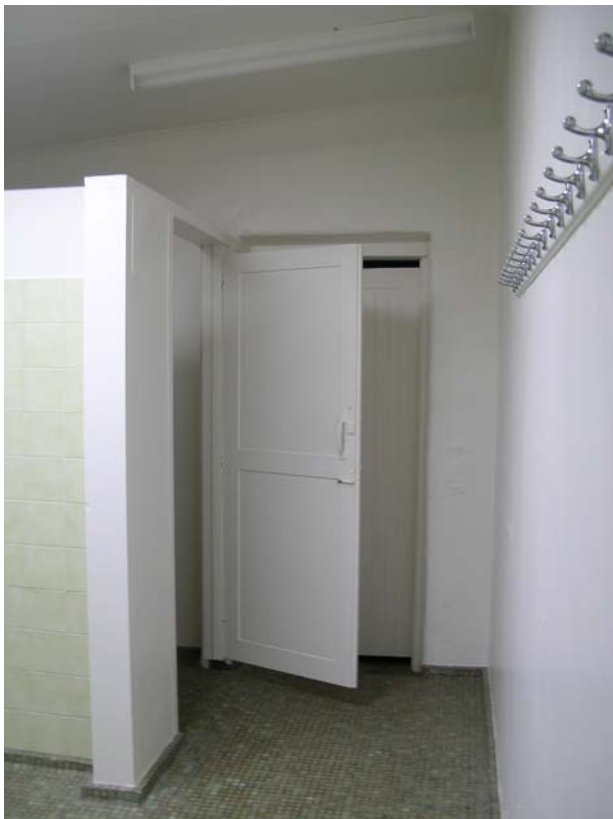
Figure 64 View of toilet and shower rooms.  
Hocking Planning and Architecture, August 2009.

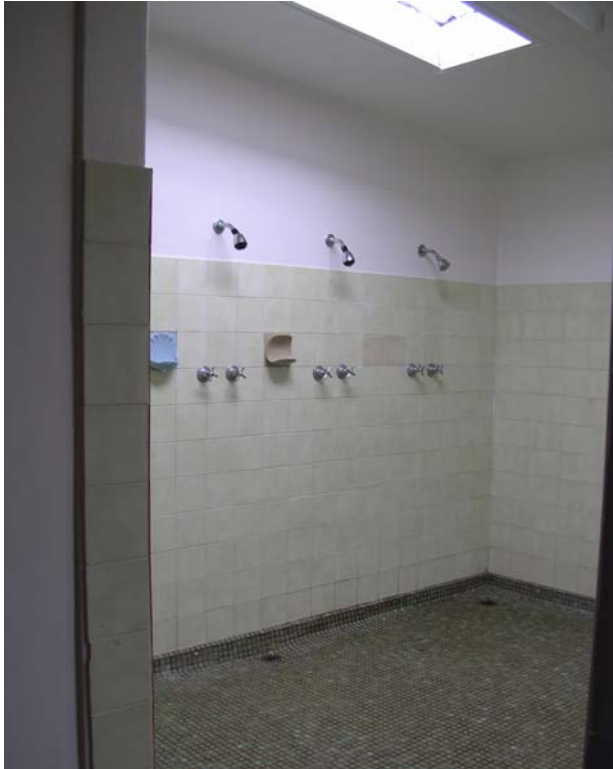
Figure 65 View of shower area.  
*Hocking Planning and Architecture, August 2009.*

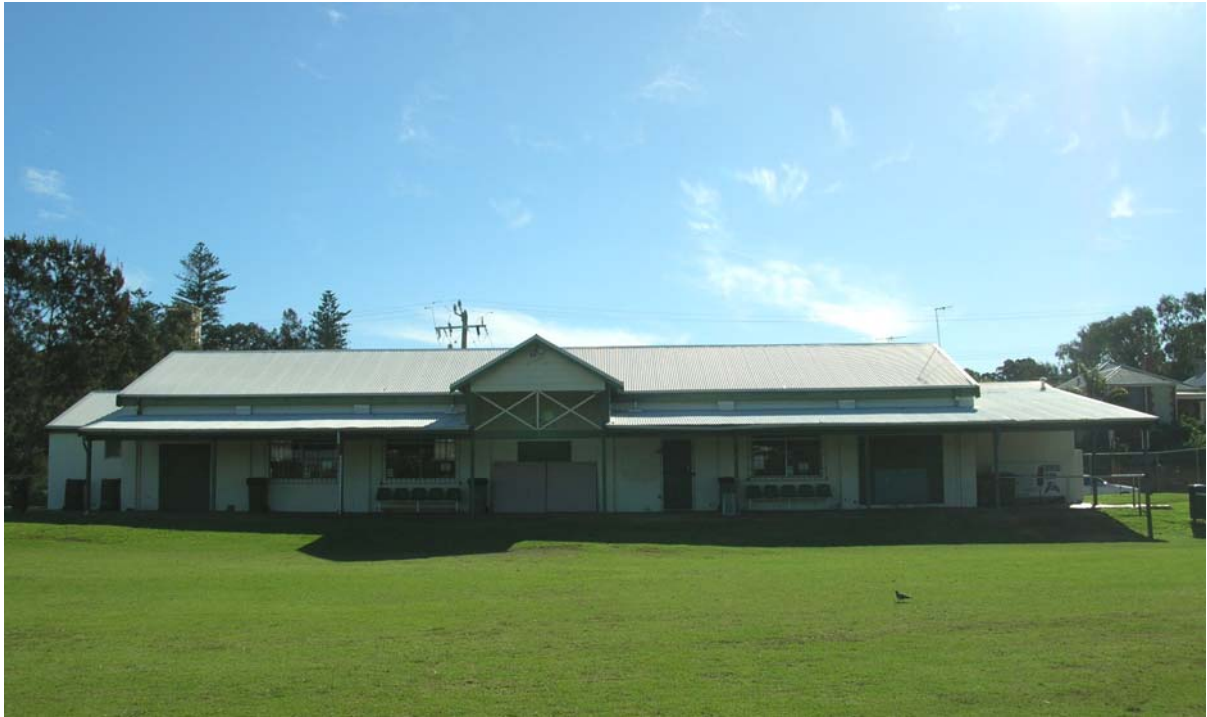
The Hall, named as the 'Stan Whipp Hall', is a single storey rectilinear building with limestone foundations, gable roof and a skillion roofed verandah along the front (south east elevation) of the building. The front elevation is broken up by a centrally located gabled roof feature, which projects from the main roof. The simple timber post and cross bracing detail found on the gabled end of the grandstand is repeated on this projected section. Internal faces of this section immediately below the underside of the roof are lined with weatherboard cladding. There are two single storey gabled roof annexes located at the ends of the building. A narrow strip of land with sparse vegetation and sections of concrete slab separates the building from the John Street boundary, which is defined by a perimeter chain link mesh fencing of 1.8 meters high. There is a small external enclosed area, currently use as storage, located approximately min-length of the main building.

*Figure 68 View of the single storey hall –‘Stan Whipp Hall’ - from the oval.  
Hocking Planning and Architecture, August 2009.*

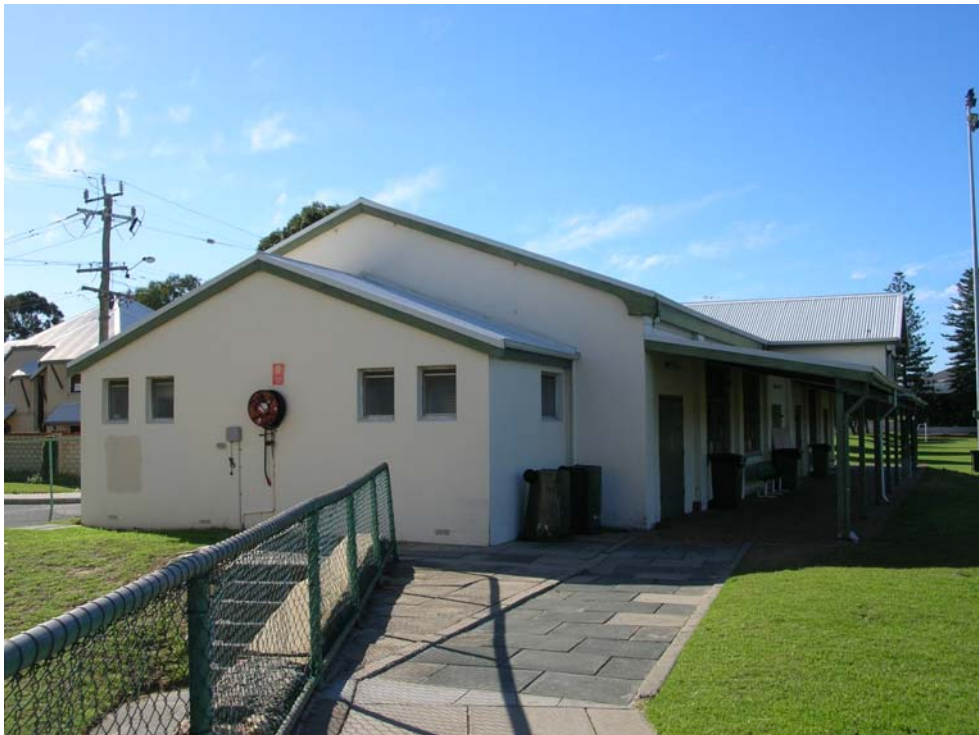
*Figure 69 View of toilet annexe, west elevation of the hall.  
Hocking Planning and Architecture, August 2009.*
