# Gilbert Fraser Reserve Precinct Conservation Management Plan

**HOCKING**  
PLANNING AND  
ARCHITECTURE

July 2010

For  
City of Fremantle

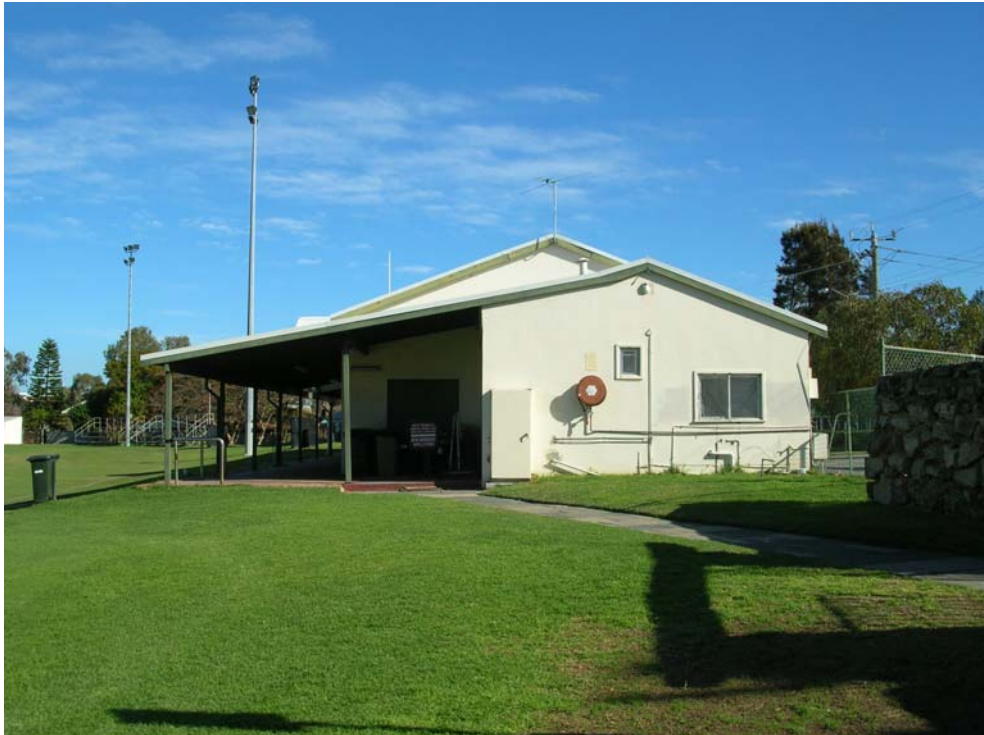
Figure 70 *View of kitchen and storage annexe, east elevation of the hall.  
Hocking Planning and Architecture, August 2009.*

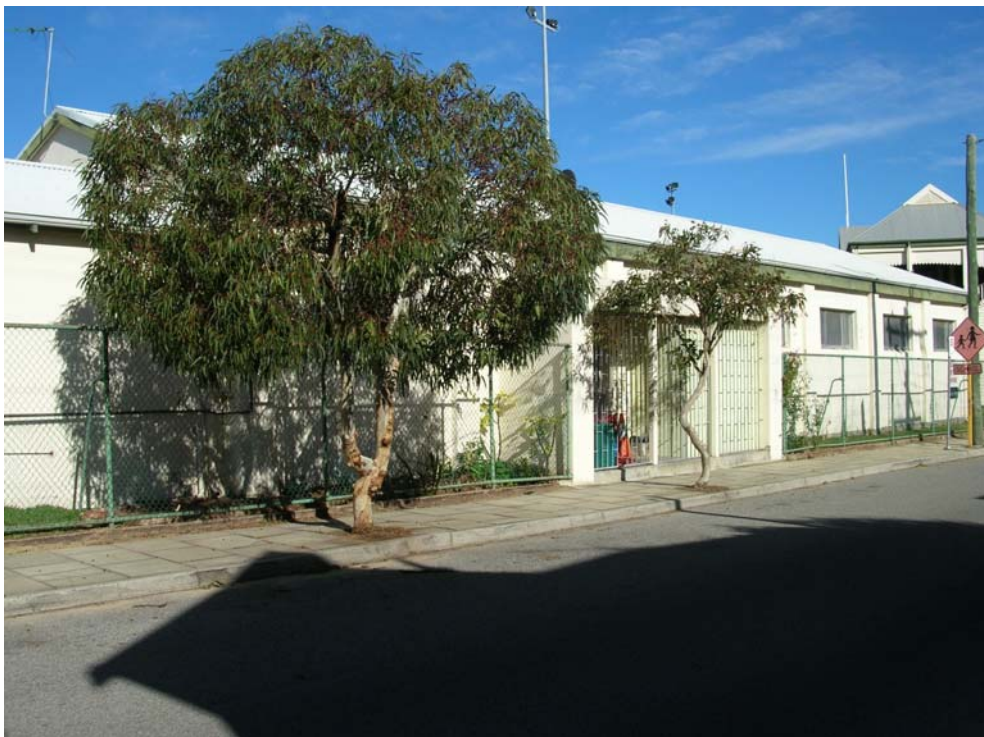
Figure 71 *Rear elevation of the hall, viewed from John Street.  
Hocking Planning and Architecture, August 2009*

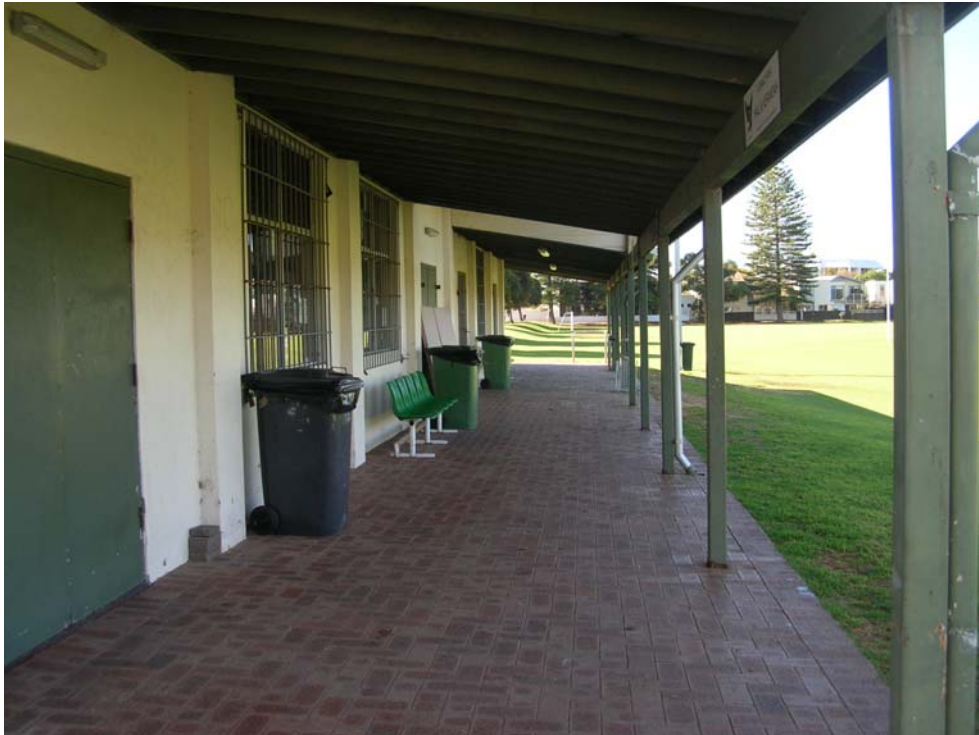
damaged and dislodged from original locations under the pressure of heavy storms. The verandah floor is of brick paving.

Figure 72 Verandah, looking east.  
Hocking Planning and Architecture, August 2009.

Generally, replacement of the existing roof plumbing system is required. The existing stormwater discharge system, sumps and soak wells need to be inspected. Several safety hazards have been identified, including unevenness of existing brick paving in the verandah area due to ground settlement and heavy traffic, sudden and unmarked changes in paving and ground levels and the stainless steel tubular handrail at the eastern end of the verandah which has not been secured to the paving but simply taped to the timber columns.

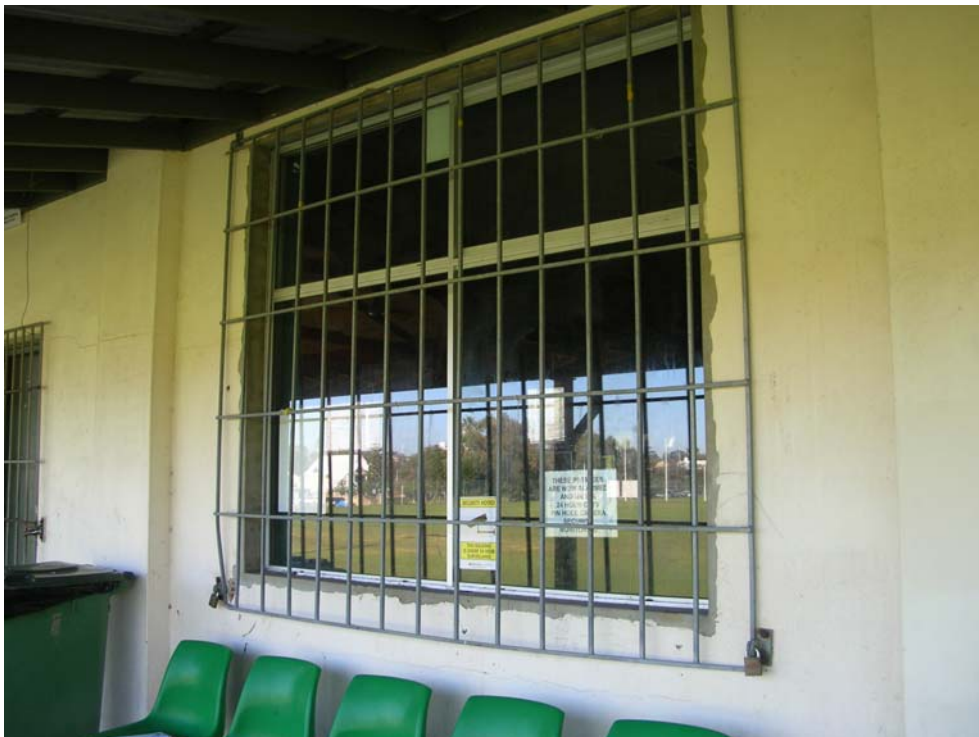
Figure 73 Detail of existing window on the south elevation.  
Hocking Planning and Architecture, August 2009.

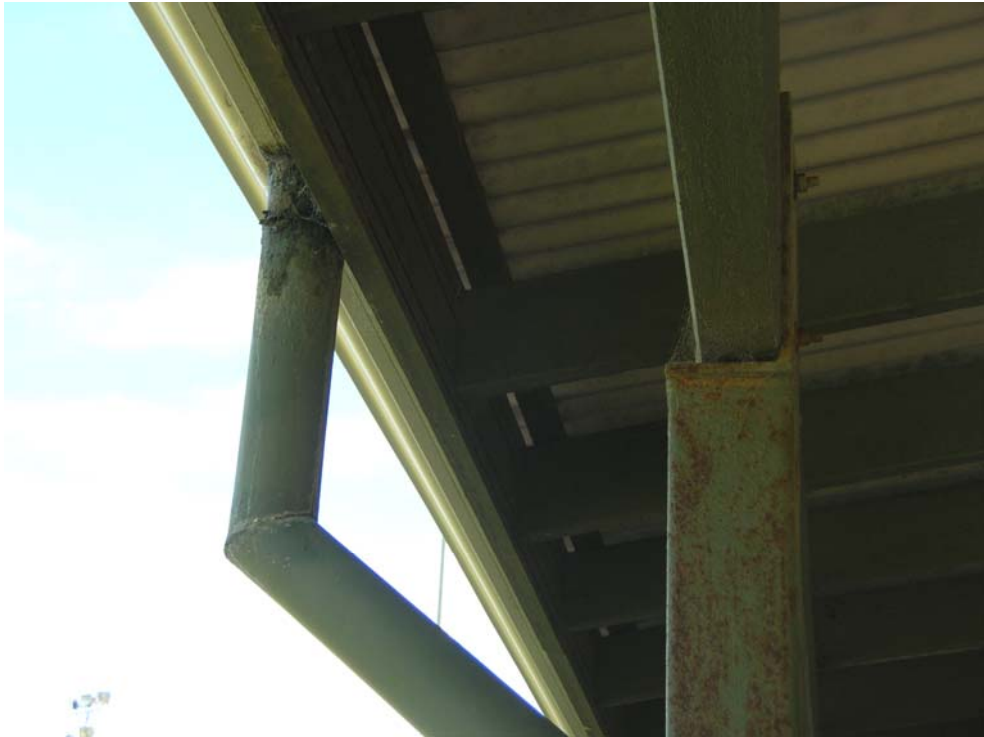
*Figure 74* Detail of rusted gutter and downpipe along roof above verandah.  
*Hocking Planning and Architecture, August 2009.*

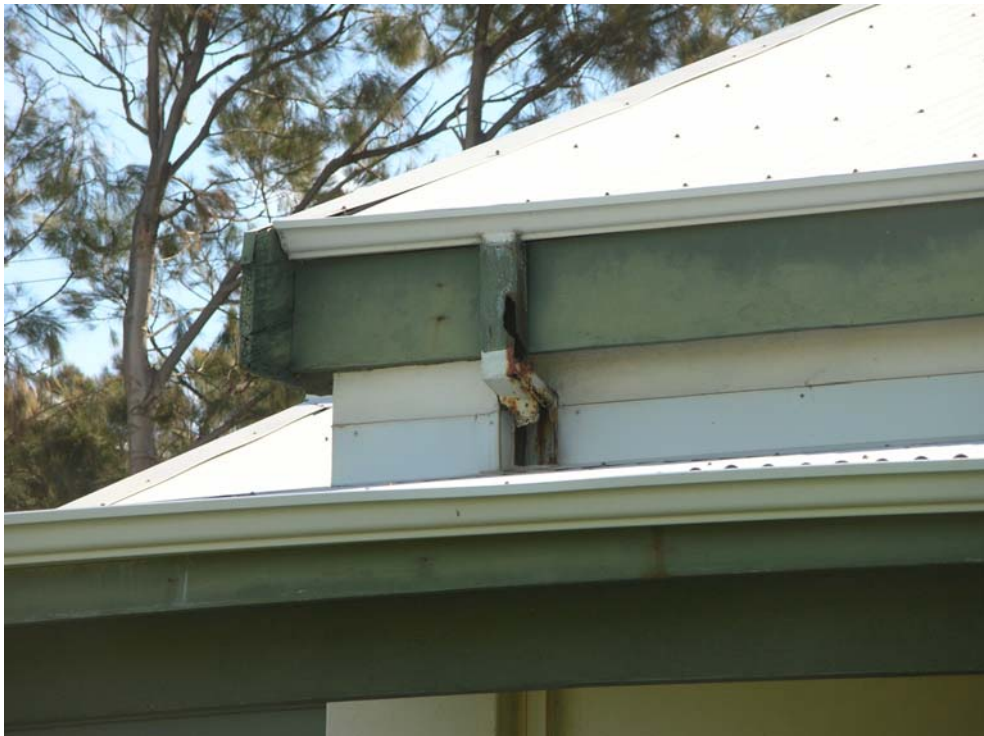
*Figure 75* Detail of rusted gutter and downpipe on the main roof.  
*Hocking Planning and Architecture, August 2009.*

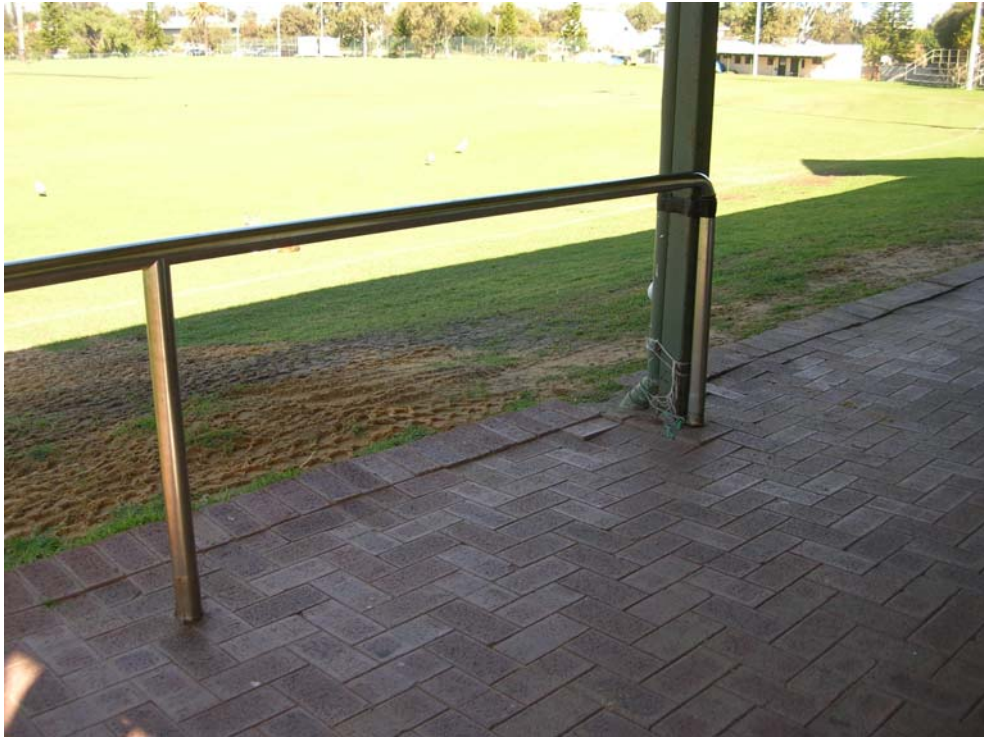
*Figure 76 Existing handrail on the eastern bay of the verandah poses a safety risk as the handrail is not secured to the ground.  
Hocking Planning and Architecture, August 2009.*

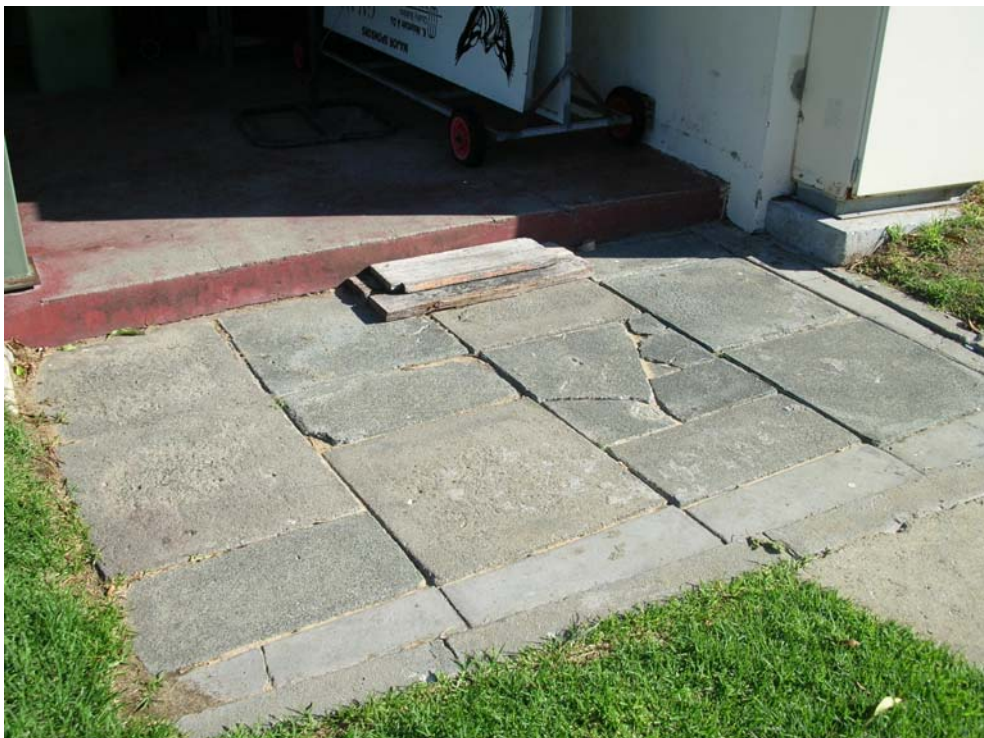
*Figure 77 Existing concrete slabs at the eastern end of the verandah. Cracked and uneven paving slabs are trip hazards.  
Hocking Planning and Architecture, August 2009.*

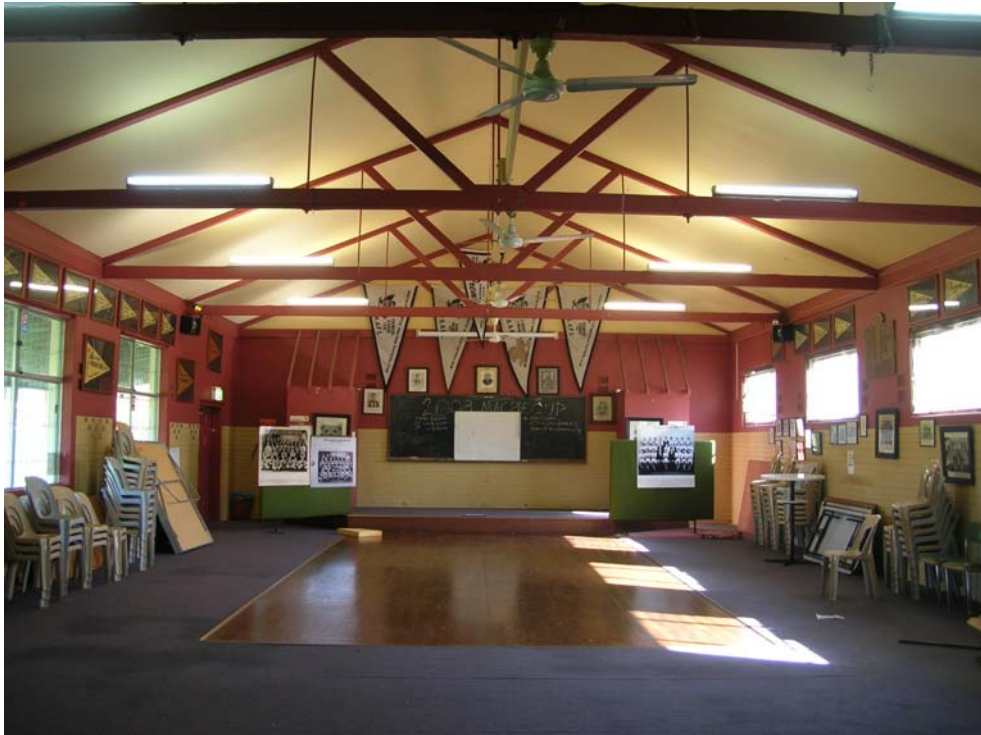
Figure 78 Interior view of the hall, looking west. The toilet annexe is located beyond the stage.  
Hocking Planning and Architecture, August 2009.

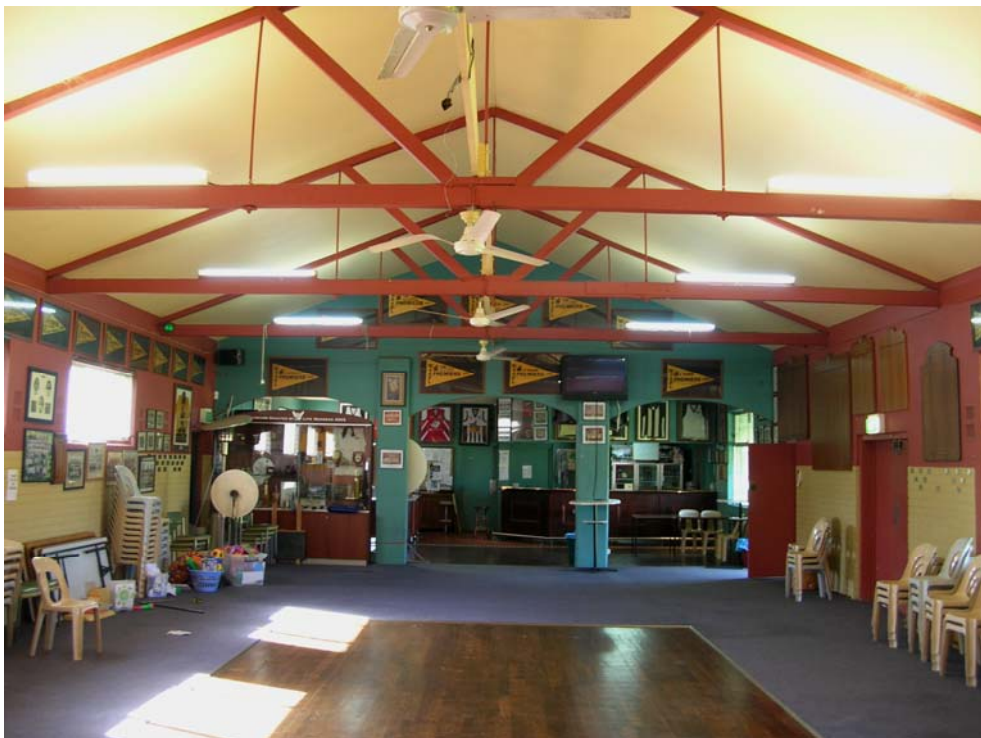
Figure 79 Interior view of hall, looking east. The food preparation and bar area is located beyond the arched openings.  
Hocking Planning and Architecture, August 2009

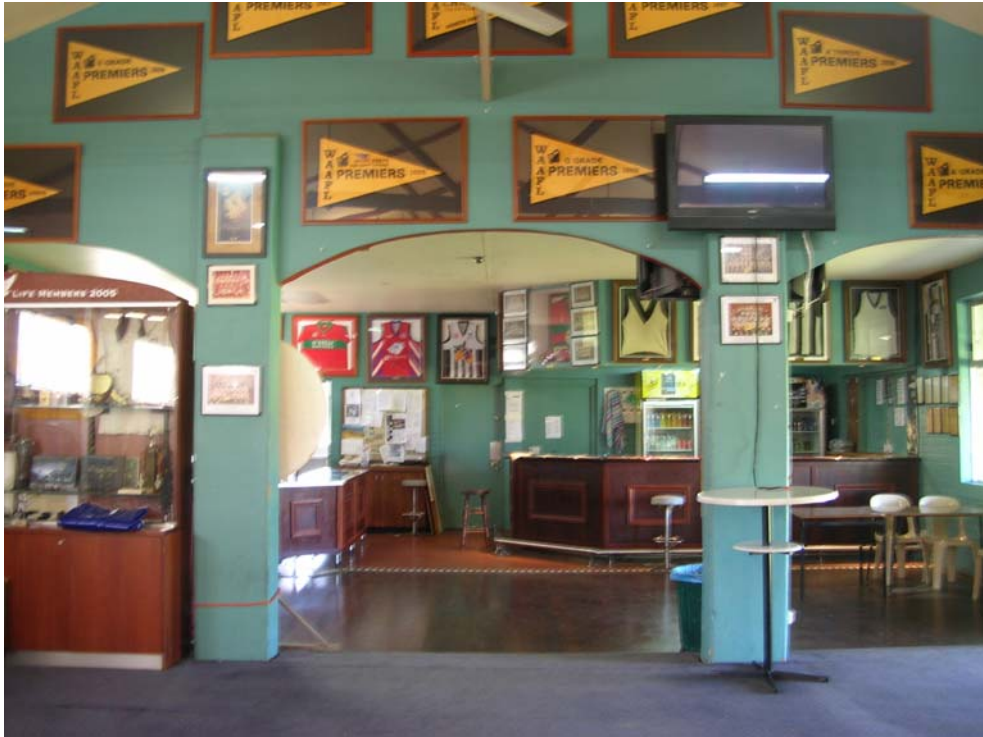
Figure 80 *Arched openings, between main space of the hall and food preparation and bar area. Hocking Planning and Architecture, August 2009*

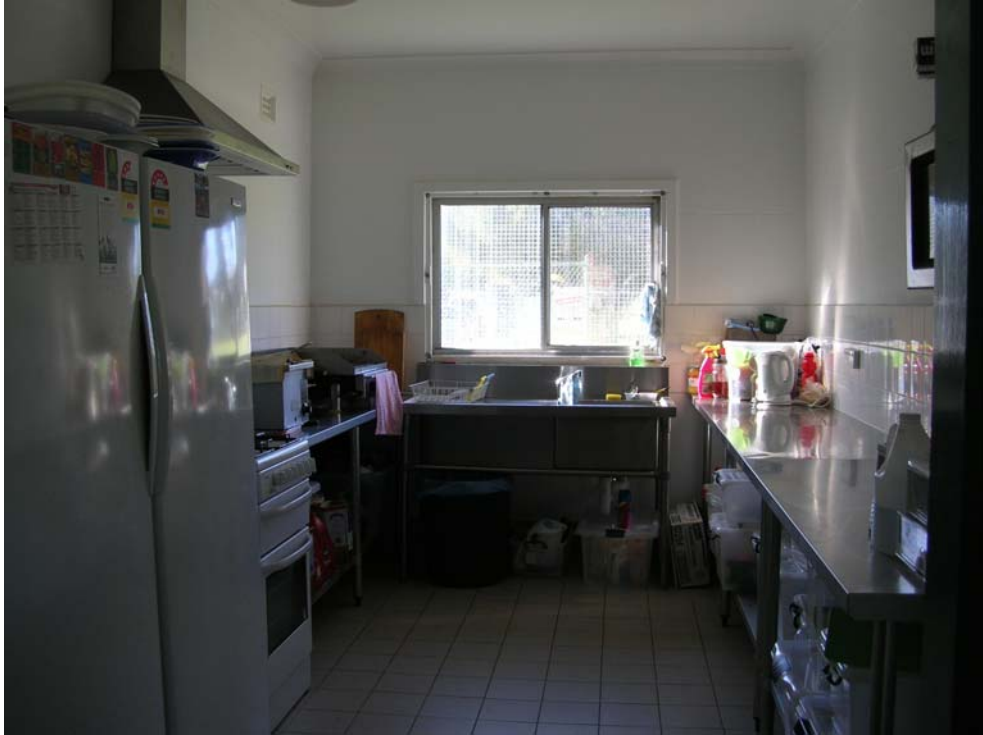
Kitchen is contemporary with stainless steel bench top, under bench cupboards and general kitchen appliances including a freestanding stove and oven unit with exhaust above and freestanding fridge and freezer unit. The room is generally tiled, floor and walls up to dado height, just below a plaster moulded dado line which runs the perimeter of the room. An aluminium framed sliding window is centrally located on the east wall at the end of the kitchen. Adjacent to the kitchen, is the refrigeration room and storage.

Figure 84 View of kitchen.  
*Hocking Planning and Architecture, August 2009*

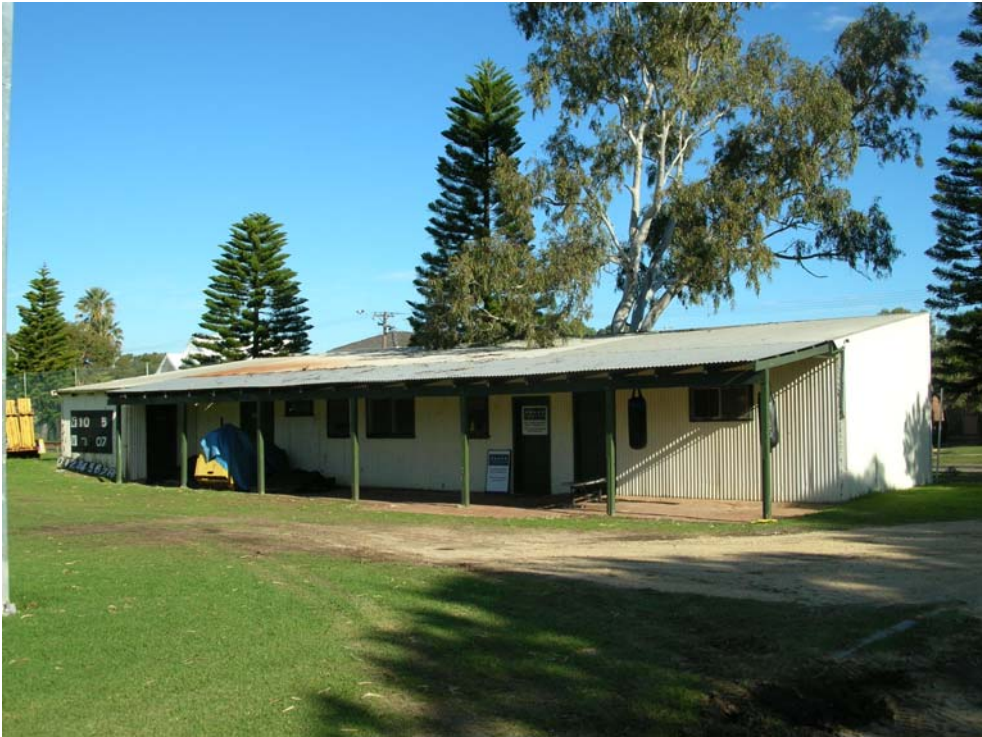
The gymnasium is accommodated within the former stable; a single storey rectilinear timber framed and corrugated sheet metal clad building with a brick paved verandah extending the full length of the building. The painted sheet metal cladding is generally in very poor condition and heavily rusted, particularly in areas beneath the eaves and along the bottom section of the walls. Remanent gutters in 'ogee' profile and downpipes along the verandah have rusted out. On the south-eastern corner of the building are an old, well-used scoreboard and a series of number boards.

*Figure 85* View of former stable from the oval.  
*Hocking Planning and Architecture, August 2009*

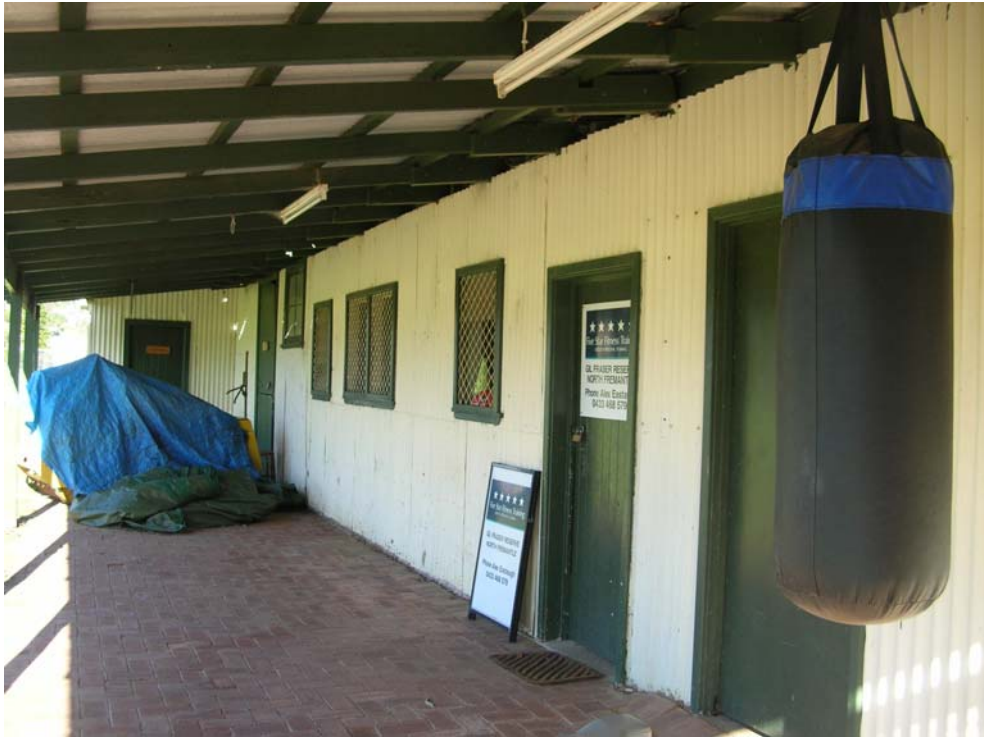
Figure 87 View of the former stable and brick paved verandah.  
Hocking Planning and Architecture, August 2009

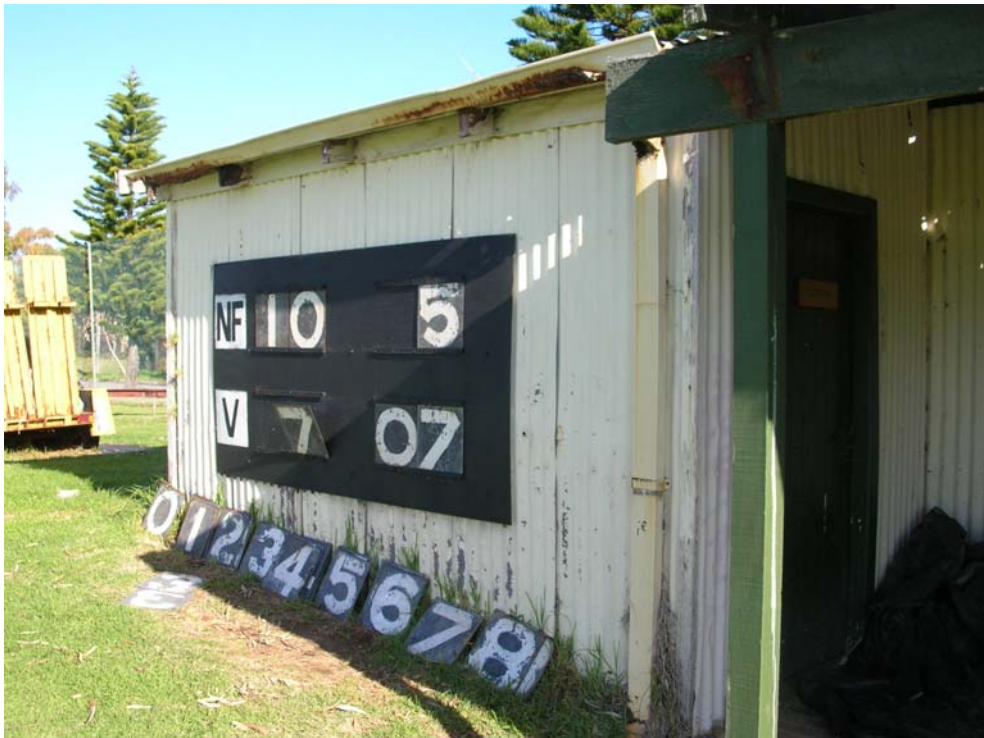
Figure 88 Scoreboard and number boards.  
Hocking Planning and Architecture, August 2009

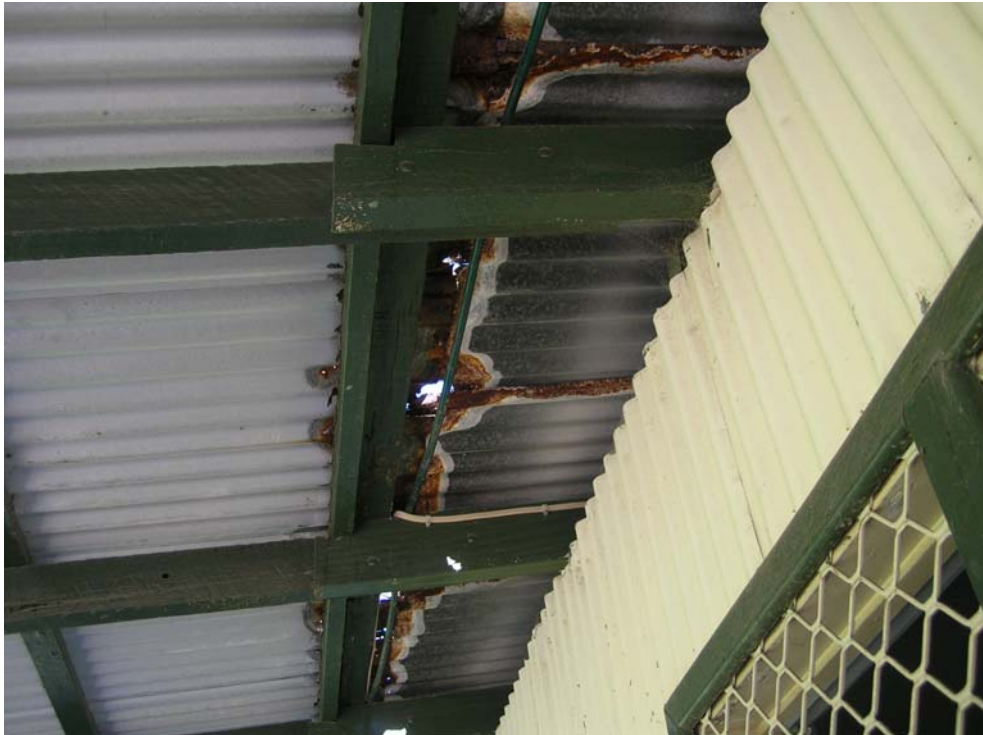
Figure 89 *Detail of heavily rusted corrugated sheet metal roof above the verandah.  
Hocking Planning and Architecture, August 2009*

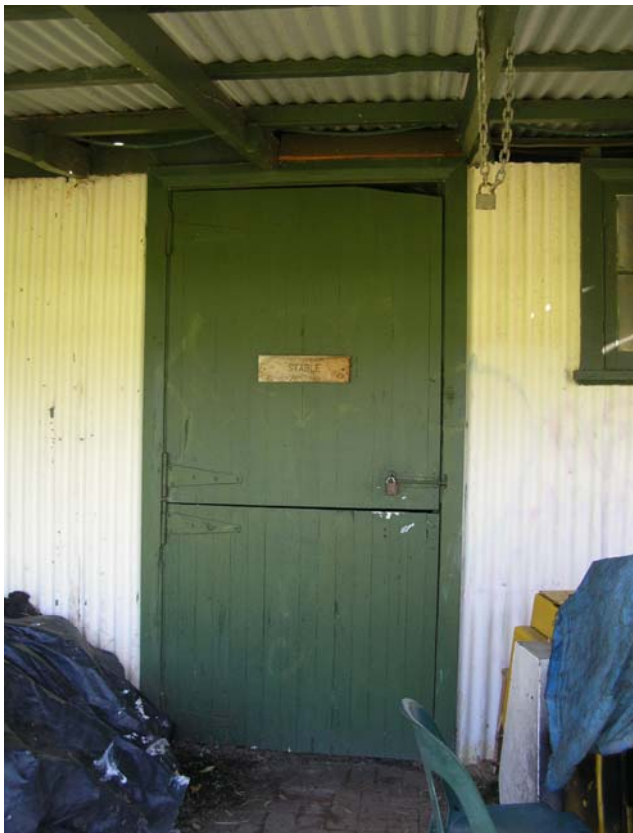
The basic plan of the building is divided into three rooms, based on external observation and configuration of the door openings. Original timber framed door openings with matchboard doors and timber signages identifying the former use are still evident. Looking through an unglazed window opening, the interior of the north-western room has timber wainscotting up to dado height, with a moulded timber dado. Above the dado, the walls have been clad with corrugated sheet metal in 'Mini Orb' profile, fixed horizontally to the original timber framing. Contemporary gym equipment has been placed around the small room.

Figure 90 *Extant timber matchboard door and signage identifying the former stables.  
Hocking Planning and Architecture, August 2009*

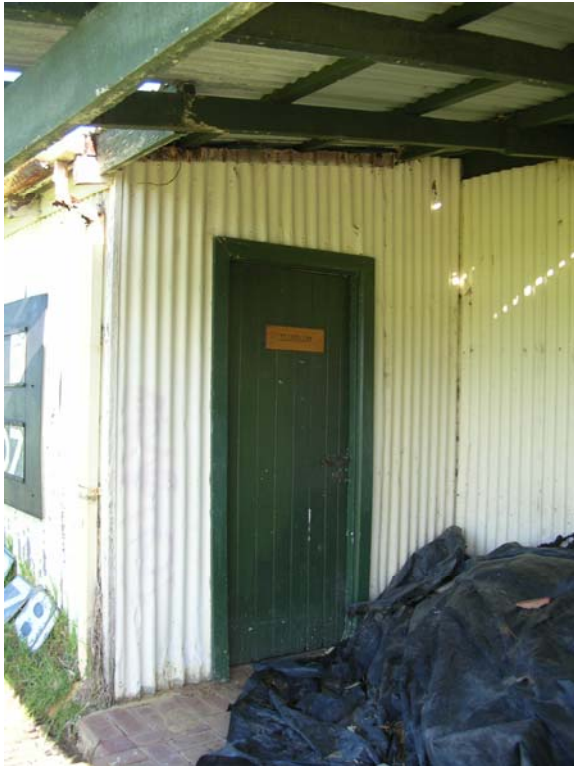
Figure 91 *Extant timber matchboard door.  
Hocking Planning and Architecture, August 2009*

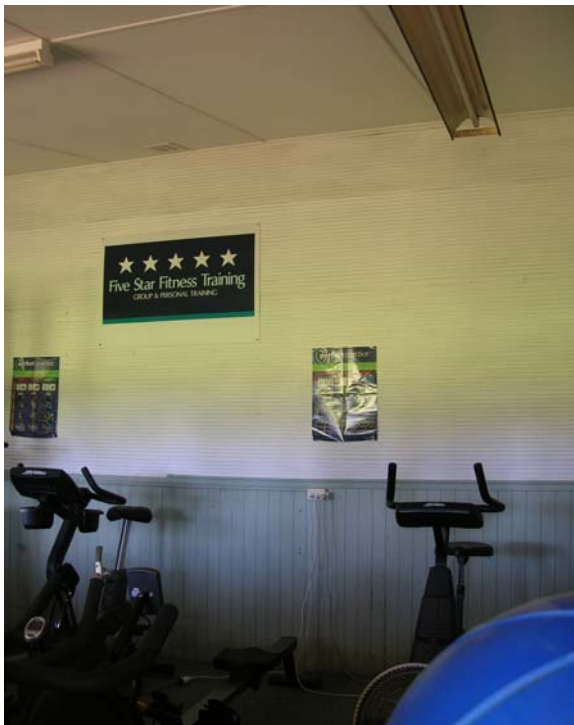
Figure 92 *Interior view of the south-western room, with timber wainscoting and corrugated sheet metal cladding above dado.  
Hocking Planning and Architecture, August 2009*

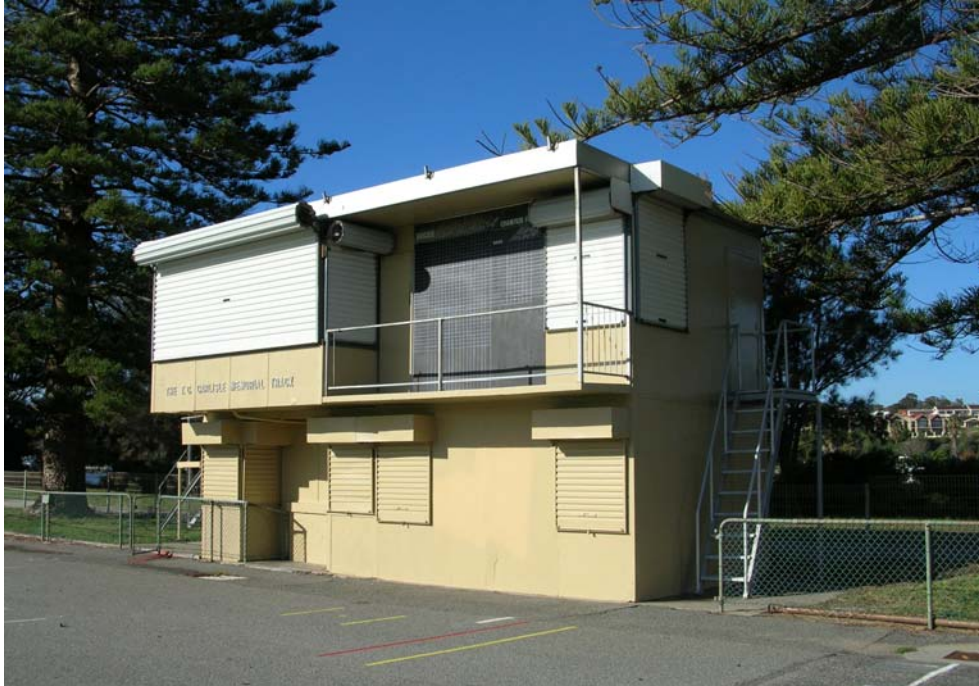
The building, dedicated to Thomas Charles Carlisle, is two-storey rendered masonry with steel framing and a flat roof construction. A flight of steel staircase to the upper level is located externally on the north-east elevation. Large openings with built in steel roller shutters and servery bench tops are located on the north-west elevation, facing the oval.

Figure 93 Exterior view of the W.A.F.B. timing stand.  
*Hocking Planning and Architecture, August 2009*

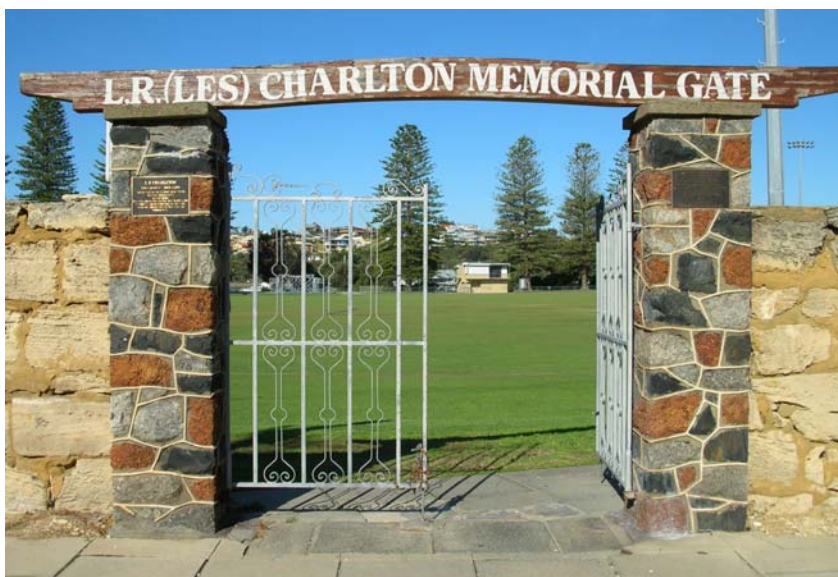
The memorial gate, relocated to its current location in the early 1990s, comprises of paired pillars of local rubble stone, painted steel gates and rubble limestone walls, mark the John Street entrance of the reserve. An informal footpath from this entry led to the brick paved verandah of the clubroom. Mortar joints between the rubble limestone have eroded away to a considerable degree.

Figure 96 *The Les Charlton Memorial Gate, on John Street. Hocking Planning and Architecture, August 2009*

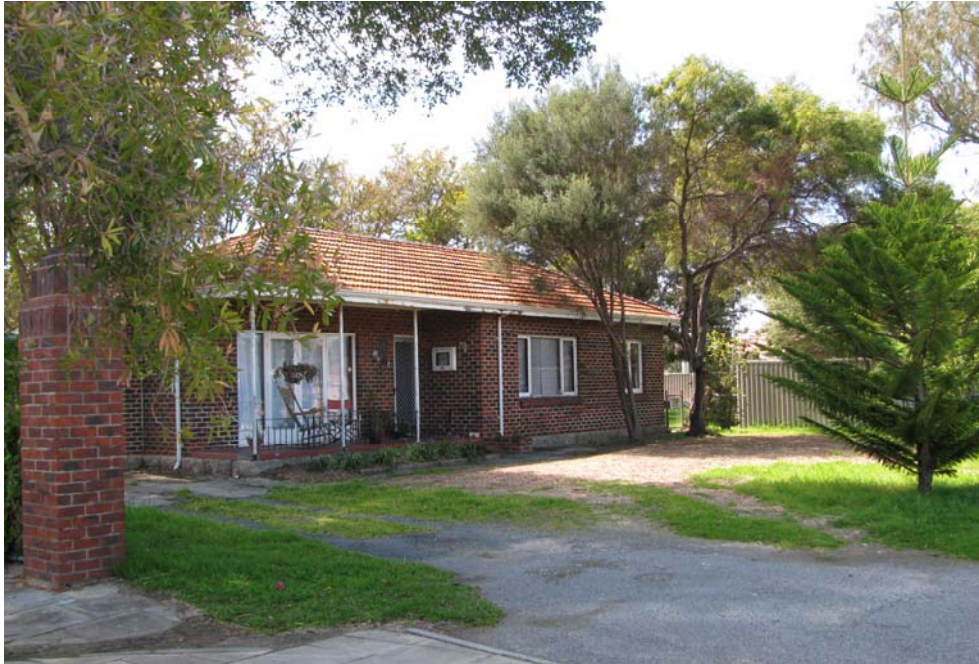
The caretaker's house is located on the south west perimeter of the site, adjacent to the Laurie Tetley Gates and car park. The house is single storey; with clay tiled roof and cavity face brick construction with frontage onto Johannah Street. The building was not inspected internally.

Figure 97 *Former caretaker's house, viewed from Johannah Street.  
Hocking Planning and Architecture, September 2009*

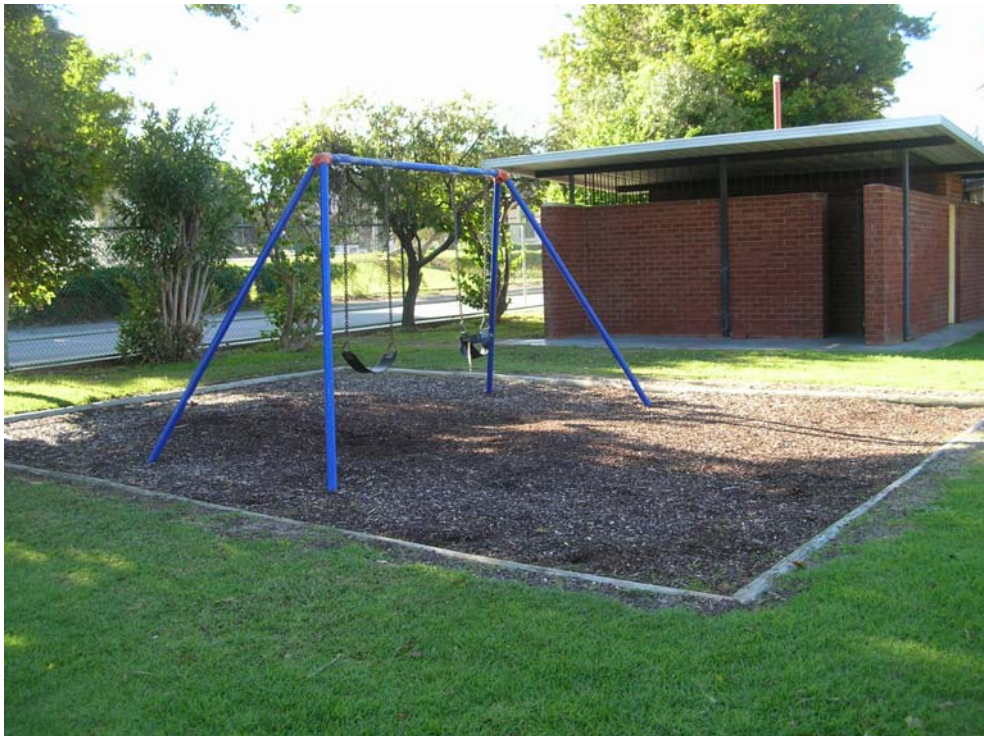
Two sandpits with contemporary playground equipment are located adjacent to the main entry, Laurie Tetley Gates. The equipment is generally in fair condition, with some wear and tear and discolouration of the powder coated finish.

*Figure 100* View of the southwestern toilet block and play equipment in the foreground.  
*Hocking Planning and Architecture, August 2009*

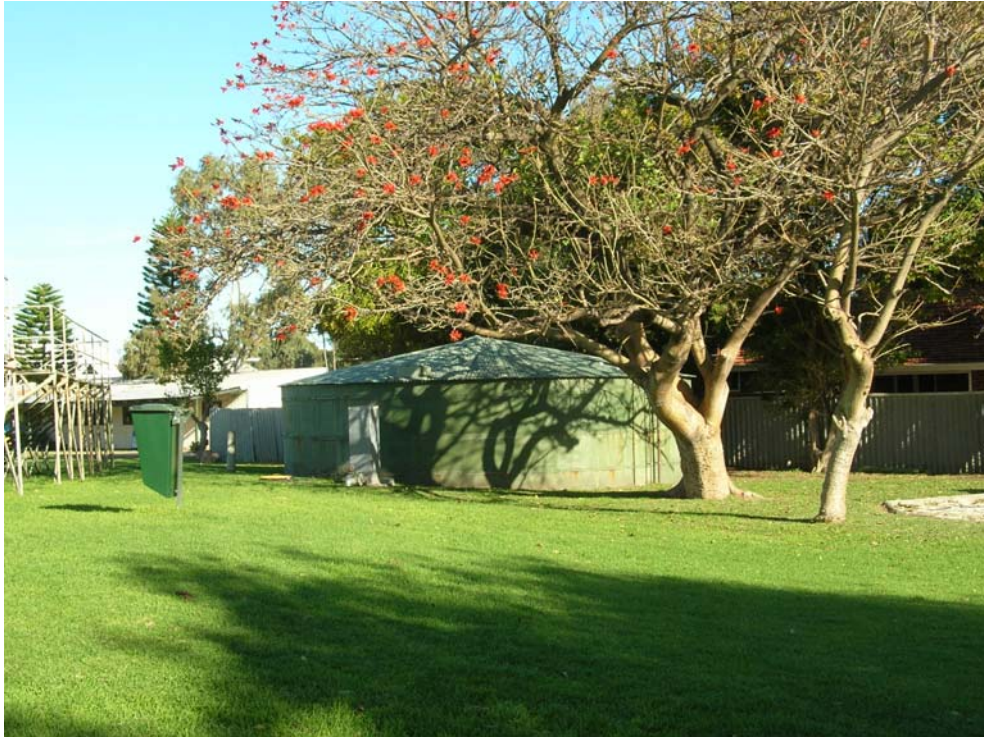
*Figure 101 View of the water tank, south-western toilet block and play equipment in the foreground.  
Hocking Planning and Architecture, August 2009*

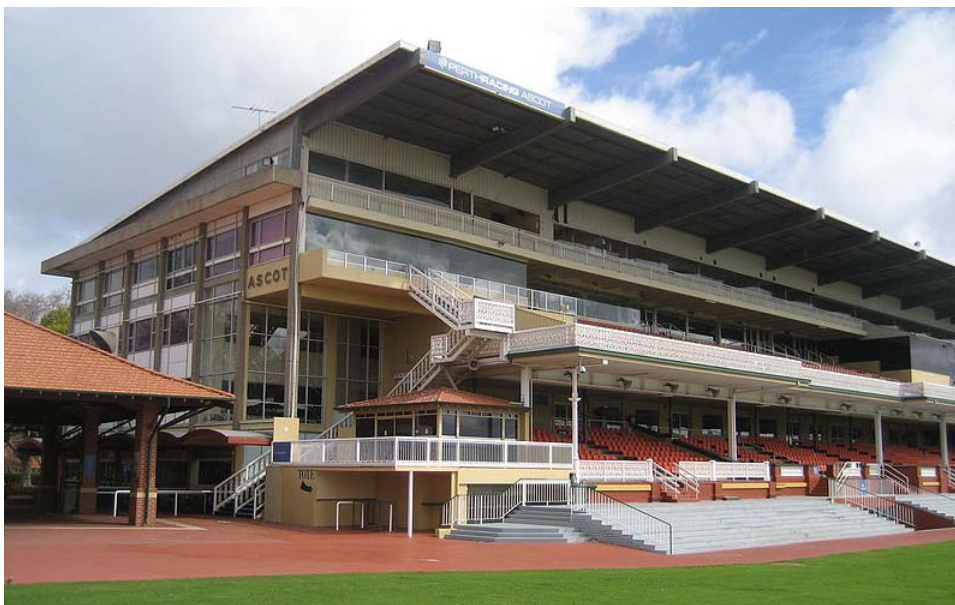
The Ascot Racecourse is a large complex, which dates from 1853. Within the complex is a large grandstand that was originally constructed in 1903 and significantly modified and added to in 1969. There are elements of the original structure remaining in the grandstand including the Victorian cast iron columns and two levels of interior space; the ground floor and the first floor behind and underneath the tiered seating.

Figure 106 *Ascot Grandstand (1969) incorporating 1903 grandstand*  
*Courtesy of Wikipedia.*

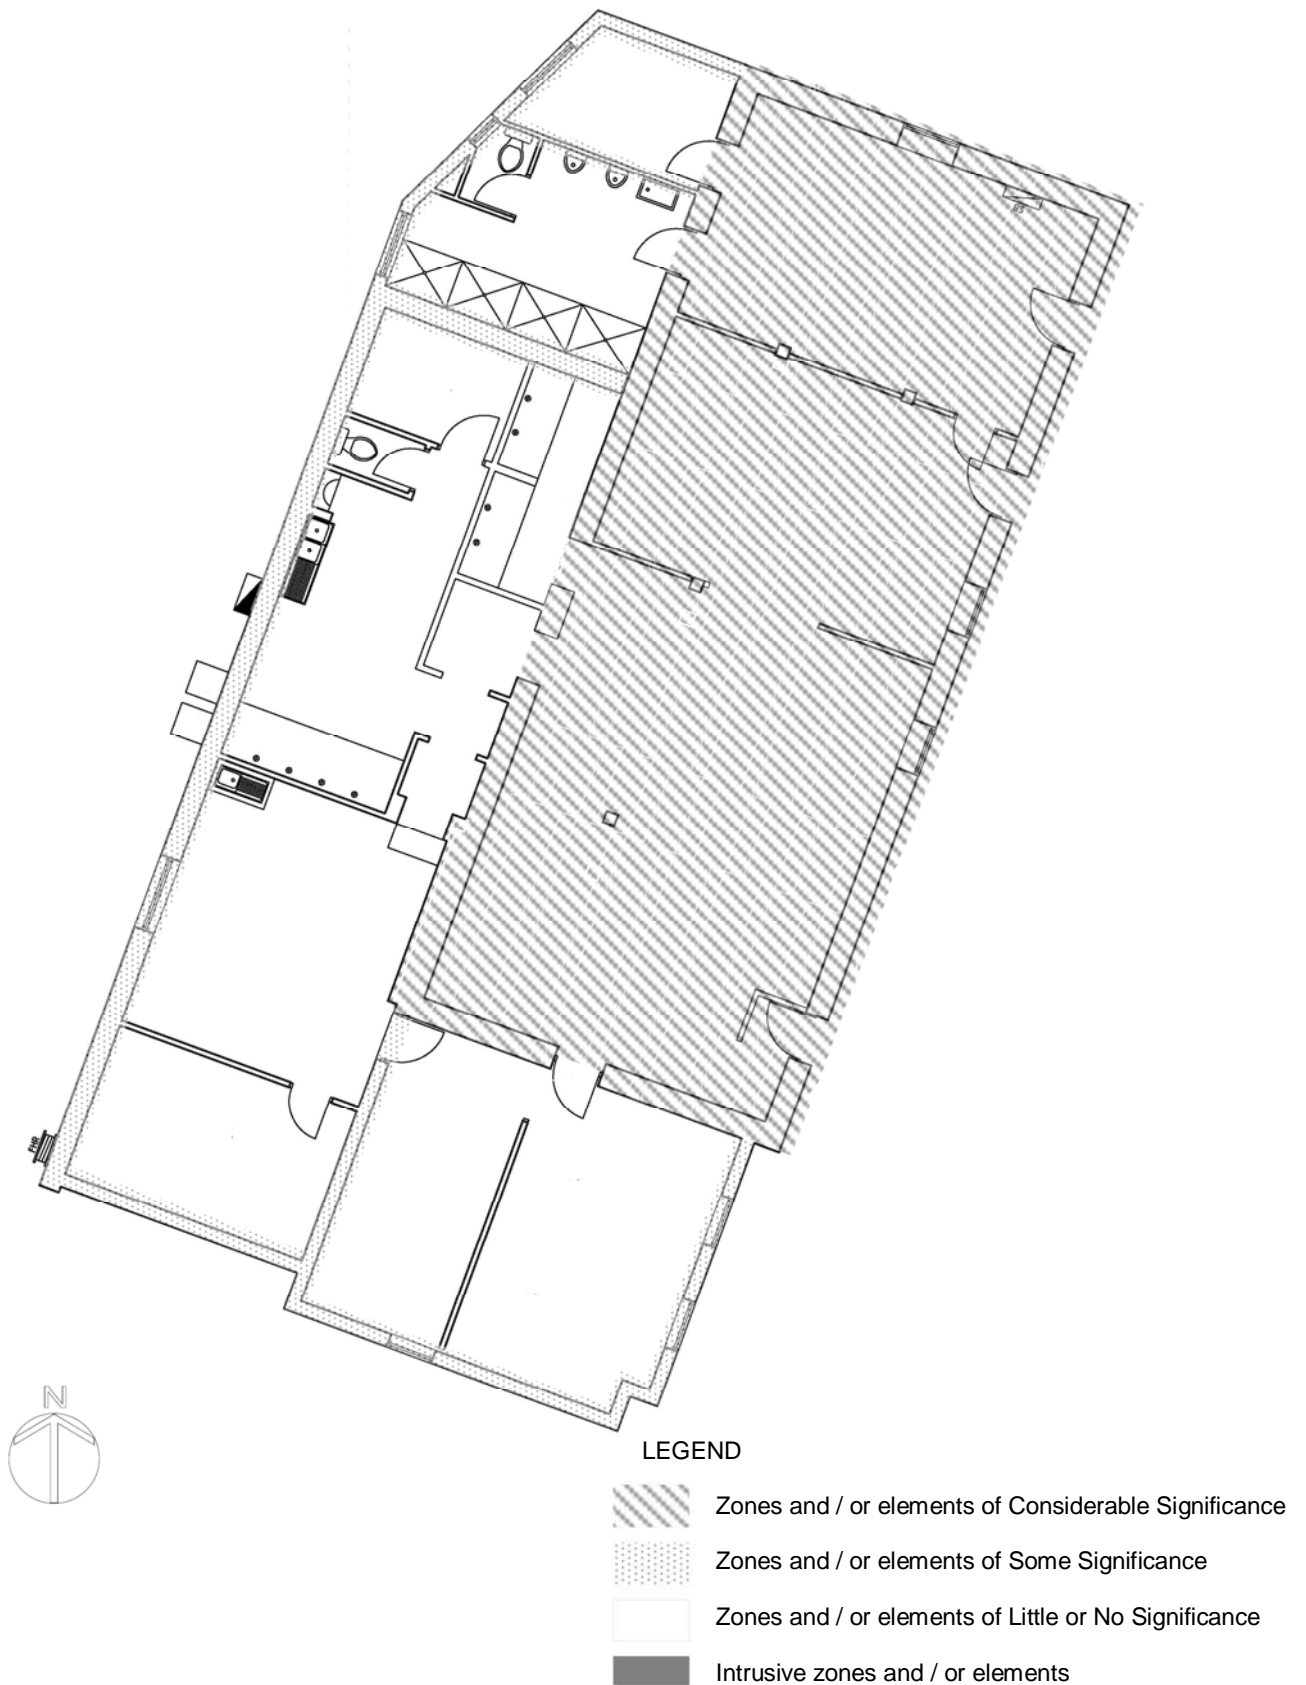
Figure 109 *Diagram identifying the various zones and / or elements of significance of the ground floor level / change rooms of the grandstand.  
Hocking Planning and Architecture, October 2009*

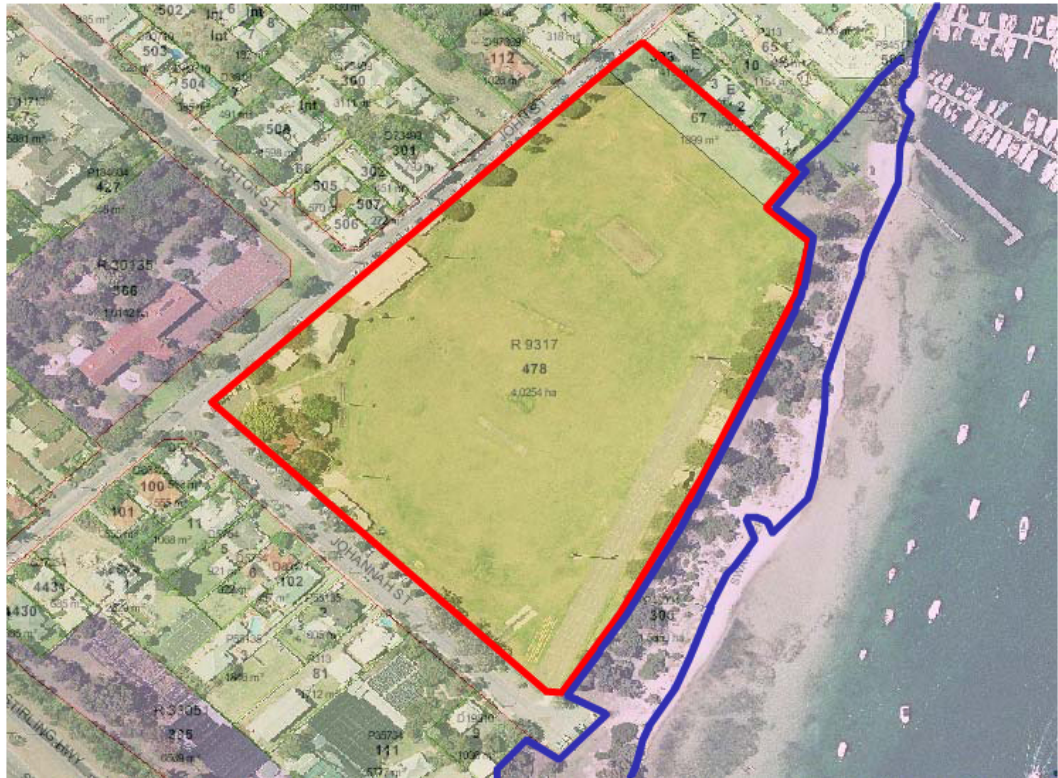
RECOMMENDED CURTILAGE FOR INCLUSION ON HCWA STATE REGISTER OF HERITAGE PLACES.
-

Figure 110 Diagram showing recommended curtilage for inclusion on the State Register of Heritage Places  
*Hocking Planning and Architecture, July 2010*

The recommended curtilage for inclusion on the State Register of Heritage Places is as shown in Figure 110, which includes the whole of the existing Reserve 9317 and Lot 67. In addition to agreement with the respective owners, the extant of the recommended curtilage would require further discussions and agreements with the Heritage Council of Western Australia and Swan River Trust (the whole of the Precinct and foreshore is within the Swan River Trust's Development Control Area and Riverpark). Refer to Policies 6 and 7 for appropriate policies and actions relating to identified built structures and landscape elements of significance within the proposed curtilage.
