# GILBERT FRASER RESERVE PRECINCT, NORTH FREMANTLE

## CONSERVATION MANAGEMENT PLAN

Prepared by Hocking Planning & Architecture, July 2010

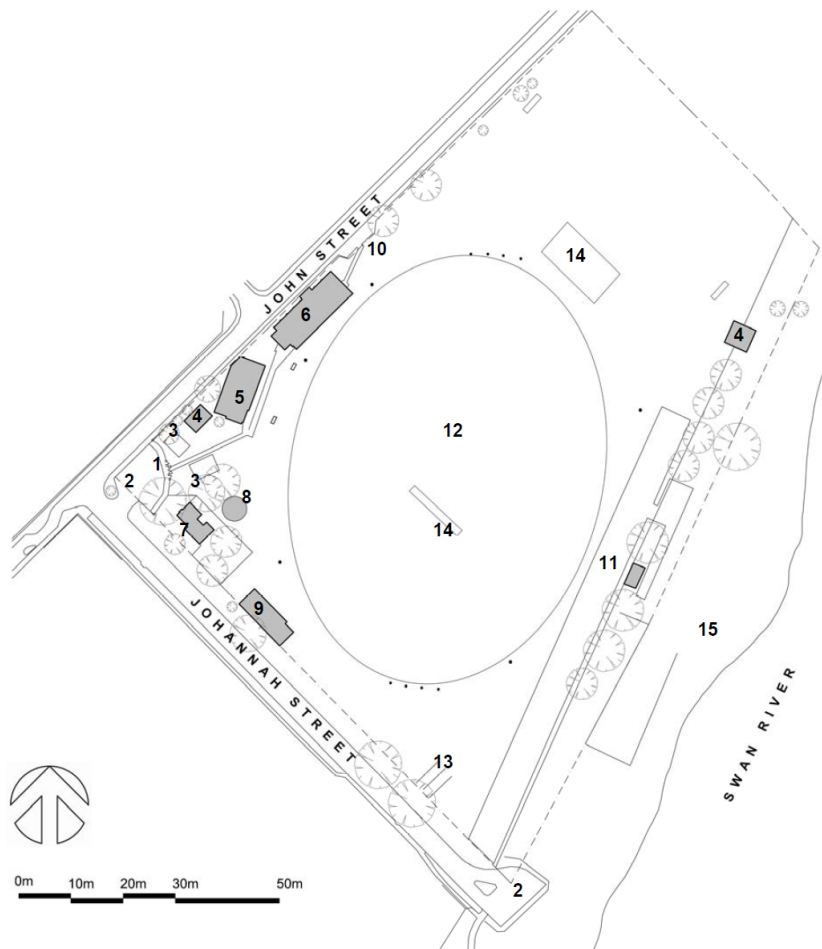
Figure 5 Site plan of the Gilbert Fraser Reserve Precinct, Base drawing provided by Facilities and Assets department, City of Fremantle, May 2009. Updates to base drawing by Hocking Planning & Architecture, October 2009

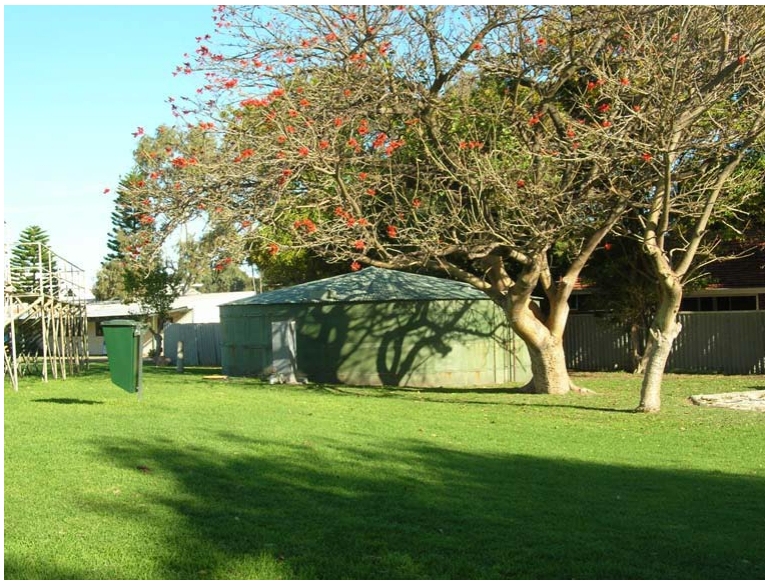
The circular concrete water tank is nestled within small plantings, to the rear of the caretaker's house. Based on documentary evidence, the tank was installed in 1998, extracting fresh water from a shallow bore to reticulate the playing field.

*Figure 101 View of the water tank. south-western toilet block and play equipment in the foreground.*

- Water tank;
- Elements within the grandstand, which are intrusive:
  - o Chain link mesh balustrades along east elevation and balustrades on existing stairs;
  - o Plywood lining and small ledge to internal face of the west elevation;
  - o 'Zincalume Custom Orb' sheet metal cladding in the changerooms.

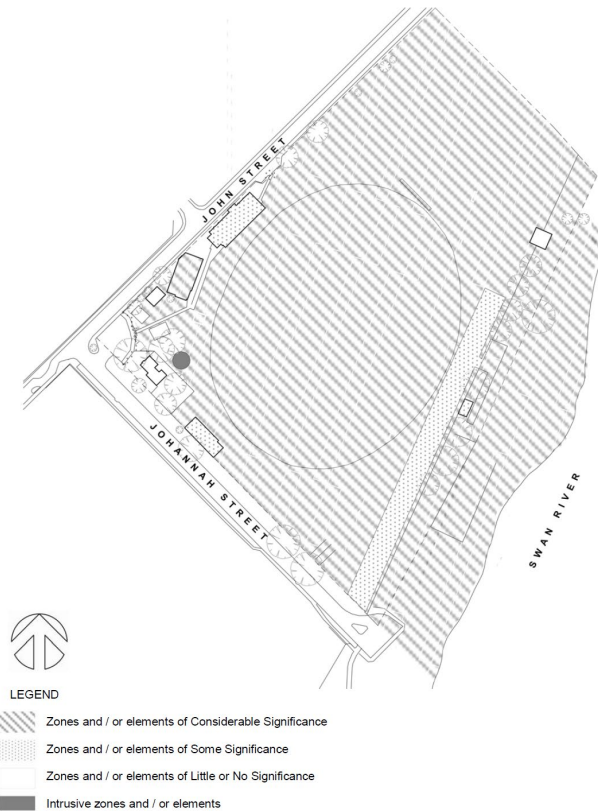
Figure 107 Diagram identifying the various zones and /or elements of significance of the whole Gilbert Fraser Reserve Precinct site.  
Hocking Planning and Architecture, October 2009

Intrusive spaces or elements have been identified, as detracting from the significance of the place and their removal and/or replacement with more appropriate detailing, should be encouraged. Their removal needs to be assessed against other considerations, such as function and economics, before implementation. Before removal/demolition ensure that the comprehensive photographic and graphic recording is completed.

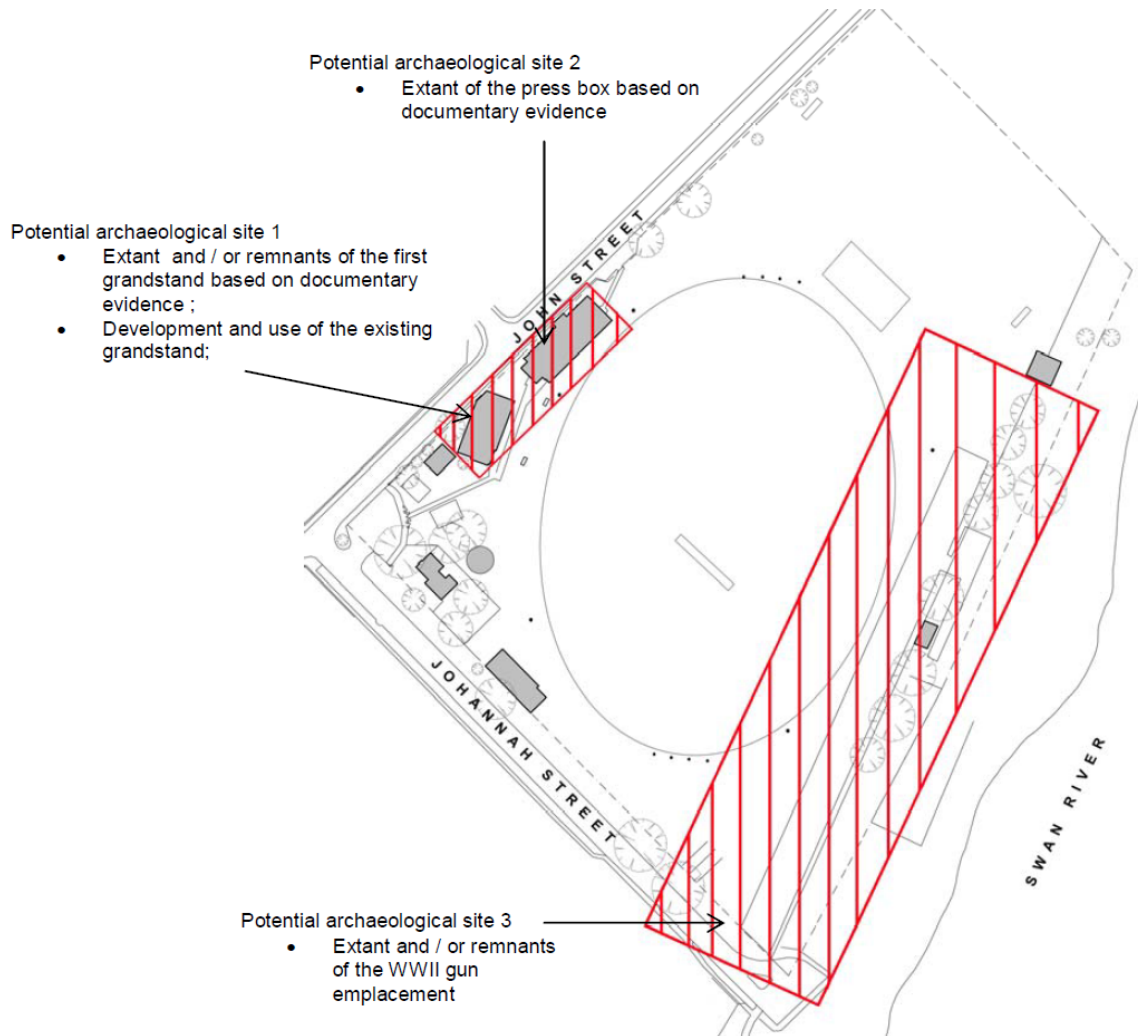
Figure 111 *Diagram showing potential archaeological areas within the Precinct Hocking Planning and Architecture, July 2010*

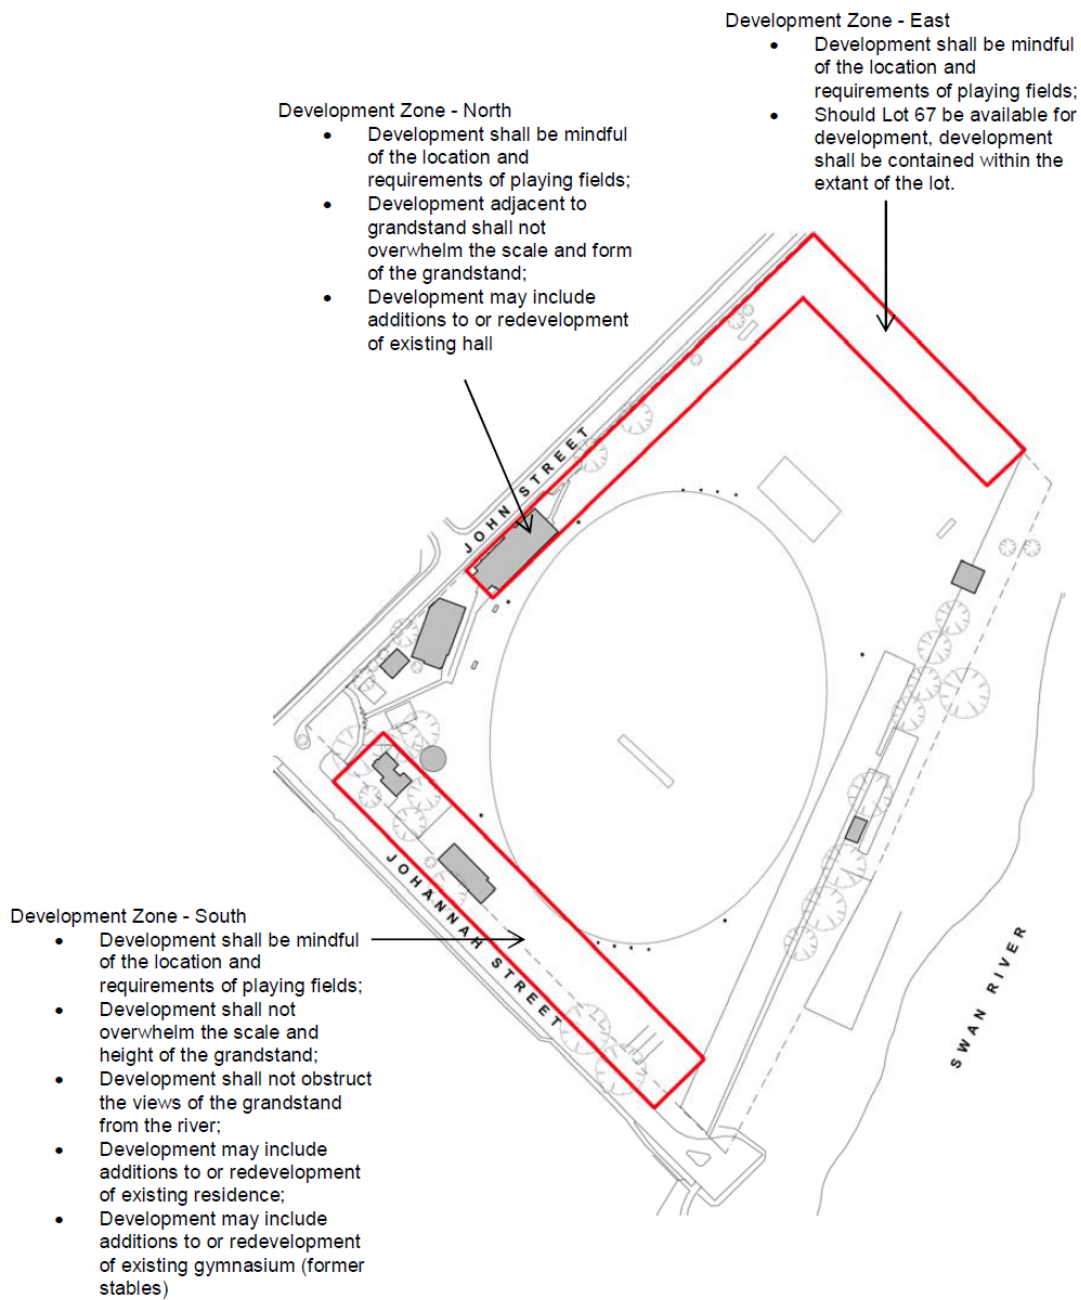
Figure 113 *Diagram showing recommended development zones within the Precinct Hocking Planning and Architecture, July 2010*
