FPOL2001-6 HARVEY BEACH JETTY

ATTACHMENT 1 - Harvey Beach Jetty – Fixed Timber Structure Inspection

**Project:** Condition Inspection  
**Structure:** Harvey Beach Jetty  
**Location:** North Fremantle  
**Client:** City of Fremantle  
**Date:** 15<sup>th</sup> January 2020

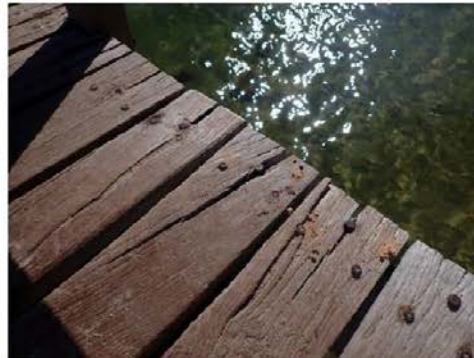
*Fixings proud of decking*

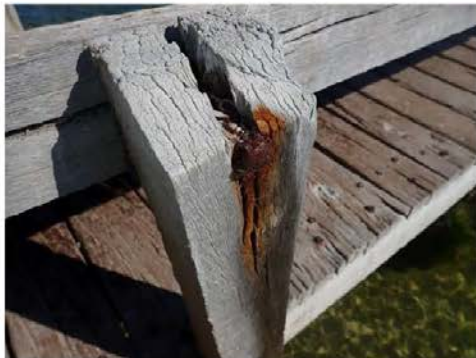
*Handrail Timber splitting (1)*

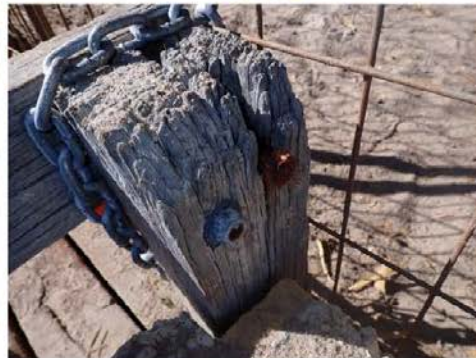
*Handrail Timber splitting (2)*

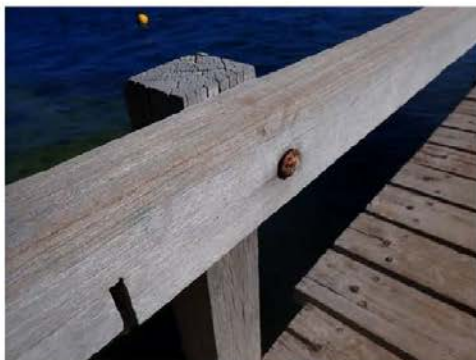
*Handrail in good condition*

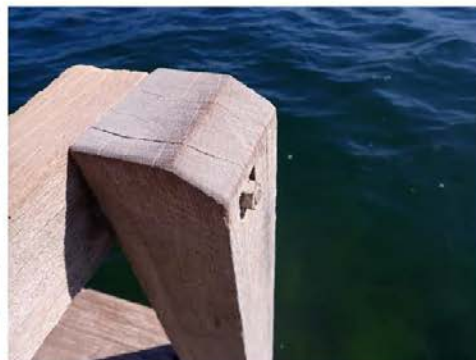
*Handrail in good condition (1)*
