**PC2307-01 - HERBERT STREET, NO. 21 (LOT 23), NORTH FREMANTLE –
DEMOLITION OF EXISTING SINGLE HOUSE AND INCIDENTAL
STRUCTURES (JZ DA0127/23).**

Structural Integrity Report

Property Address: 21 Herbert Street North Fremantle 6159

Asbestos Inspection and Condition Report

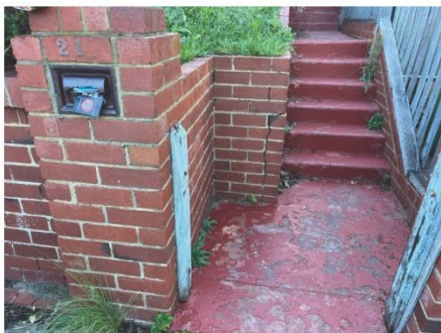
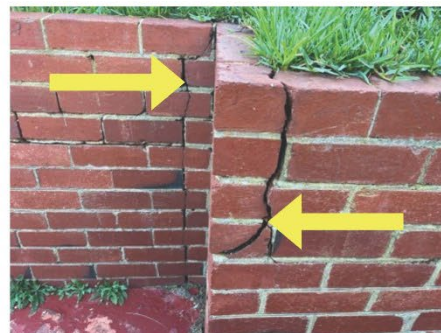
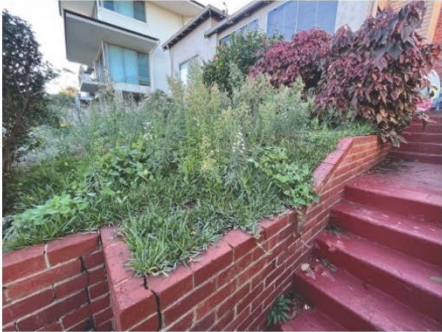
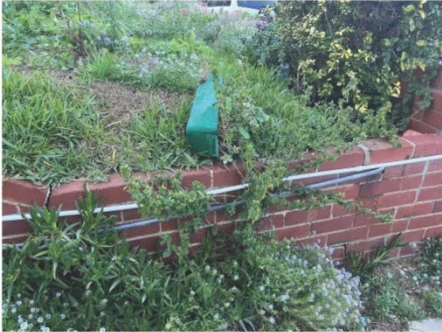
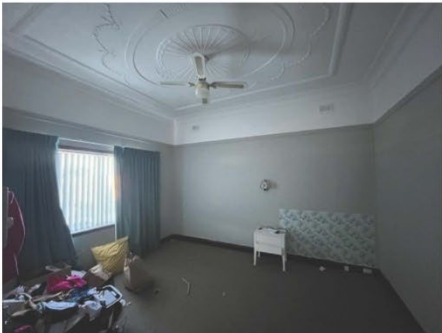
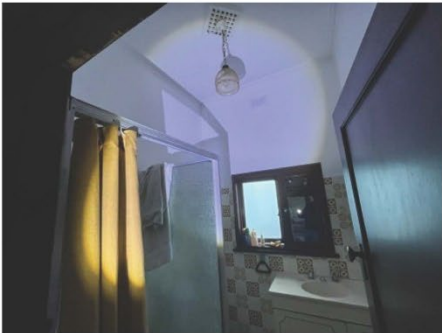
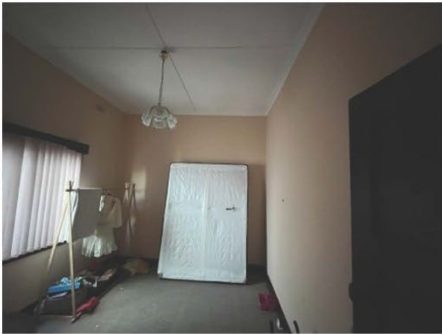
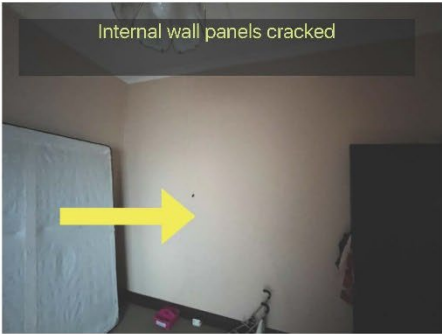
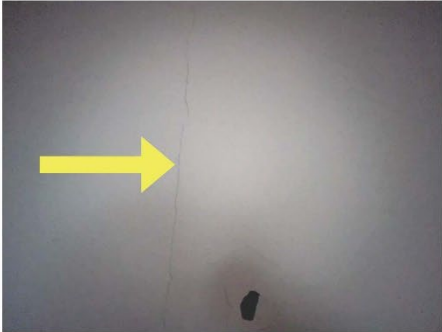
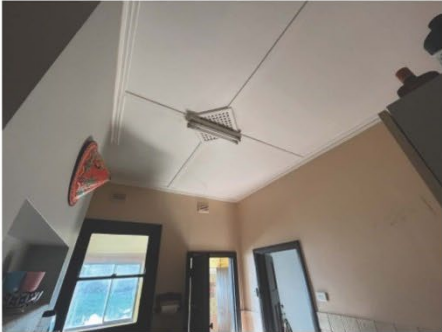
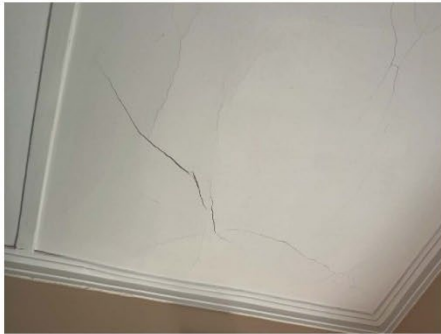
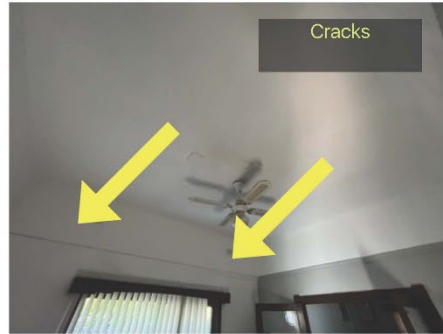
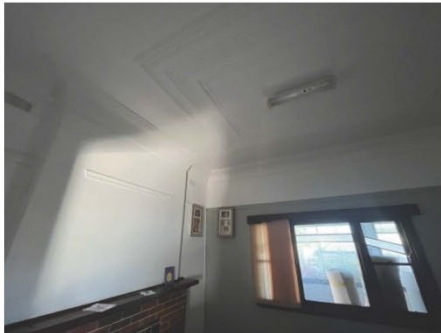
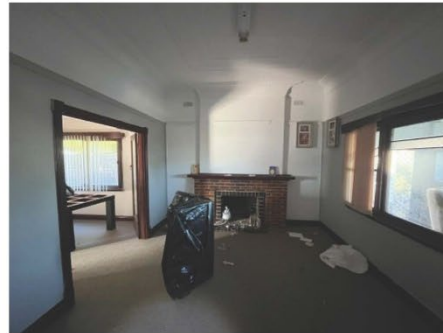
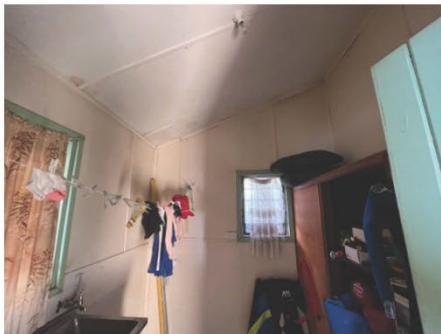
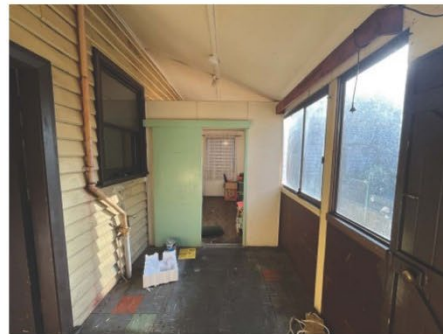
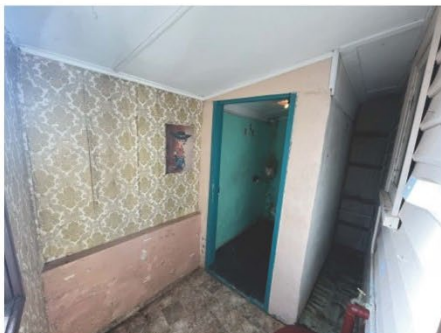
Location: All areas
Finding: Additional Photos - Areas inspected

These photographs are an indication of the areas inspected. Some photographs may point out obstructions and limitations which impeded full inspection of the property at the time of inspection. Some photographs may also point out maintenance items which are normally excluded from a structural inspection. Always contact your building inspector should you have any questions.
