# Additional information

## Ordinary Meeting of Council

| Contents | | Page |
|---|---|---|
| FPOL2104-11 | ROUND HOUSE CONSERVATION MANAGEMENT PLAN | 54 |

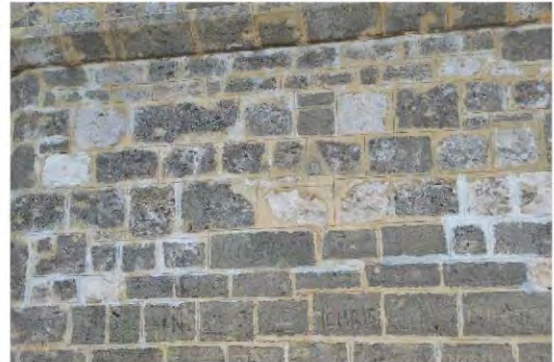
Figure 96: Evidence of previous repairs to external walls

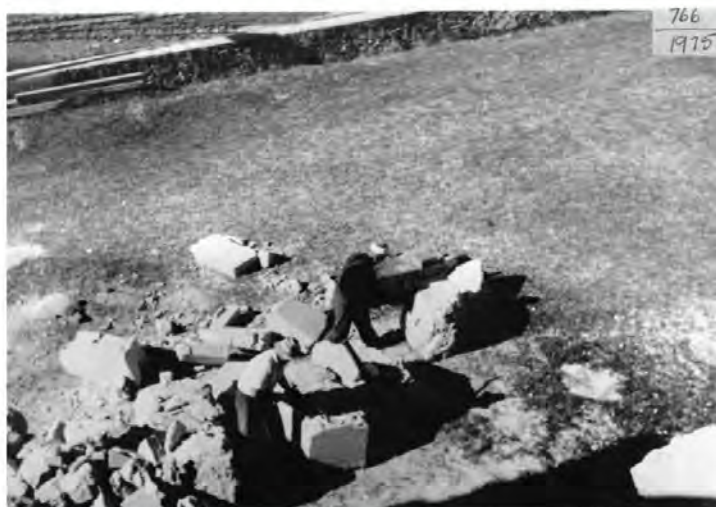
Figure 33: 1975 limestone blocks being cut by hand on site

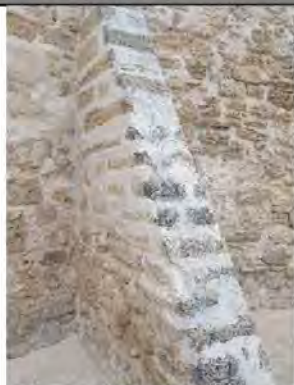
2004 lime mortar – harder capping mortar

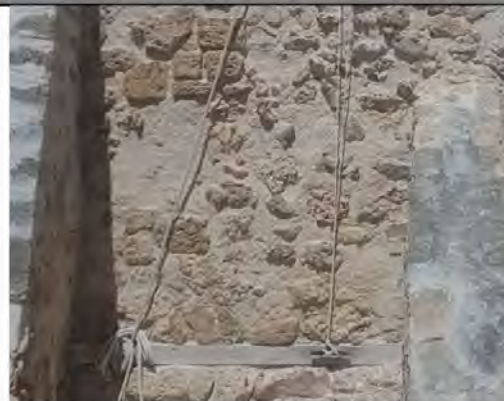
2004 lime mortar – friable mortar build-up beneath original surface of conservation works mortar

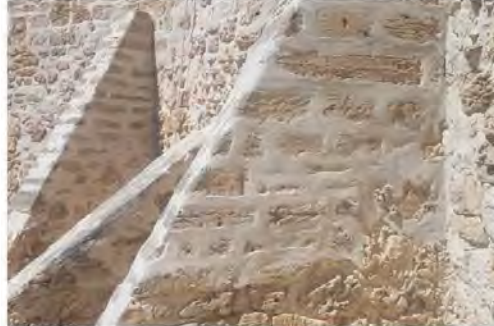
2004 lime mortar surface finish

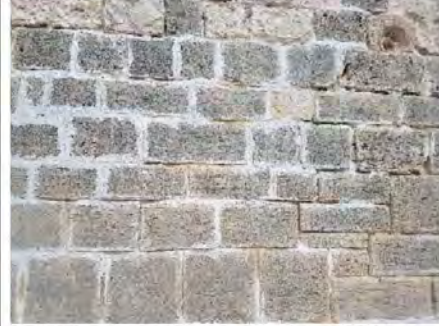
2004 lime mortar – weathered and friable

All mortar joints showing signs of degradation should be repointed. Re-pointing will have to go deep into the wall in order to remove cement mortars ~ 100mm in places.

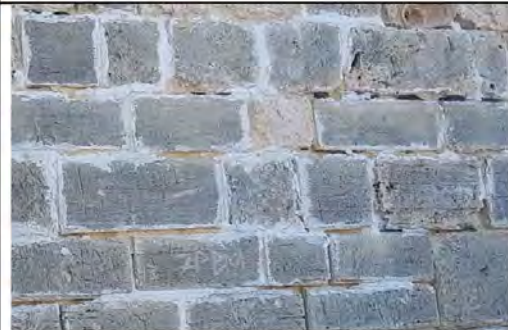
1975 cement (?), (behind 2004 eroded)

Cement mortar can be seen to have been used in the re-pointing of the walls in many areas. This is likely to have been predominantly from the 1975 works. The less pervious and stronger composition of cement mortar means that water that seeps into the more porous limestone block is able to sit on the shelf that the cement bed joint creates keeping the limestone block wet or damp for extended periods. This can affect the stability of the stone causing accelerated weathering of the surface and a weakening of the block itself.

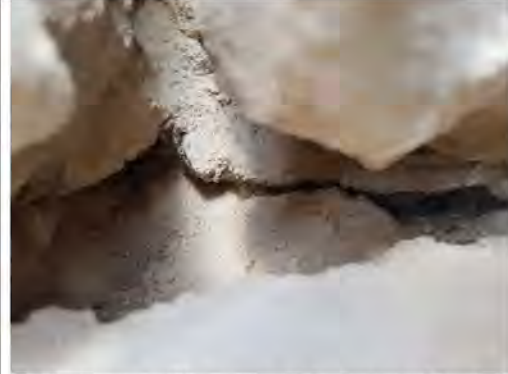
Original mortar (?) appears to have turned back to sand

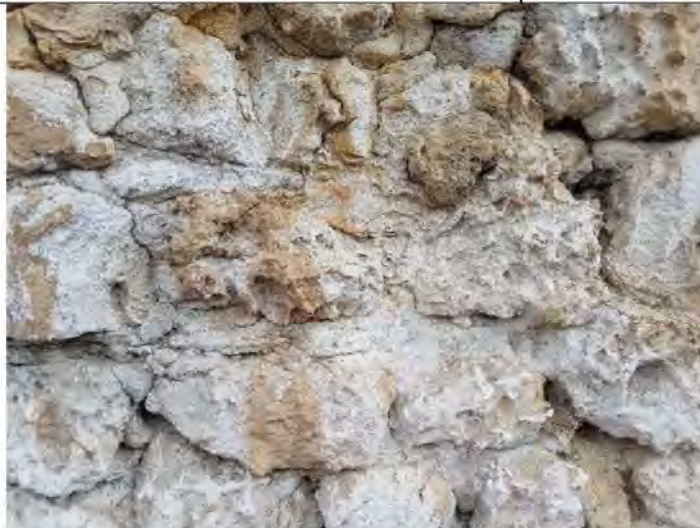
Original mortar (?) with calcium carbonate shell to surface and extensive salt deposits from ground water movement – stair wall

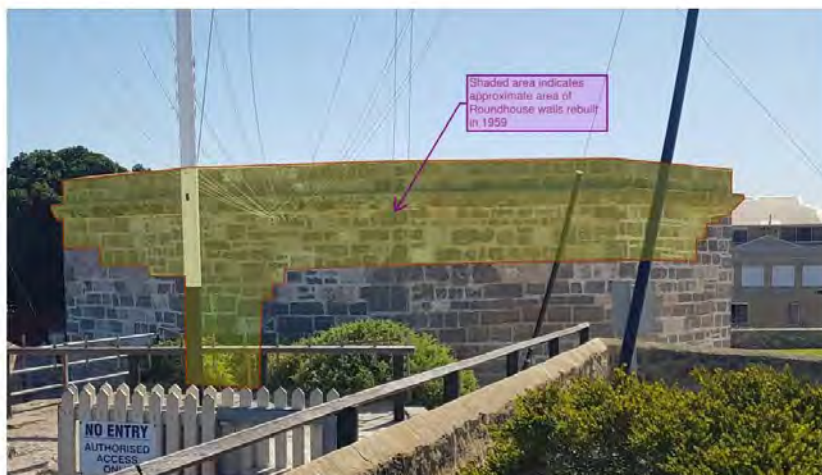
Figure 35: Approx area of Roundhouse walls rebuilt in 1929 / 1959 conservation and restoration works

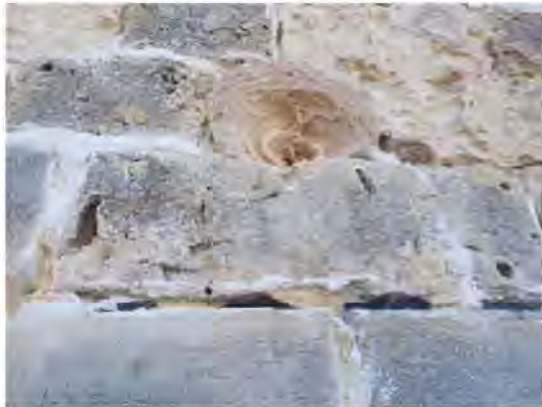
Slate and brick setting blocks in mortar joints were used as part of the construction during limestone block replacement works to set the joint width between beds of blocks and prevent the mortar from squeezing out while the mortar set. Where the mortar joints have eroded these are visible again.

Figure 38: Slate setting blocks for stones

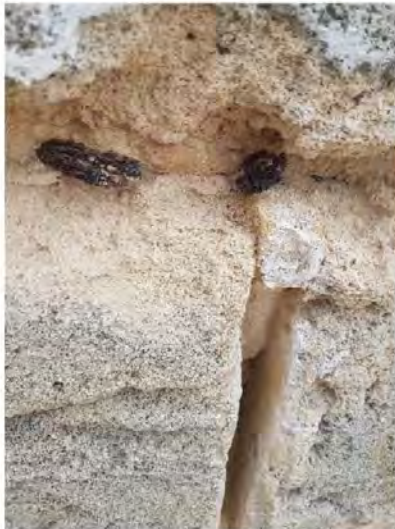
Most steel embedments appear to have been generally removed from the walls, however a few still remain. On the NW and West sides these items are heavily rusted.

Figure 42: Steel embedments West side

The remaining steel embedments should be removed from the walls to prevent them from splitting the masonry locally around the steel as it continues to rust.

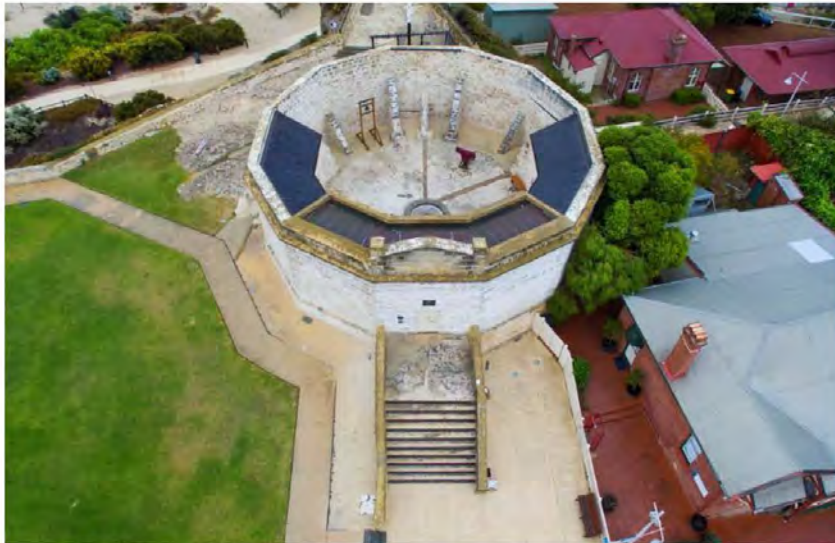
Above the ceiling joists is a ceiling void of 100mm and a second set of joists supporting a plywood deck. Based on the 1975 photos this plywood deck was overlain with a screed and then a membrane was applied to the top surface. We are not aware of any roof works since this date. The fall to this roof is quite shallow, which would explain why the contractor that built the Roundhouse had problems with getting it waterproof from the start.

Figure 46: Roundhouse roof from NE

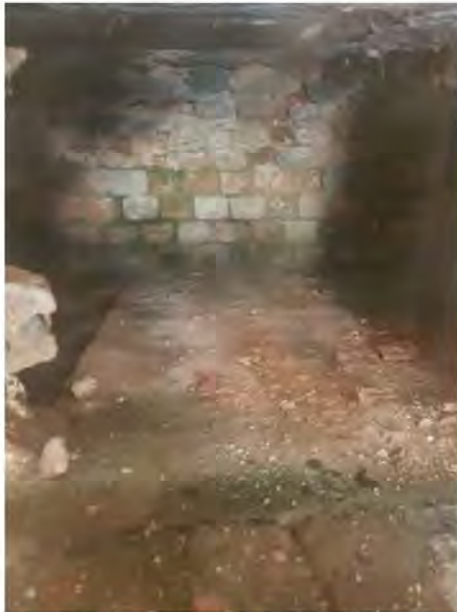
Figure 57: Evidence of recent fretting of bricks in oven roof

The bakehouse is currently a damp environment. Given its age there is obviously no waterproofing surrounding the underground room and the masonry is porous to allow water seeping down from the landing of the stairs above to get into the space.

This damp environment is promoting biological growth on the brickwork and limestone walls. Algae and lichen are covering some of the masonry surfaces that are frequently or continuously wet. Biological growth thrives when moisture and a food source such as calcium carbonate coincide in damp locations of buildings that are not exposed to constant sunlight. This is the case with the bakehouse. The masonry staying in a wet condition for extended periods of time and the biological growth will be causing the condition of the masonry to deteriorate over time, so more fretting of the brickwork and limestone can be expected if these conditions are allowed to continue in their current state.

In the short term we recommend that the volunteers open up the bakehouse door for extended periods each day they are at the Roundhouse in order to allow the room to dry out.

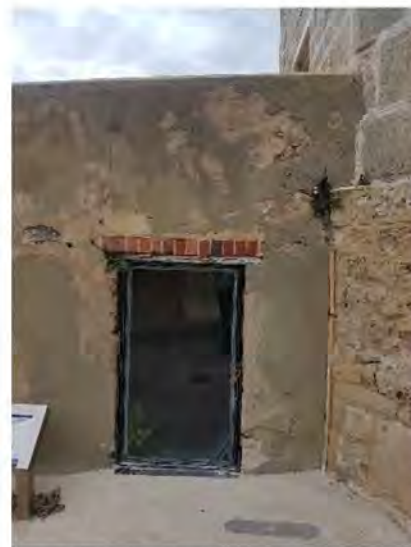
Figure 58: Current sealed door

The current door on the bakehouse is a solid door well sealed. Whilst this part of the Roundhouse used to be on the tour for tourists visiting the site, we understand that these days it is not often opened up. This means that the water that arrives in the room is unable to dry out. We note from historic records that the door has been changed a number of times in the past and during some of those periods it has been an open slatted gate. See example from 1998 below:

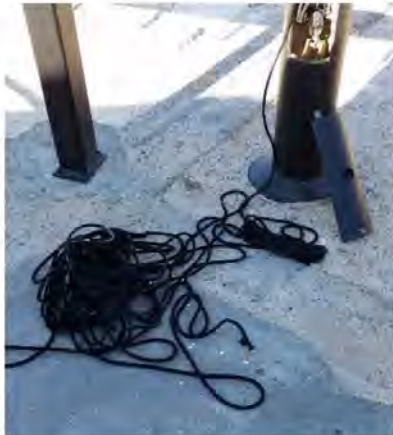
Figure 61: Access hatch and rope stored in the mast

There is an access hatch at the base of the mast for access to the ropes that allow the lowering of the ball and flags. The ropes are stalled within the body of the mast passed down into the base. A large amount of rope is stored this way and takes a reasonable amount of time to lower into the mast.

On removal of the rope it could be seen that the mast has water sat in the bottom of the base section of mast below ground. The water sat in the mast will not be doing the rope any good in terms of its expected life and the steel of the mast at the water line is at risk of corrosion over time.

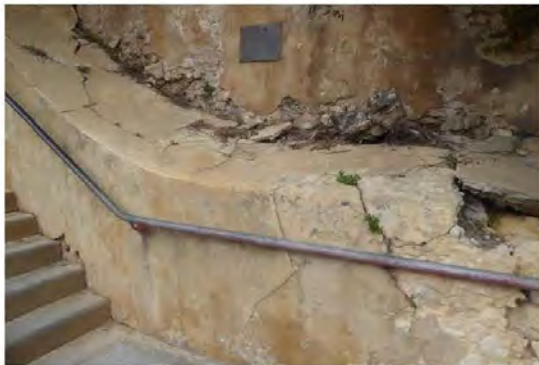
Figure 1: Failing render to steps from High Street

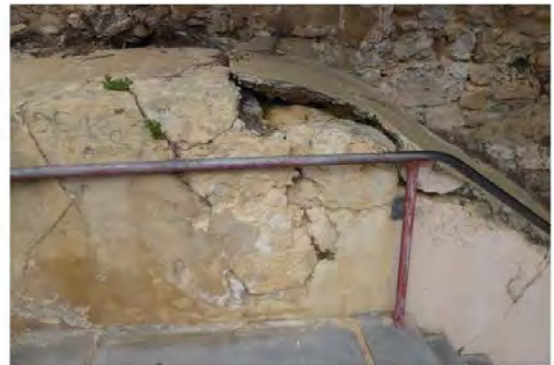
Figure 2: Failing render to steps from High Street

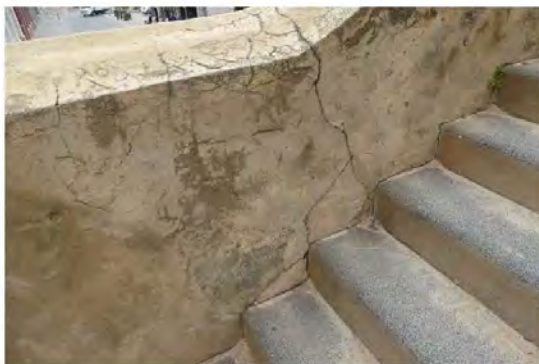
Figure 3: Failing render to steps from High Street

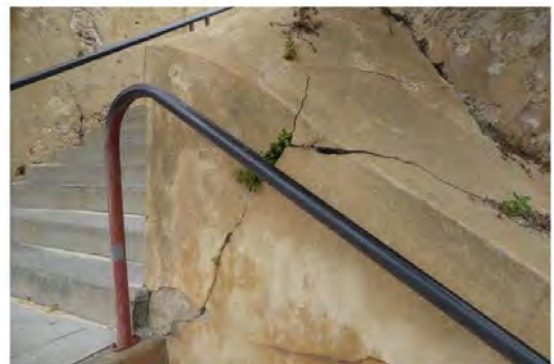
Figure 4: Failing render to steps from High Street

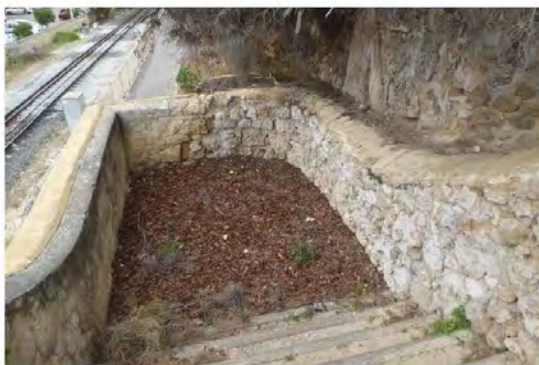
Figure 5: Collected debris in remnant step landing

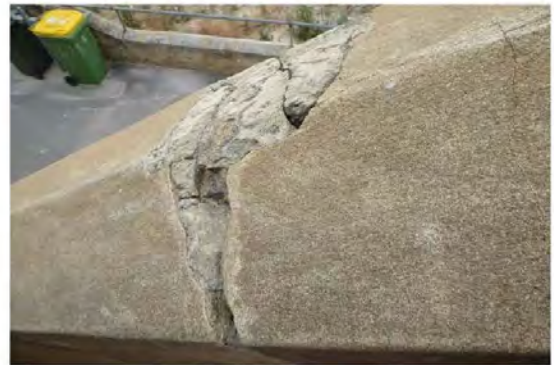
Figure 8: Failing render to steps from High Street

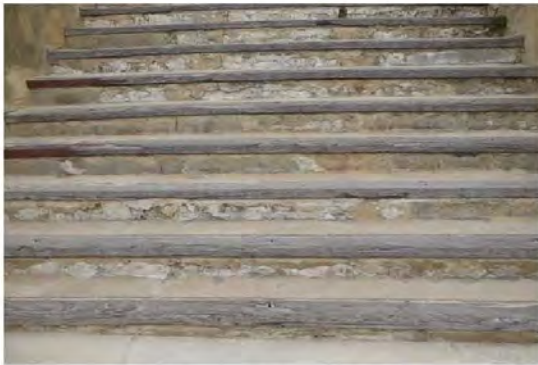
Figure 9: Timber nosings to steps to Round House

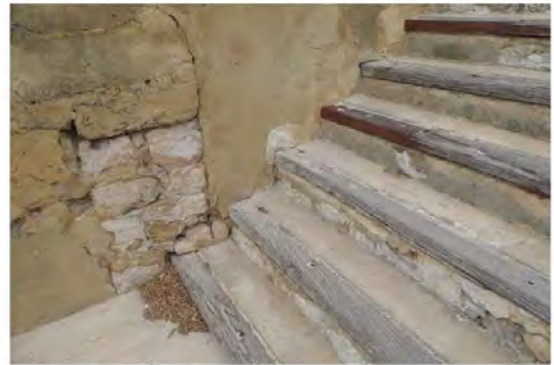
Figure 10: Timber nosings to steps to Round House

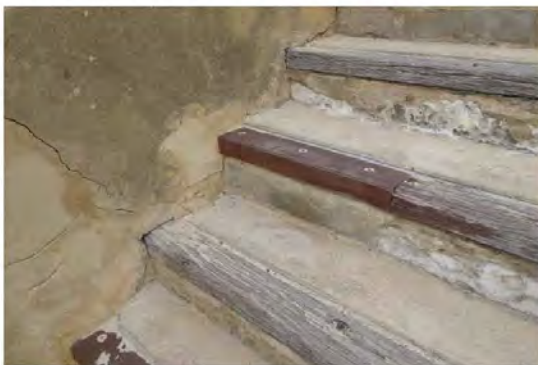
Figure 11: Timber nosings to steps to Round House

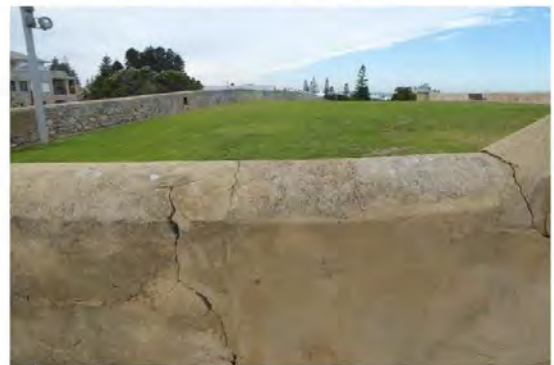
Figure 12: Cracked render to balustrade

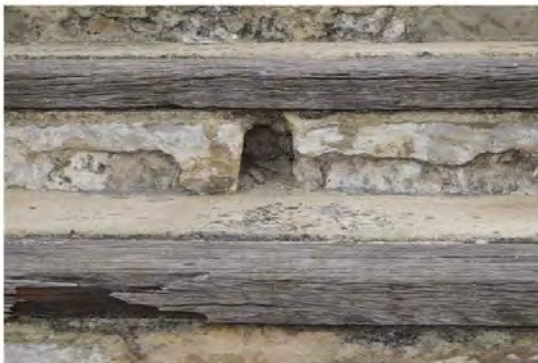
Figure 13: Missing mortar to risers

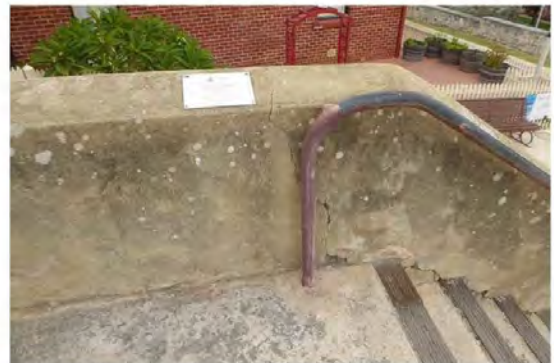
Figure 14: Cracked render to balustrade

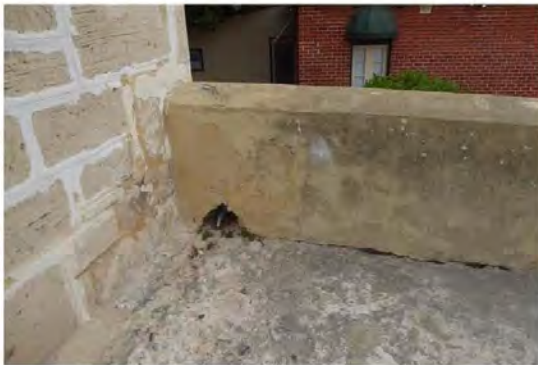
Figure 15: Drainage channel and discharge point

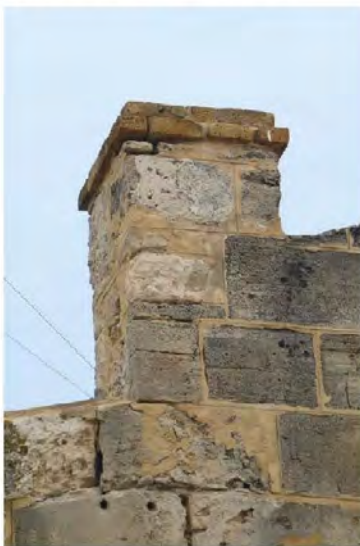
Figure 19: Missing mortar to parapet elements

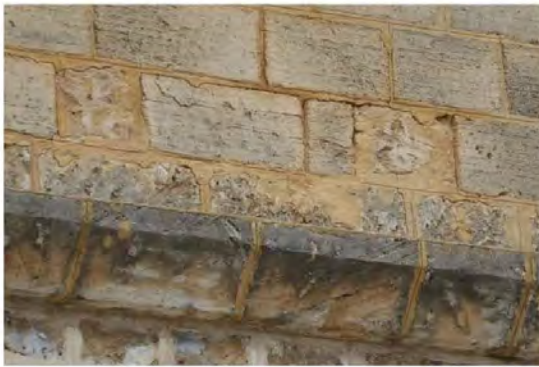
Figure 21: Fretting limestone and missing mortar

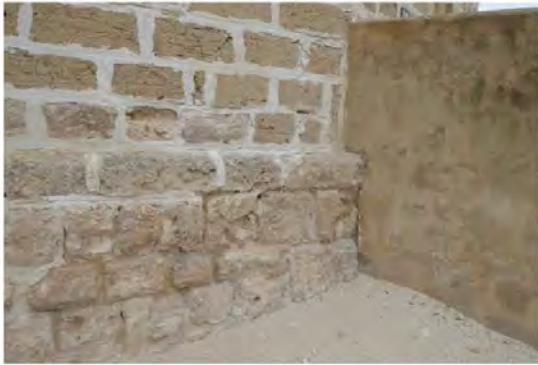
Figure 27: Plinth abutting steps balustrade

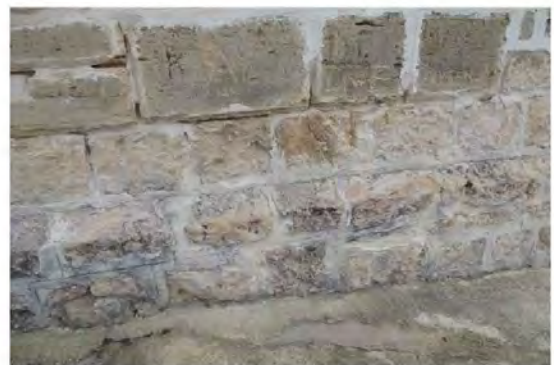
Figure 40: Eroded and repaired joints

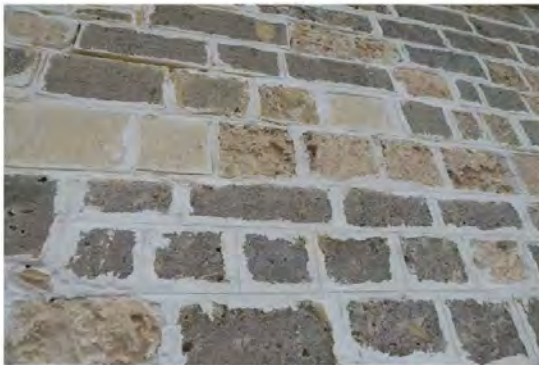
Figure 41: Repaired joints and replacement limestone

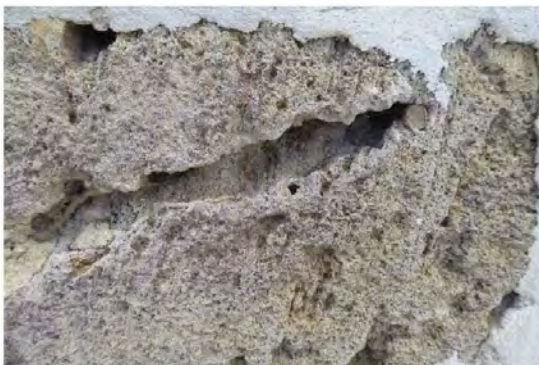
Figure 45: Defects in limestone

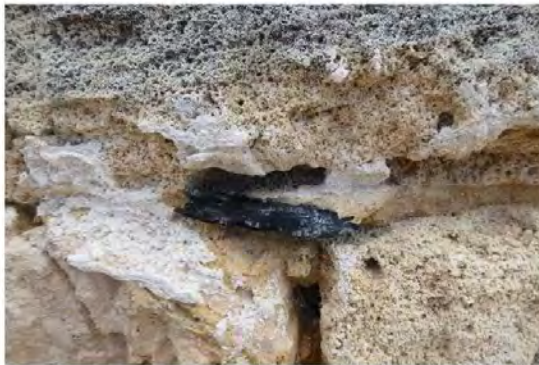
Figure 47: Packers in joints

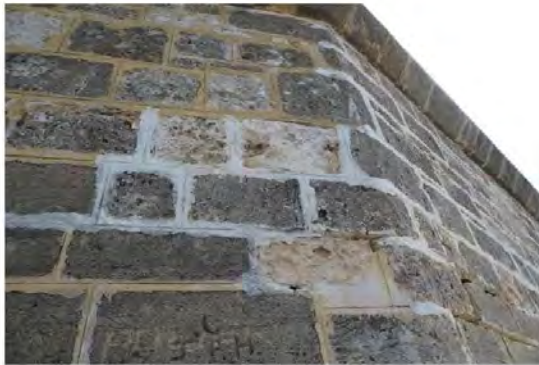
Figure 49: Mix of mortars in repairs

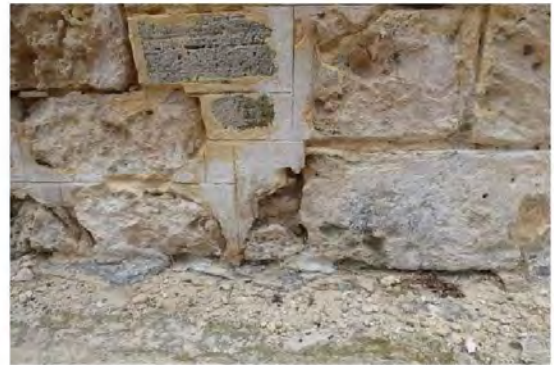
Figure 50: Eroded joints and limestone

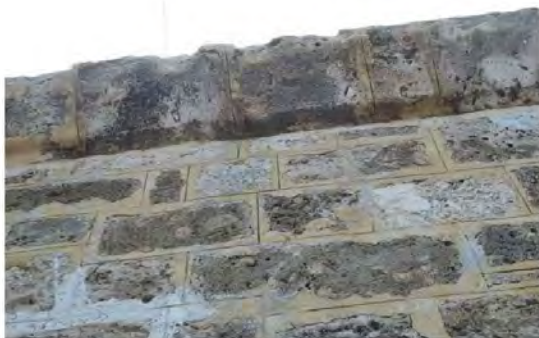
Figure 51: Eroded string course stone

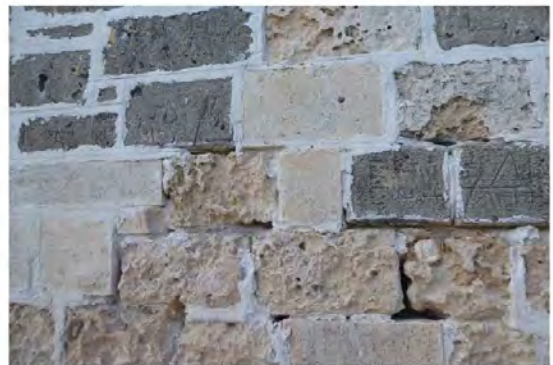
Figure 60: Previous repairs and eroded joints

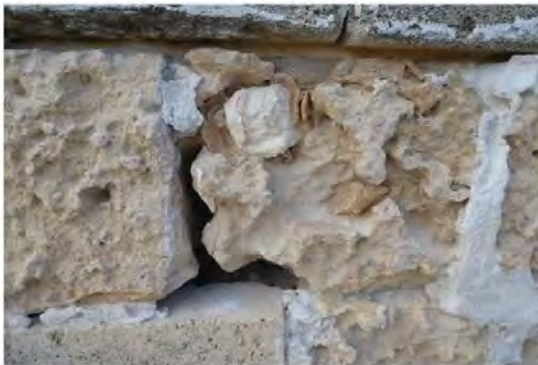
Figure 61: Completely eroded joint

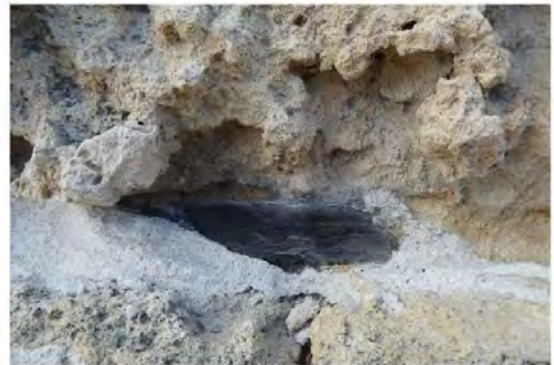
Figure 62: Eroded joint revealing packer

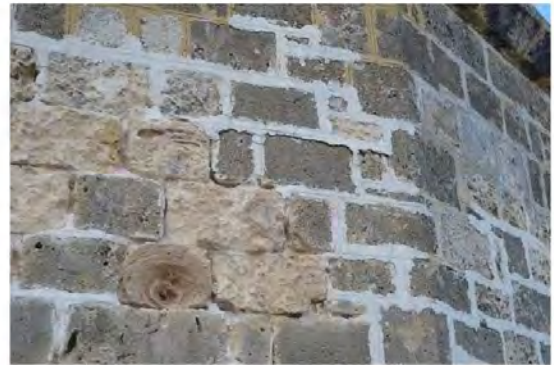
Figure 64: Repairs and eroded limestone

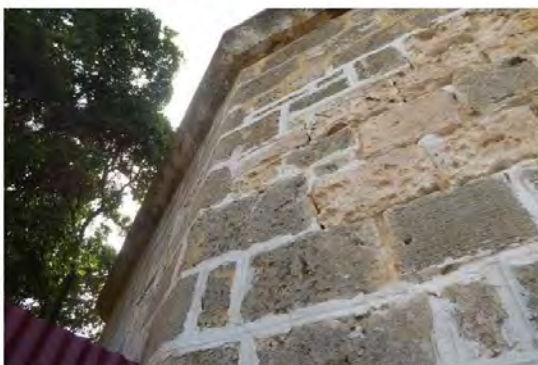
Figure 65: Repairs to face 10

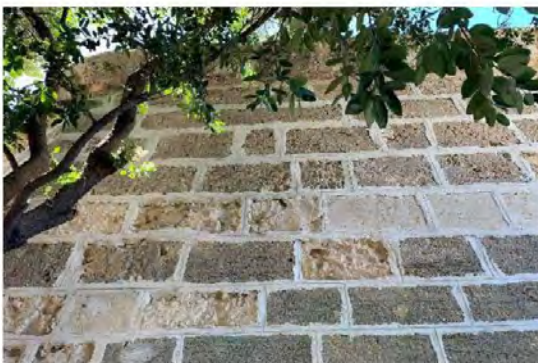
Figure 67: Face 10 repairs and eroding limestone

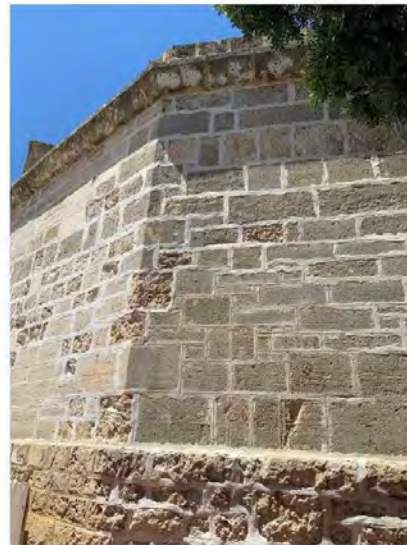
Figure 76: Eroding stone face 11

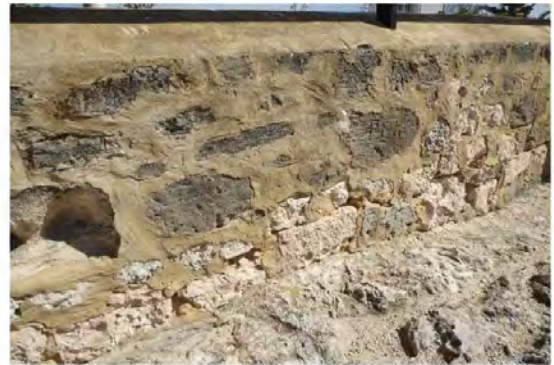
Figure 84: Previous repairs to boundary wall

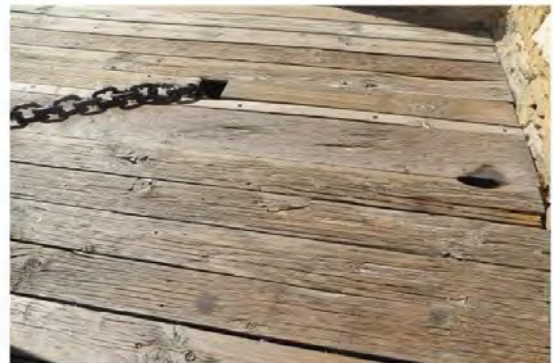
Figure 88: Drying timbers to deck

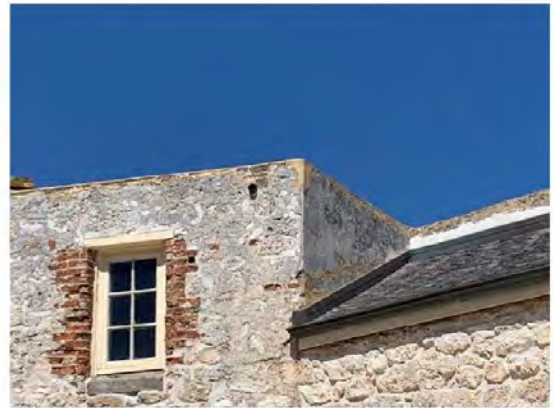
Figure 92: Various treatments to elevations

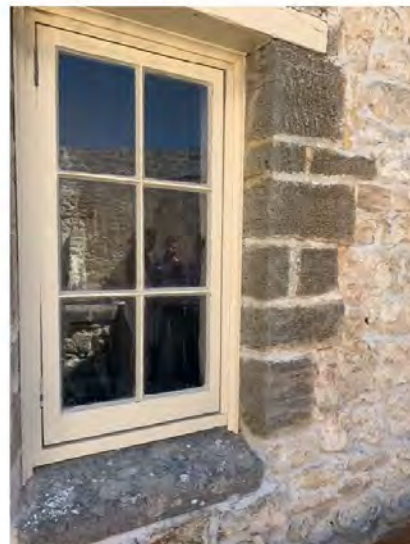
Figure 94: Replacement limestone and windows

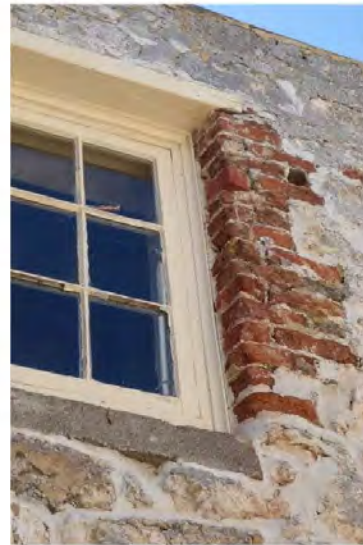
Figure 96: Brick infill around window

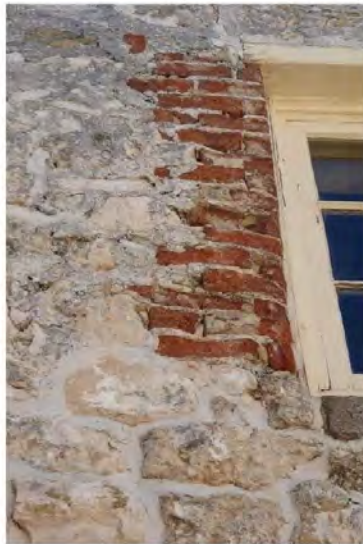
Figure 97: Brick infill around window

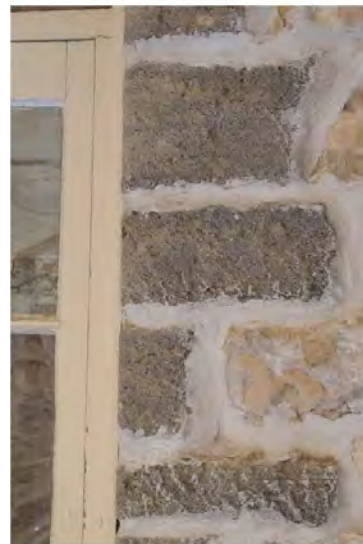
Figure 98: replacement stone around window

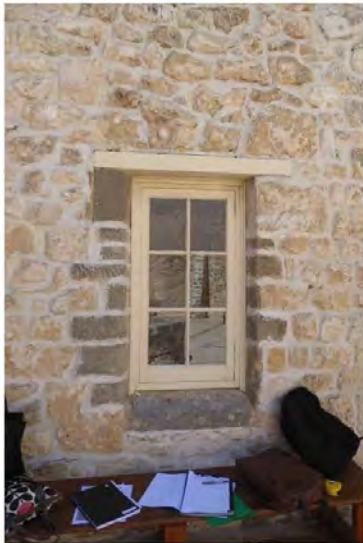
Figure 99: Replacement stones, window and lintels

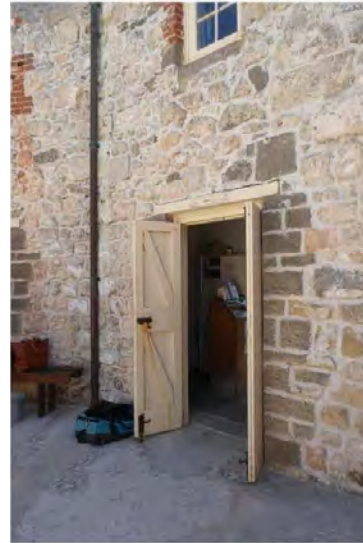
Figure 100: Entry doors with rust staining

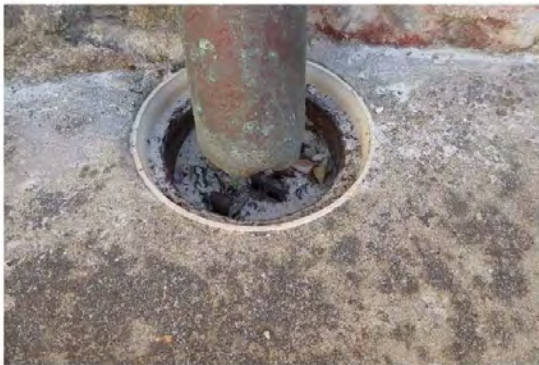
Figure 105: Silted up drain

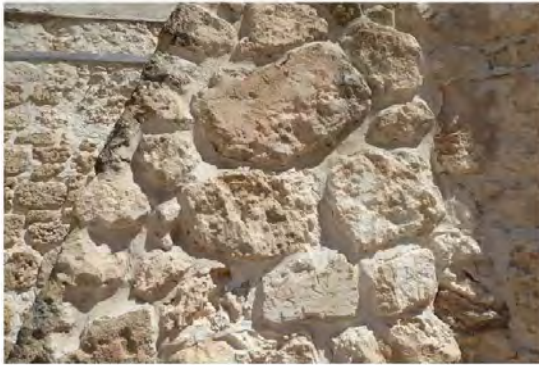
Figure 113: Eroding joints to 2004 mortar repairs

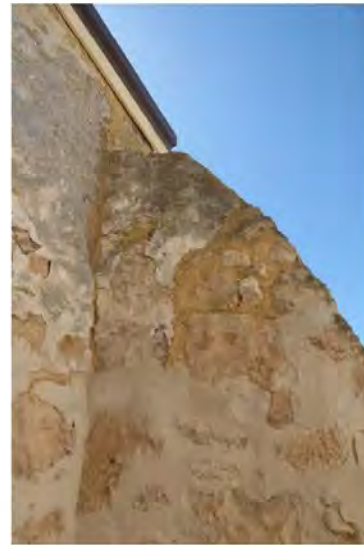
Figure 116: Hard cement and lime repairs

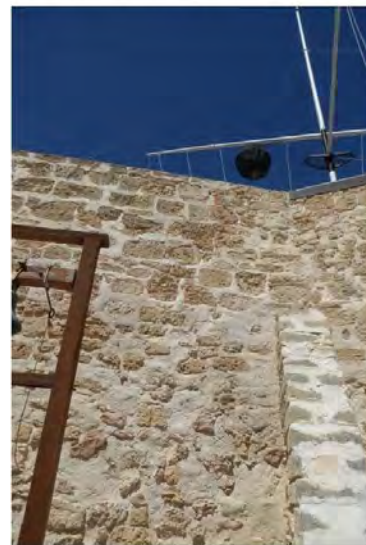
Figure 125: Previous repairs

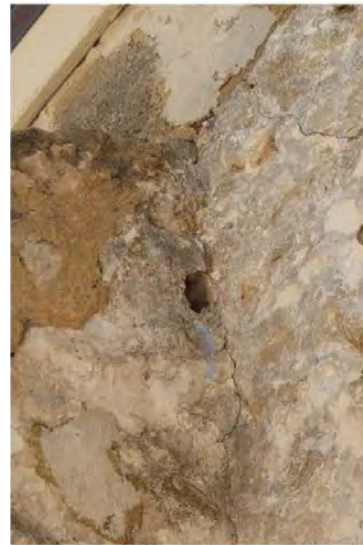
Figure 127: Eroding brick to vent

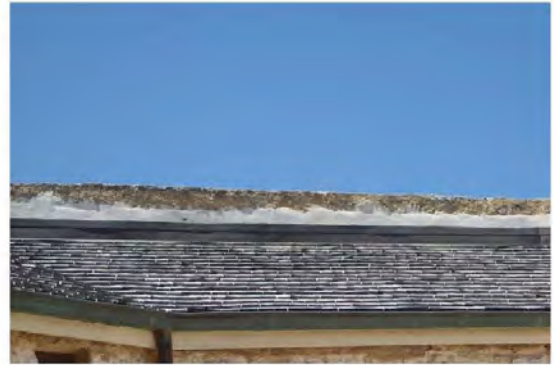
Figure 133: Flashings to roof need inspection

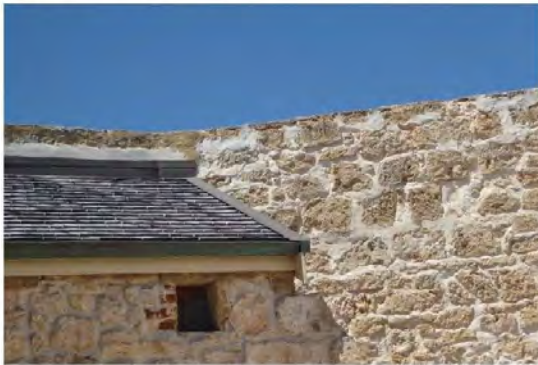
Figure 134: Shingle roof – need closer inspection

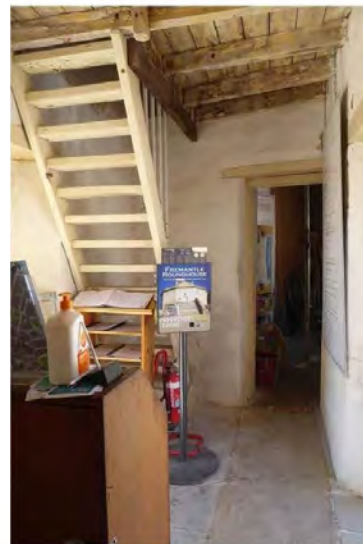
Figure 141: Wearing paint to ceiling

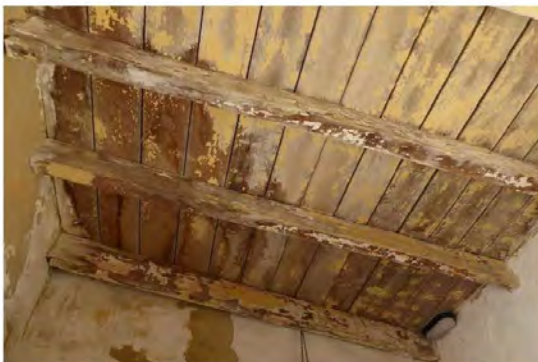
Figure 142: Falling paint due to damp

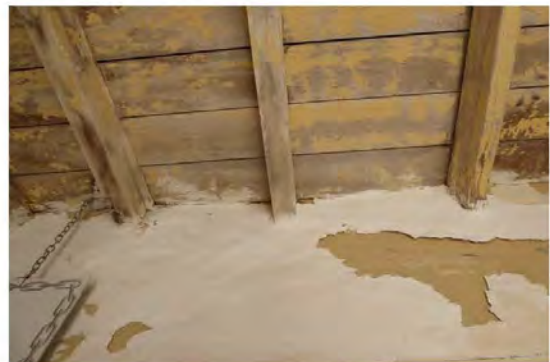
Figure 143: Drummy and patched render

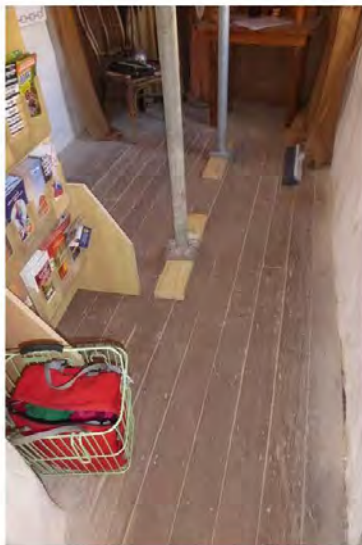
Figure 145: Timber boards to Room 2

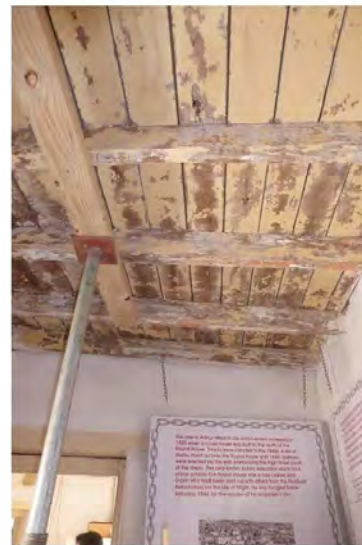
Figure 146: Failing paint to ceiling in Room 2

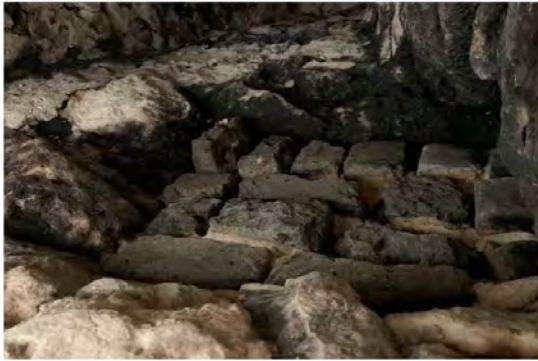
Figure 151: Brick infill in stone chimney

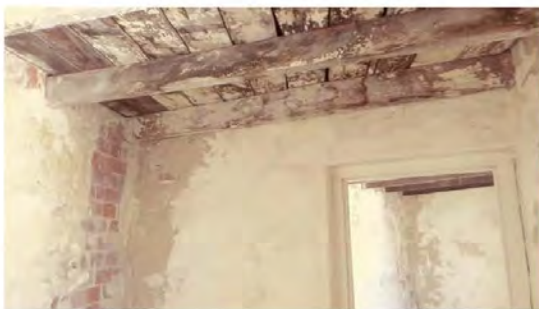
Figure 159: Brick infill and wearing point

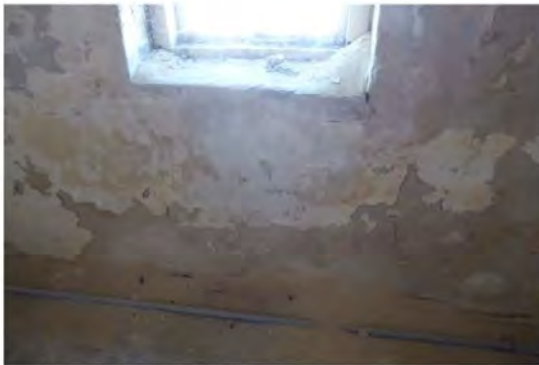
Figure 161: Failing paint and render to west wall Room 14

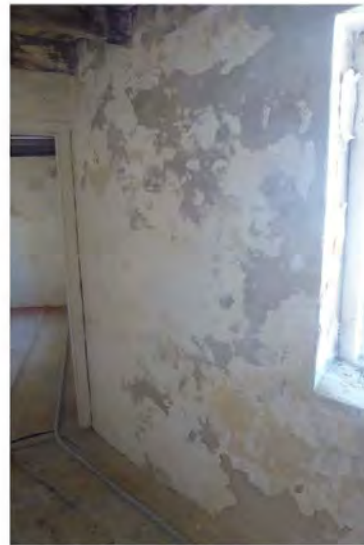
Figure 162: Failing paint and render to west wall Room 14

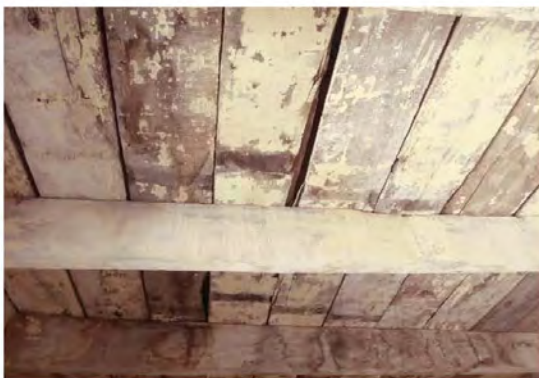
Figure 165: Wearing paint to ceiling in Room 13

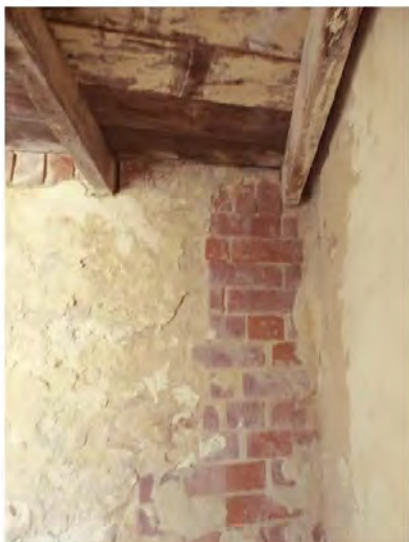
Figure 171: Room 1 brick infill c.1975

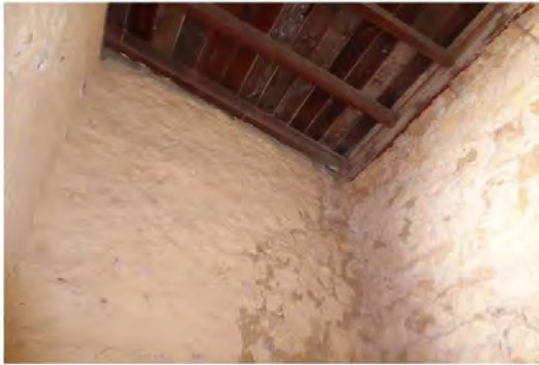
Figure 173: Wearing paint finish to cells

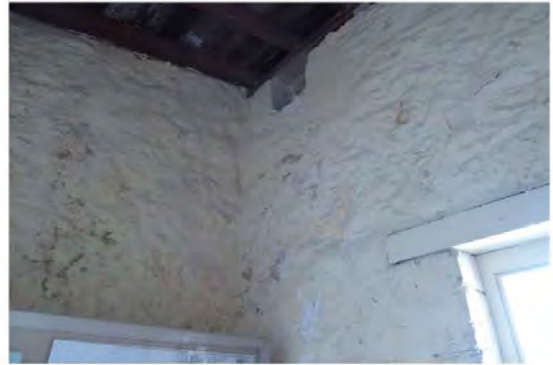
Figure 174: Wearing paint finish to cells

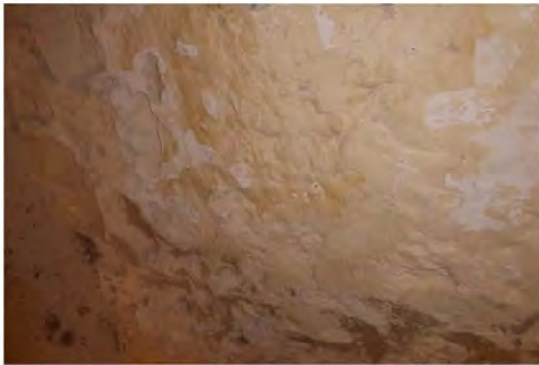
Figure 175: Wearing paint finish to cells

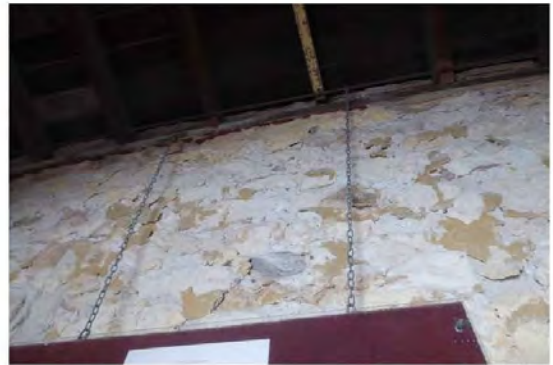
Figure 176: Wearing paint finish to cells

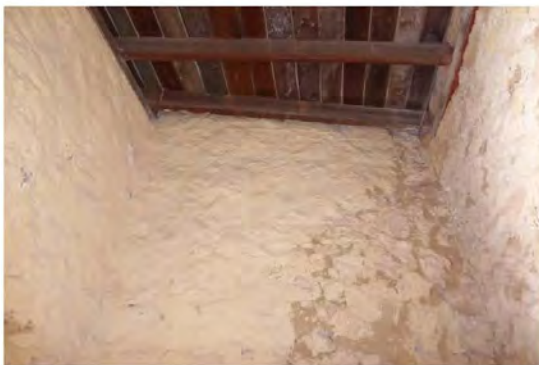
Figure 177: Wearing paint finish to cells

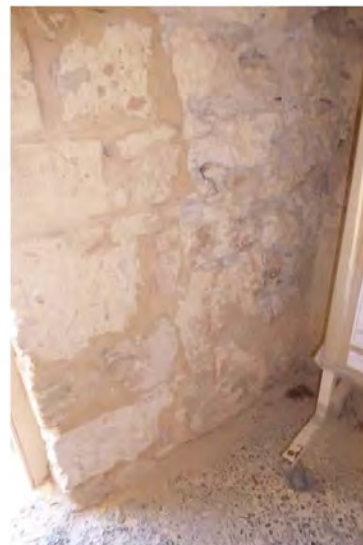
Figure 178: Previous repairs to limestone

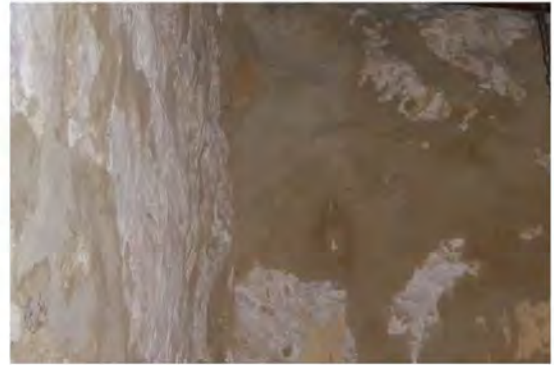
Figure 180: Previous cement repairs

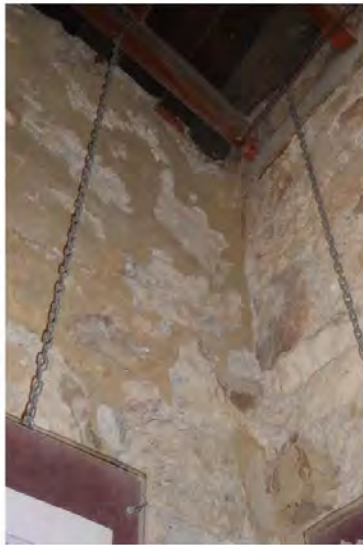
Figure 181: Wearing paint finish to cells

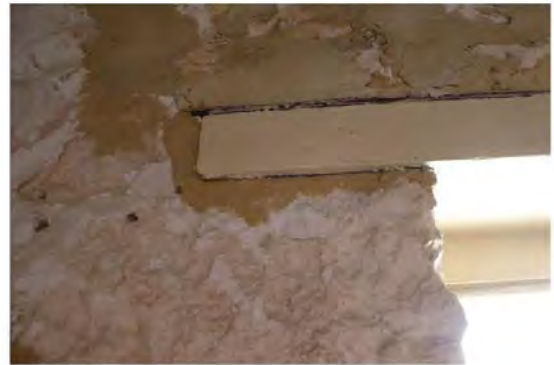
Figure 182: Previous repairs around Intel

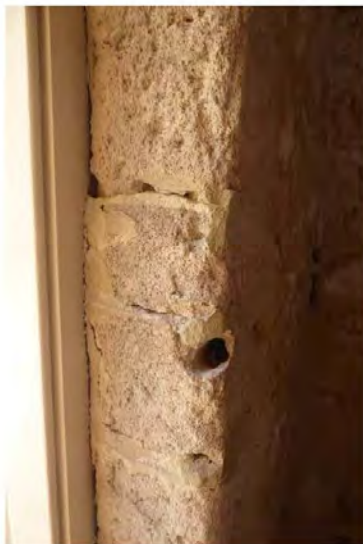
Figure 183: Eroding mortar and stones

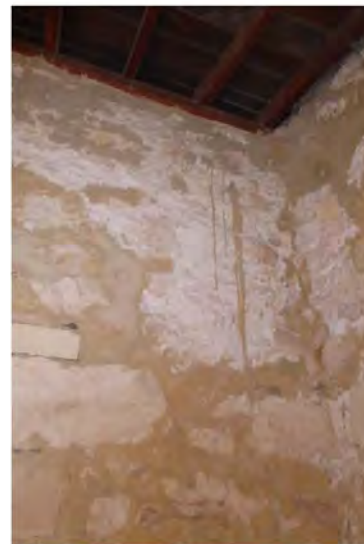
Figure 184: Wearing paint finish to cells

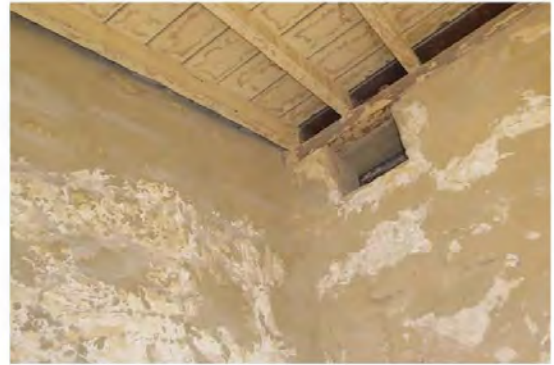
Figure 186: Wearing paint finish to cells

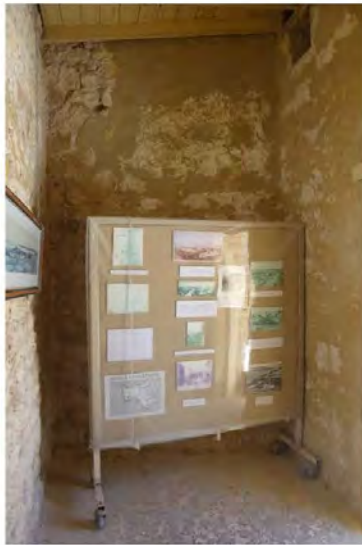
Figure 187: Wearing paint finish to cells and cement repairs

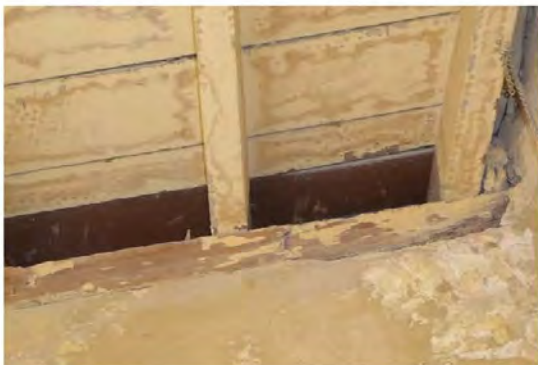
Figure 189: Failing paint to ceiling

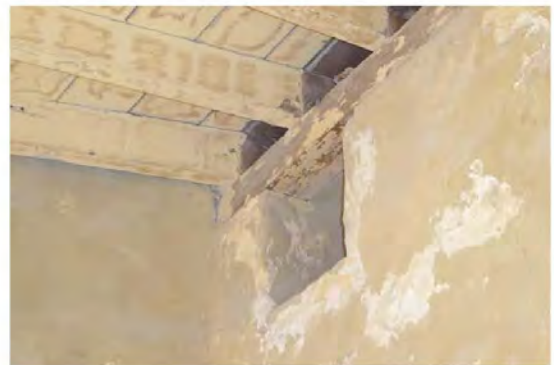
Figure 190: Cement render repairs

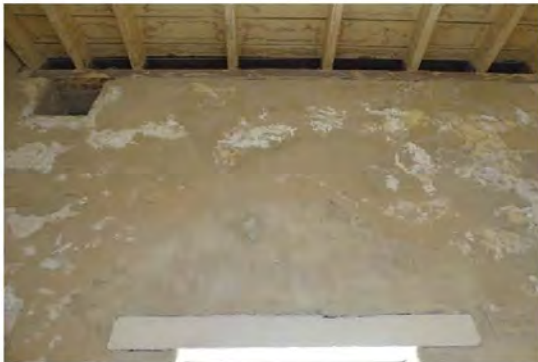
Figure 193: Wearing paint finish to cells

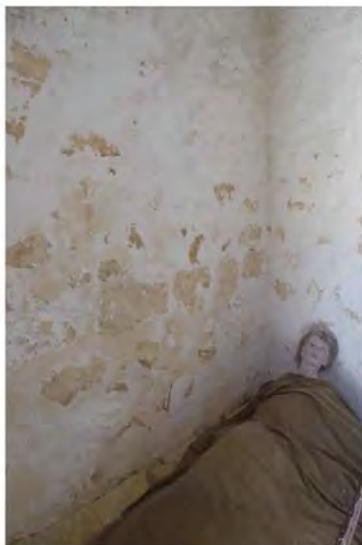
Figure 195: Wearing paint finish to cell 2

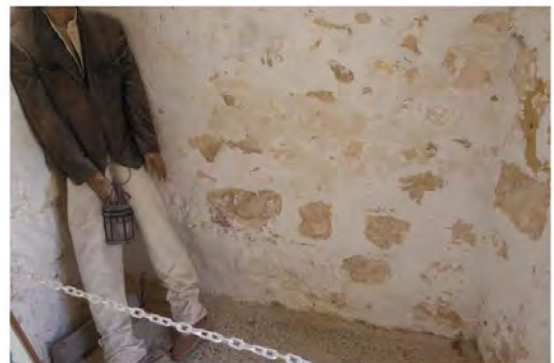
Figure 196: Wearing paint finish to cell 2
