FPOL2001-6 HARVEY BEACH JETTY

ATTACHMENT 1 - Harvey Beach Jetty – Fixed Timber Structure Inspection

**Project:** Condition Inspection  
**Structure:** Harvey Beach Jetty  
**Location:** North Fremantle  
**Client:** City of Fremantle  
**Date:** 15<sup>th</sup> January 2020

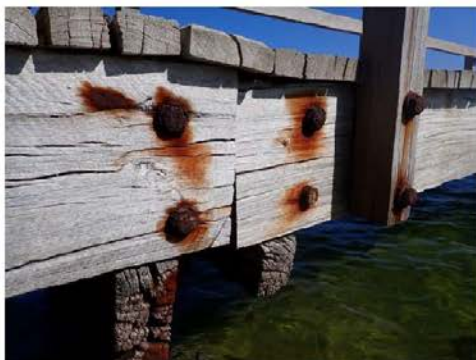
- Whaler 1A spanned between shore and Bent One (1) and was observed to be in an overall poor-average condition.
- The failure of Pile 1A on Bent One (1) has resulted in Whaler 1A being subject to significant stress. Subsequently, stress cracking can be observed in multiple locations on both the external and internal faces of the whaler.
- Whalers 1A and 1B are joined by a timber splice plate above the Bent One (1) on the internal side of the whaler. As the splice plate is small in length, fixings have been installed too close to the end of the whalers and splice plate causing the timbers to split at the end grain.
- All fixings associated with Whaler 1A were observed to be in poor condition subject to significant corrosion and are in need of replacement.
- Whaler 1A has a condition rating of five (5) and is recommended to be replaced.

*Whaler 1A to 1B external*

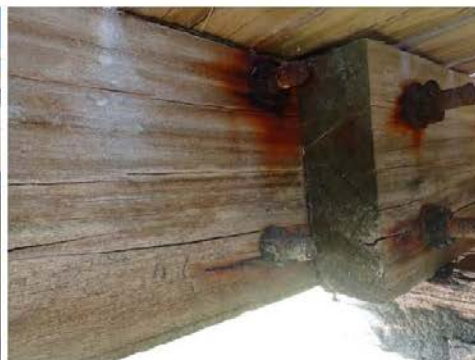
*Whaler 1A to 1B splice plate*

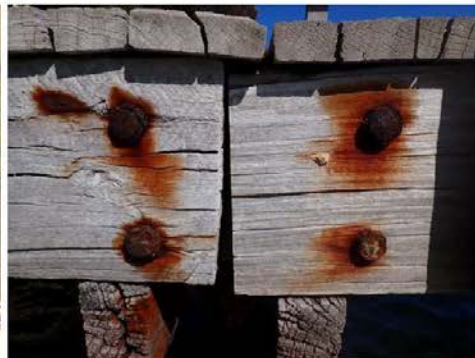
*Whaler 1A to 1B external*

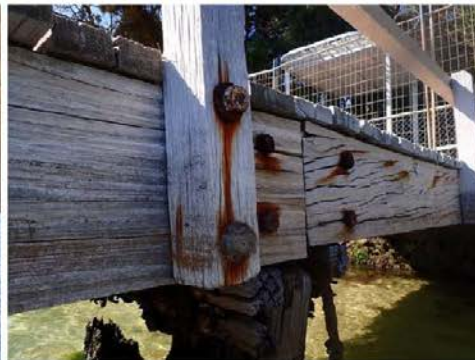
*Whaler 1A to 1B external*
