# Additional information

## Ordinary Meeting of Council

| Contents | | Page |
|---|---|---|
| FPOL2104-11 | ROUND HOUSE CONSERVATION MANAGEMENT PLAN | 54 |

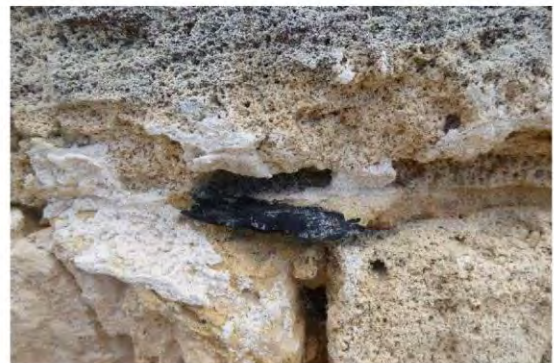
Figure 97: Timber packers in joints

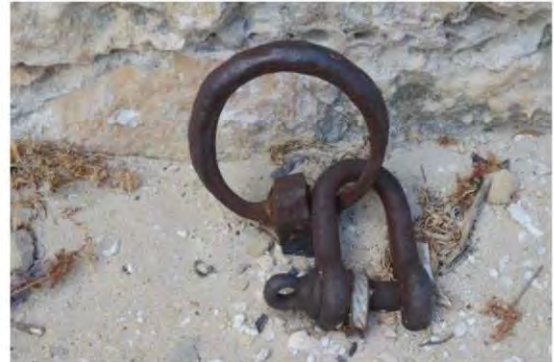
Figure 98: Remnant rope fixings from earlier Signal Mast

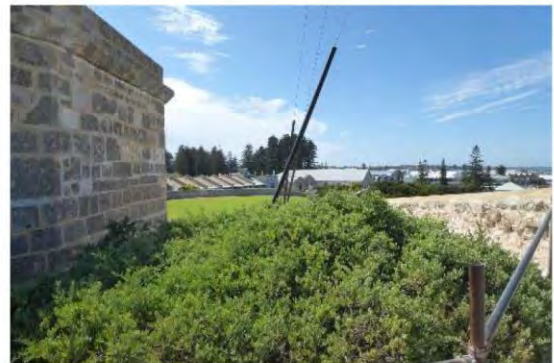
Figure 100: Vegetation at rear of Round House

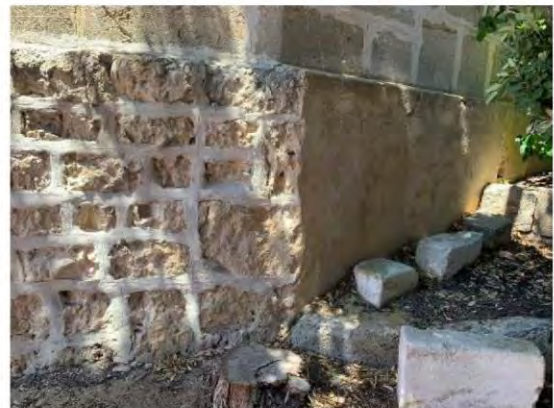
Figure 103: Rendered and un-rendered sections of plinths to faces 12 and 11

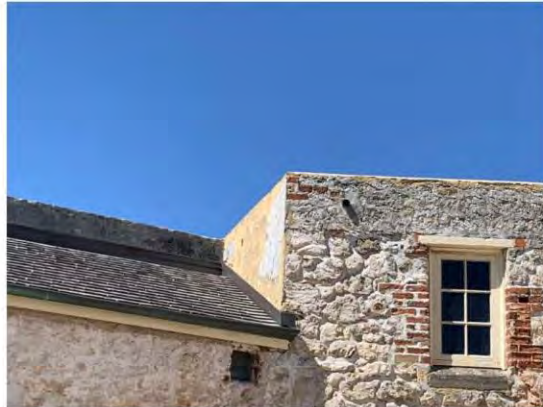
Figure 120: Rendered north wall of Room 13

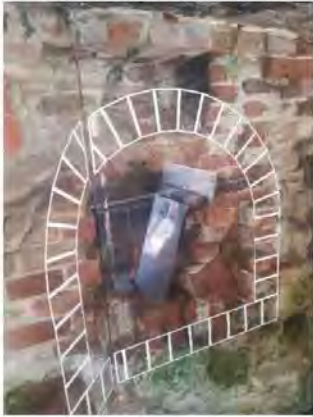
| 2001 | <p>Conservation works were undertaken to the Baker's Oven beneath the Roundhouse steps. *</p> <p>Conservation and stabilisation works were undertaken to the Whalers' Tunnel and cliff faces. The tunnel was then re-opened to the public. *</p> | <p>Figure 19: Bakehouse interpretive works 2001</p> |

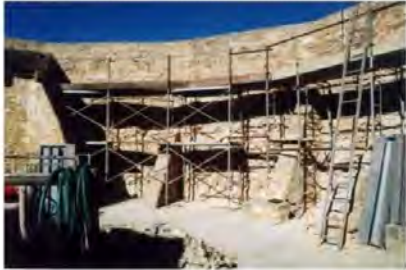
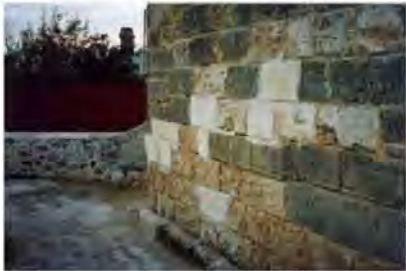
| 2004 | Conservation works were undertaken at the Roundhouse. The conservation work concentrated on the stonework.* | <p>Photograph 4 Photograph taken prior to the commencement of conservation work to the Roundhouse. Courtesy and Griffiths Architects (2002)</p> <p>Figure 20: 2004 conservation works</p> |

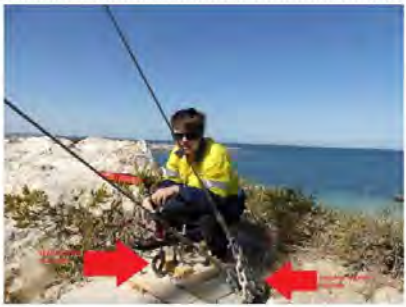
| 2016 | Roundhouse Mast guide wires refurbished by Raim Services<br>Anchor points were moved in the rock and tested prior to engagement | <p>Figure 21: Mast guide wire anchor move and testing 2016</p> |

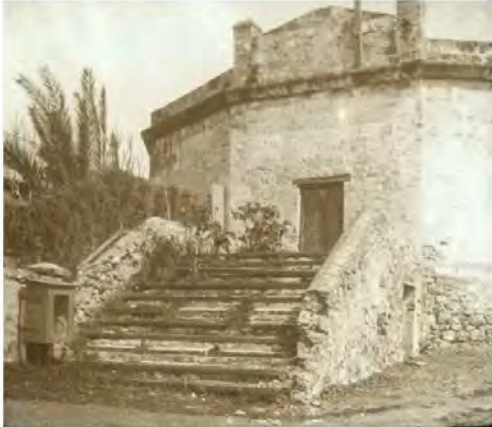
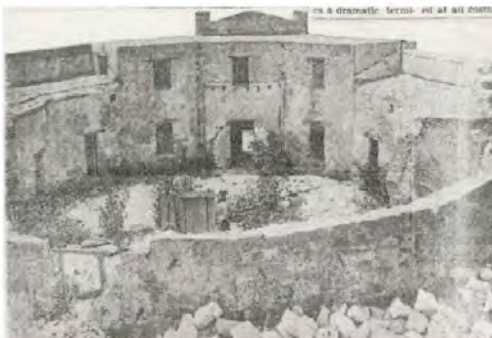
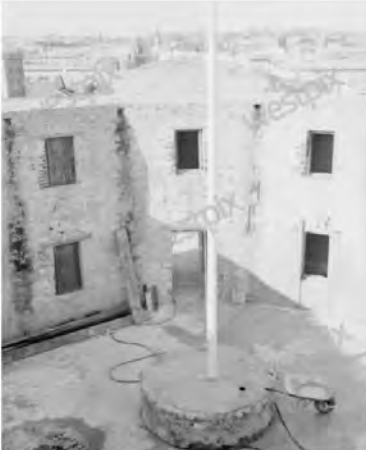
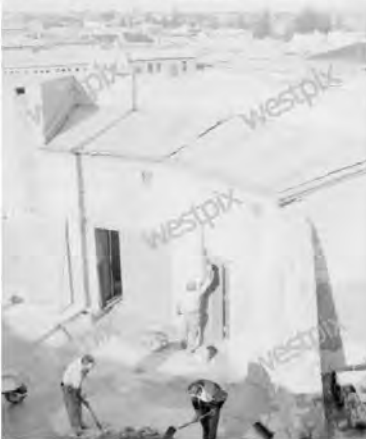
| Condition Before | After conservation works |
|---|---|
| <p>Figure 22: 1926 condition</p> <p>Figure 23: 1929 condition</p> | <p>Figure 24: 1959 works</p> |

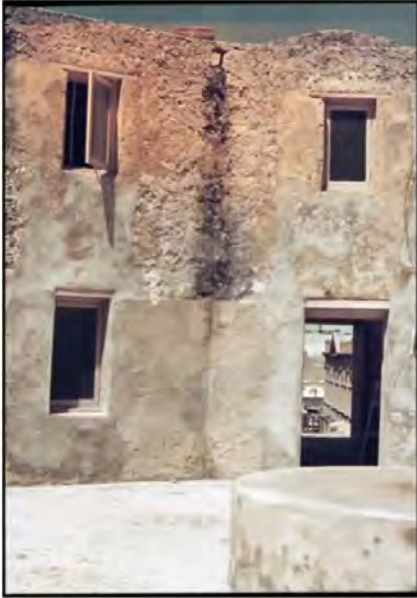
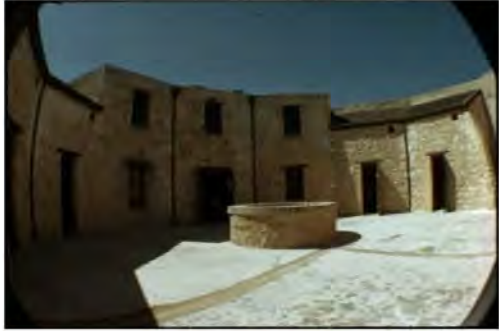
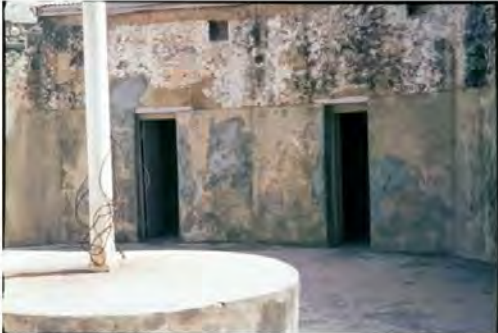
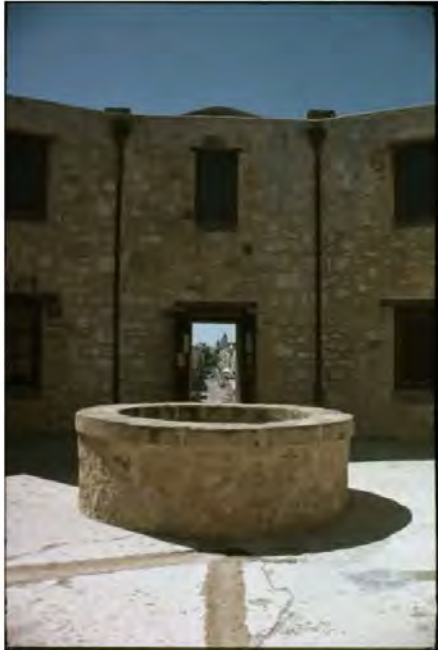
| Condition Before | After conservation works |
|---|---|
| Figure 25: 1969 condition | Figure 27: 1975 after conservation works |
| State Library of Western Australia<br>Figure 26: 1974 condition | |

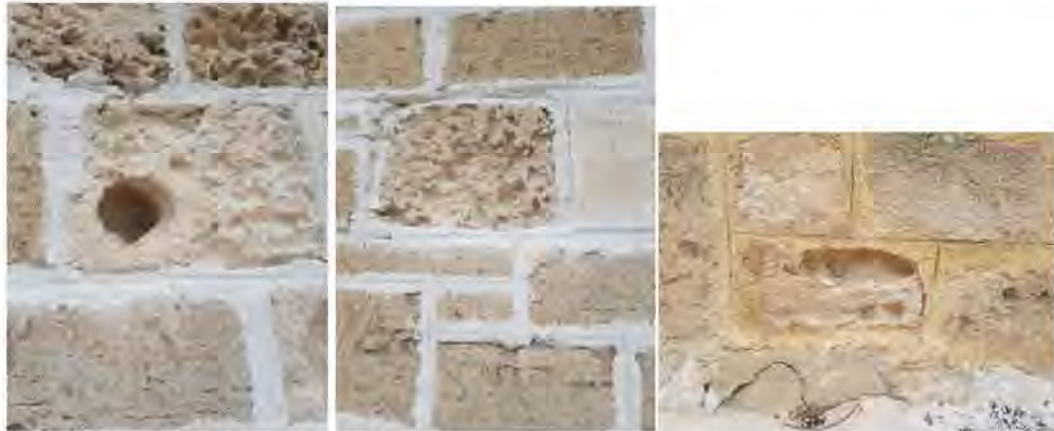
Figure 30: Weathered original limestone block faces

What we are trying to look for in this study is evidence of where this weathering could be getting worse (relative to time) and areas that are particularly bad currently. We are also interested in finding any remaining cement mortar on the building that could be making the situation worse.

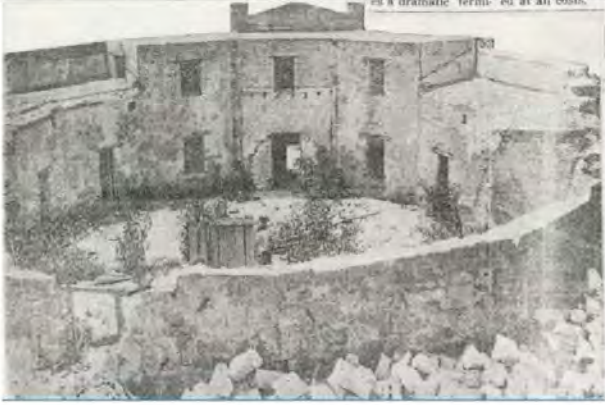
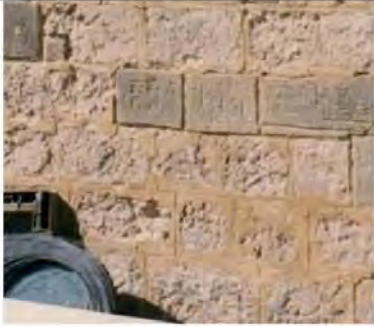
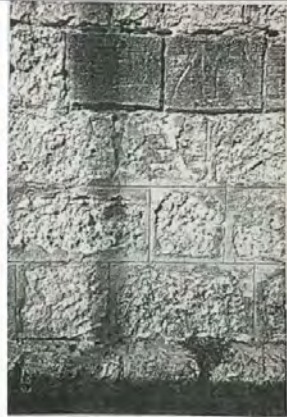
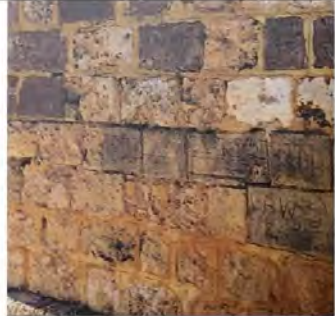
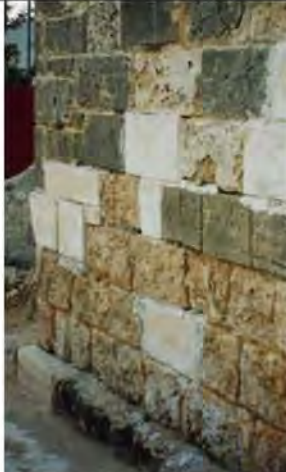
| 1. West Wall (Ocean Side) | | |

We've compiled a few of the comparison photos below to indicate the condition of the limestone over time. Generally we have only found photos of sufficient quality to make this assessment from the 1960s onwards, but it still gives us a good view of how the walls are performing:

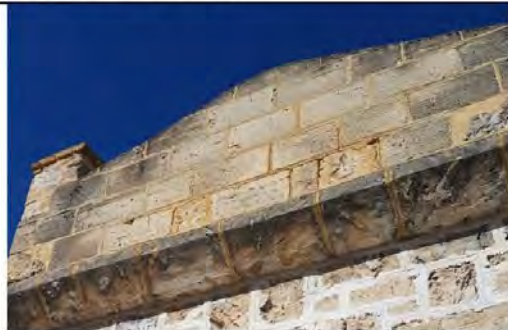
1975 cement (?)

Cement mortar can be seen to have been used in the re-pointing of the walls in many areas. This is likely to have been predominantly from the 1975 works. The less pervious and stronger composition of cement mortar means that water that seeps into the more porous limestone block is able to sit on the shelf that the cement bed joint creates keeping the limestone block wet or damp for extended periods. This can affect the stability of the stone causing accelerated weathering of the surface and a weakening of the block itself.

All mortar joints showing signs of degradation should be repointed. Re-pointing will have to go deep into the wall in order to remove cement mortars ~ 100mm in places.

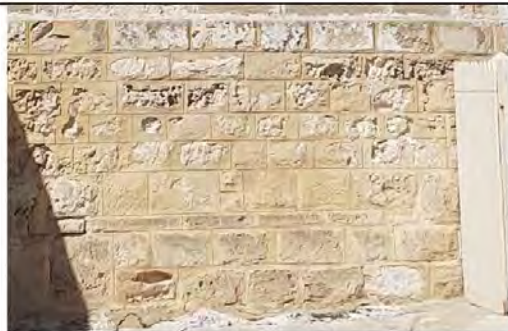
1975 cement (?)

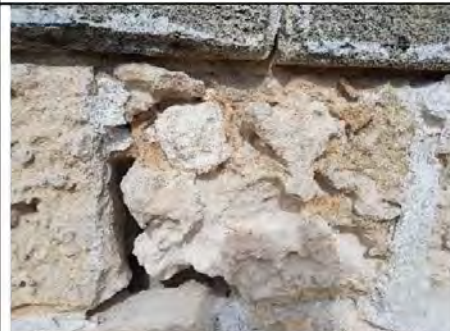
Early yellow/orange mortar (assumed to have used sand from a limestone root pocket on site)

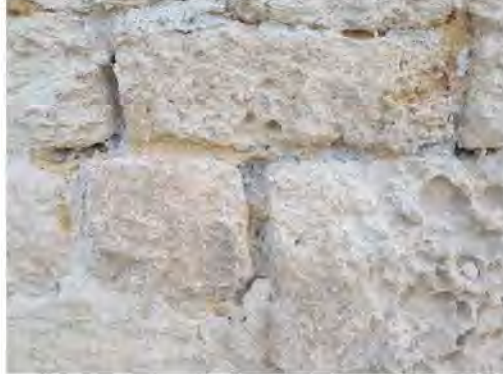
Early mortar – grey with shells, stones and possible inclusion of pozzolans

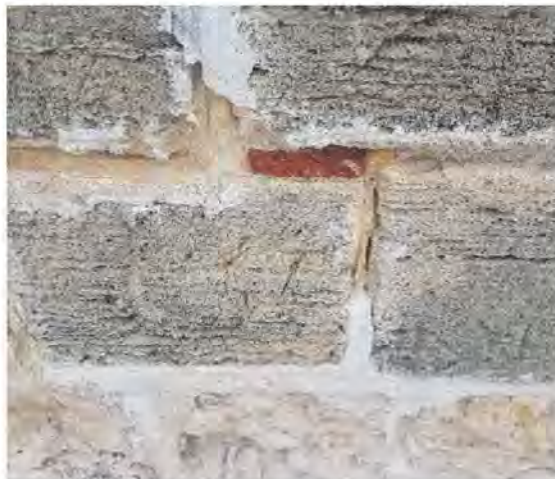
Slate and brick setting blocks in mortar joints were used as part of the construction during limestone block replacement works to set the joint width between beds of blocks and prevent the mortar from squeezing out while the mortar set. Where the mortar joints have eroded these are visible again.

Figure 39: brick setting block

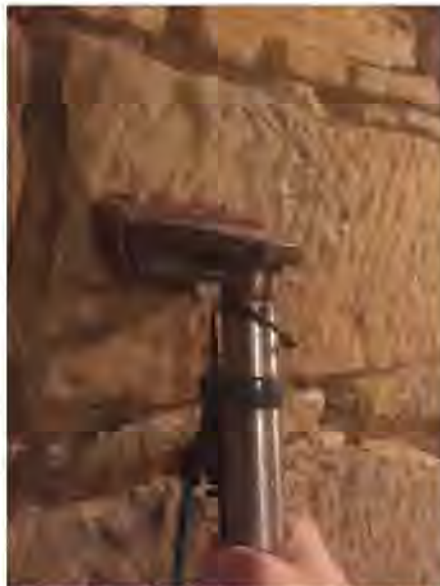
Figure 43: Captive head washing

We recommend that captive head washing is carried out on the Roundhouse annually to reduce the risks of salts and airborne pollutants causing excessive weathering damage to the limestone.

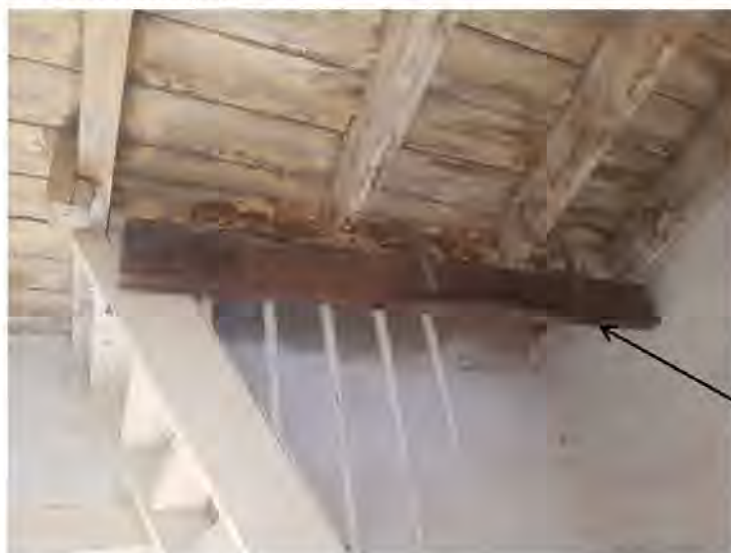
A short timber has been strapped to the underside of the stair trimmer, presumably to attempt to increase its capacity following concerns. The method of strapping means that it is performing little to no function and can be removed with no impact.

Added timber can be removed

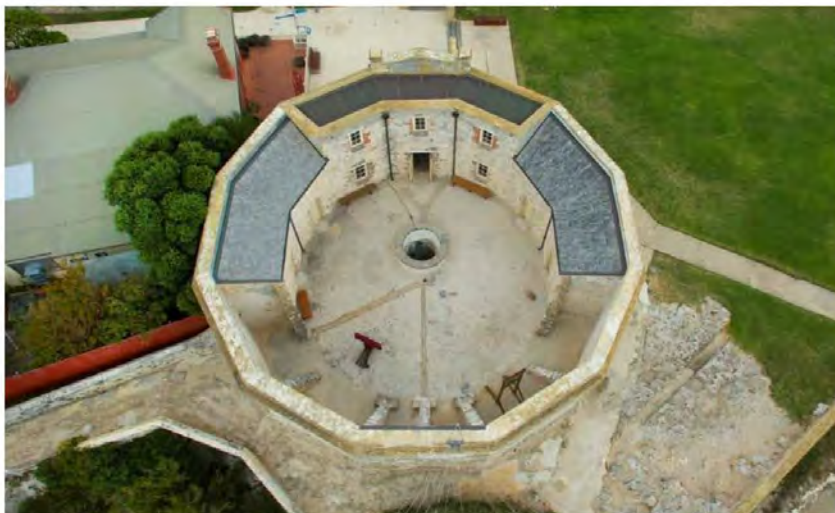
Above the ceiling joists is a ceiling void of 100mm and a second set of joists supporting a plywood deck. Based on the 1975 photos this plywood deck was overlain with a screed and then a membrane was applied to the top surface. We are not aware of any roof works since this date. The fall to this roof is quite shallow, which would explain why the contractor that built the Roundhouse had problems with getting it waterproof from the start.

Figure 47: Roundhouse roof from SW

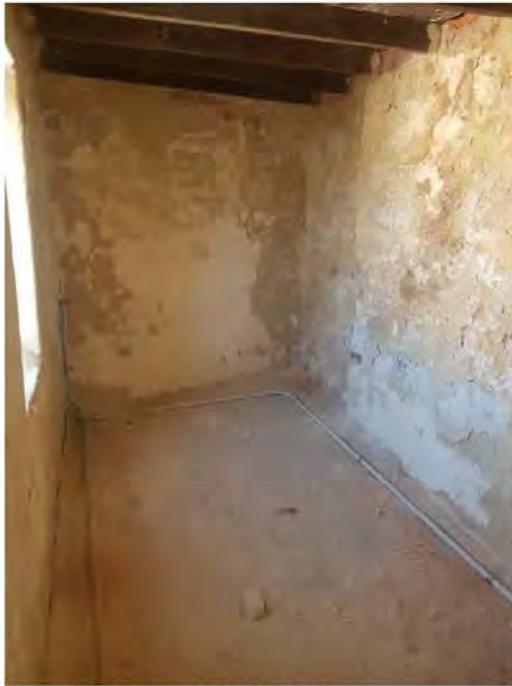
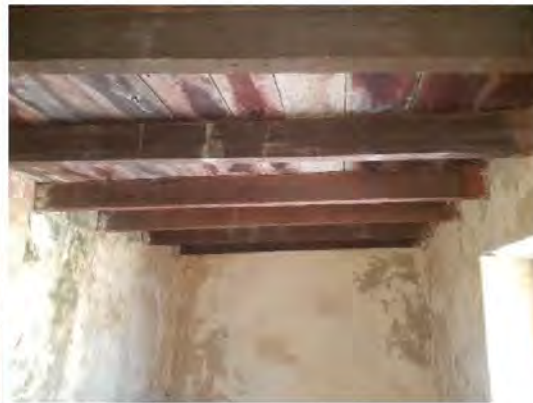
Figure 48: 1st floor space and ceiling joists

We recommend cleaning the debris from the 1<sup>st</sup> floor. No other structural works are proposed.

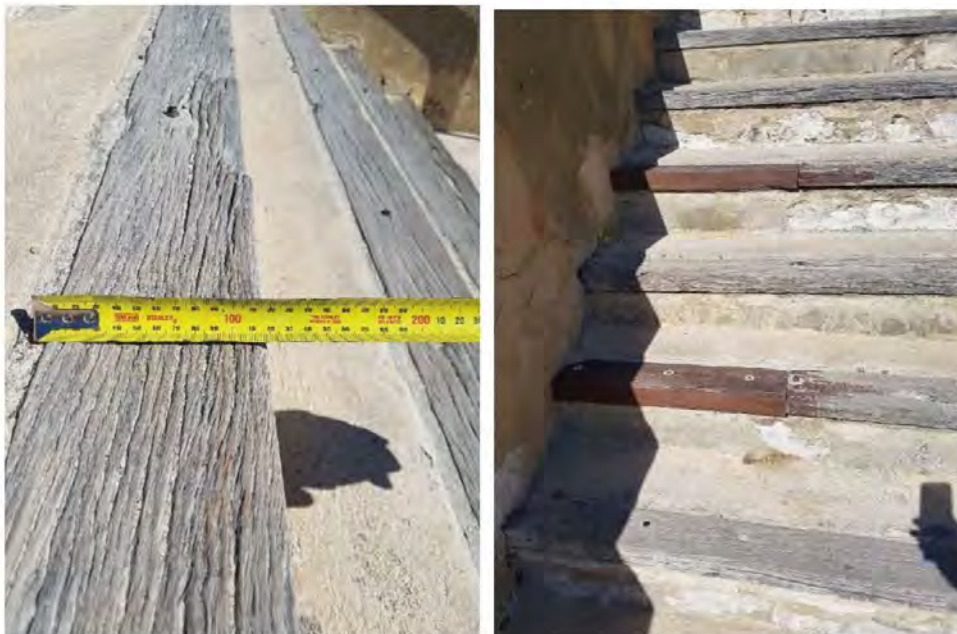
Figure 52: Steps

The steps to the Roundhouse were given a revamp in 1983 with new timber nosings to the short flight constructed by Guy Weguelin. Guy used a 120x55 timber for the step nosing cut into the tread. Since that date a couple of steps have had new pieces inserted, but generally they remain as Guy laid them.

Whilst the Roundhouse steps timber nosings are quite weathered, there were no serious structural issues found, so we are not proposing any structural works to the steps.

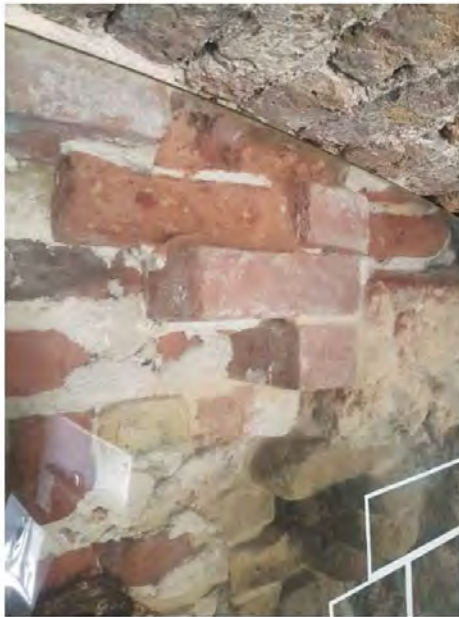
Figure 56: Fretting brickwork

The bakehouse is currently a damp environment. Given its age there is obviously no waterproofing surrounding the underground room and the masonry is porous to allow water seeping down from the landing of the stairs above to get into the space.

This damp environment is promoting biological growth on the brickwork and limestone walls. Algae and lichen are covering some of the masonry surfaces that are frequently or continuously wet. Biological growth thrives when moisture and a food source such as calcium carbonate coincide in damp locations of buildings that are not exposed to constant sunlight. This is the case with the bakehouse. The masonry staying in a wet condition for extended periods of time and the biological growth will be causing the condition of the masonry to deteriorate over time, so more fretting of the brickwork and limestone can be expected if these conditions are allowed to continue in their current state.

In the short term we recommend that the volunteers open up the bakehouse door for extended periods each day they are at the Roundhouse in order to allow the room to dry out.

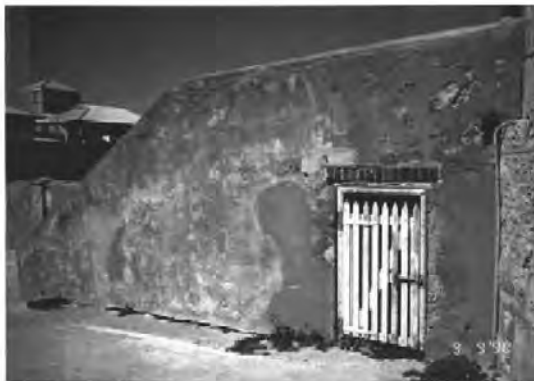
Figure 59: 1998 gate

With a slatted gate arrangement there would be sufficient air flow to enable the room to dry out particularly if the flue is still clear enough to allow air movement out that route too.

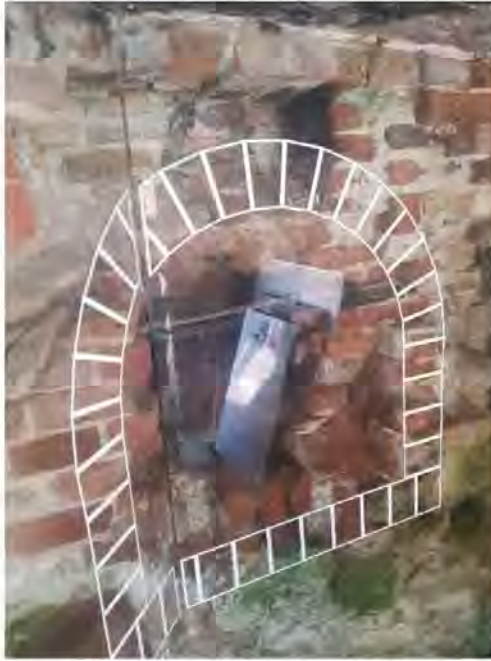
Figure 60: Bakehouse interpretive perspex screens

The perspex interpretation boards inside the bakehouse that are located close to the masonry are not helping with this situation as they further prevent air movement from being able to dry the masonry out.

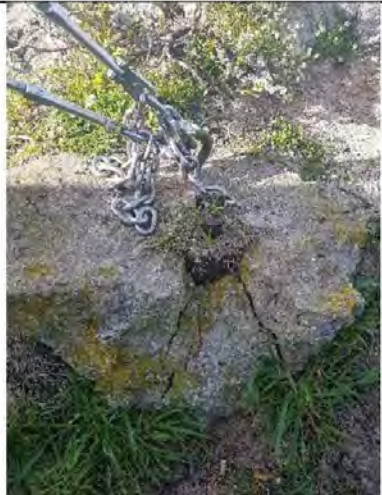
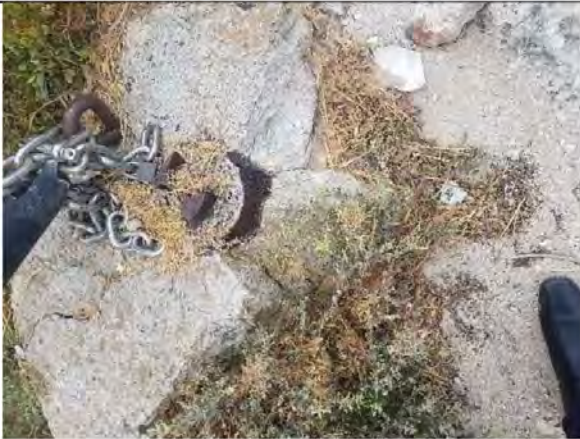
| 2016 condition | 2020 condition |

Anchor point for stays 1 & 2 is into natural rock. Adjacent to the anchor point is a pre-existing post that has also been set into the same piece of rock. This existing post is rusting over time and splitting the rock. There is no evidence that the split rock is having an effect on the capacity of the anchor point and in our opinion it is not currently a safety concern for the anchor point. Our report of 2016 recommended re-inspection by an Engineer on a regular basis to monitor this and ensure that it does not become an issue. As part of this inspection we re-inspected the anchor point and saw no further signs of cracks that could cause issues to the anchor point.

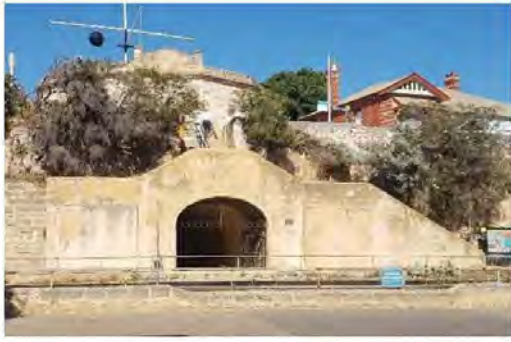
The many changes over the years have lead to a mixture of masonry materials, with discontinuities and different foundation conditions for the steps. The steps have been rendered since at least the 60s and we suspect this is because the quality of the stones used for the walls of the steps were not the best.

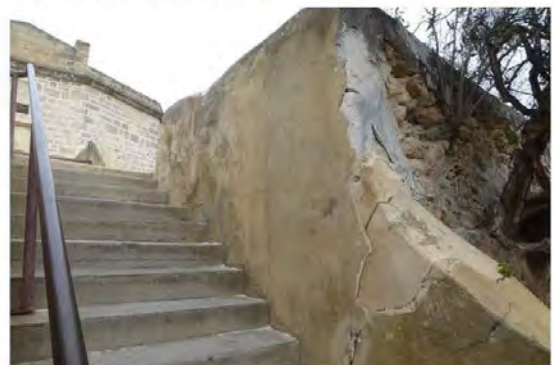
Figure 6: Failing render to steps from High Street

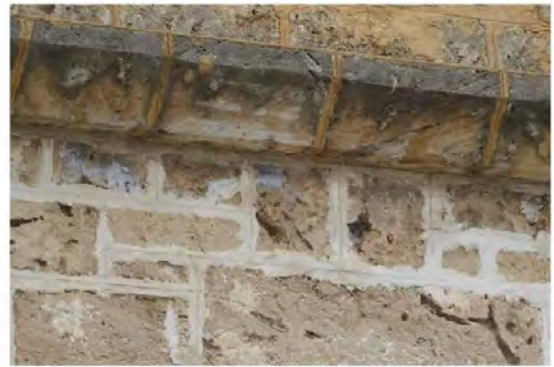
Figure 22: Eroding limestone, traces of white wash

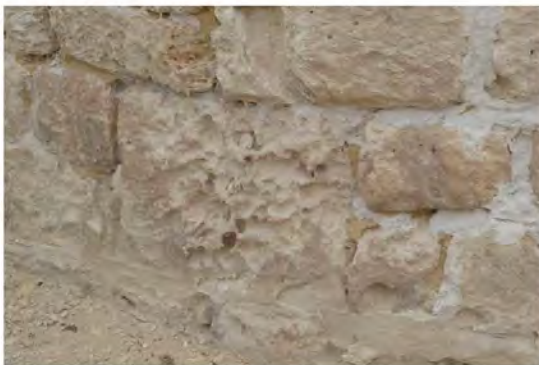
Figure 25: Missing mortar

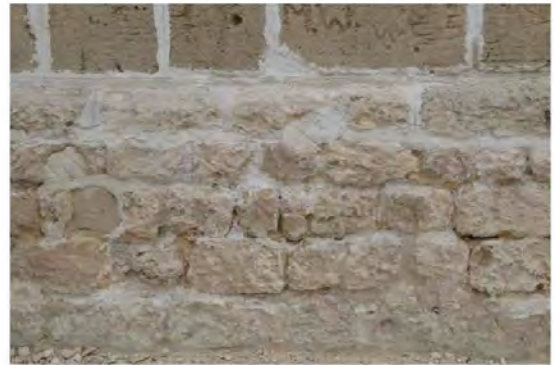
Figure 30: Missing mortar

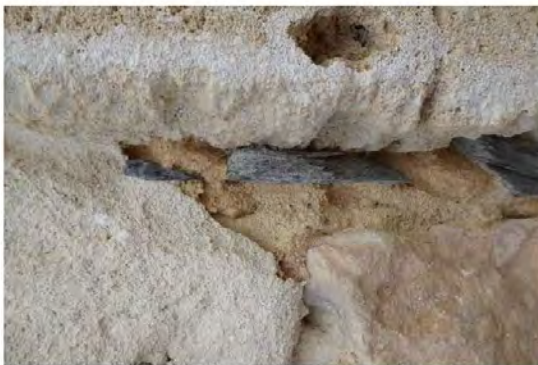
Figure 31: Joint packers

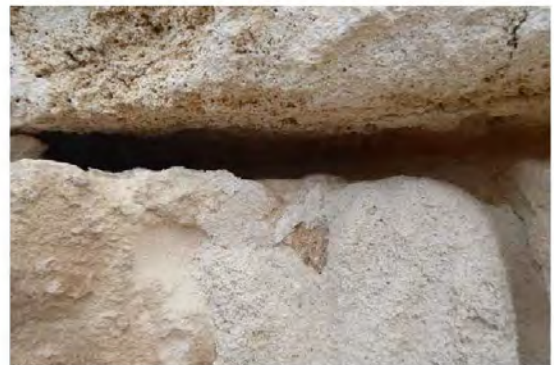
Figure 32: Eroded joint

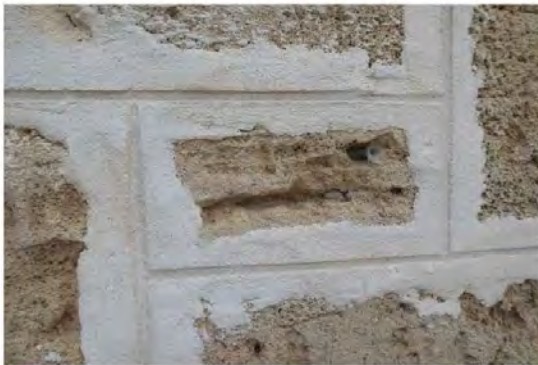
Figure 33: 2004 pointing

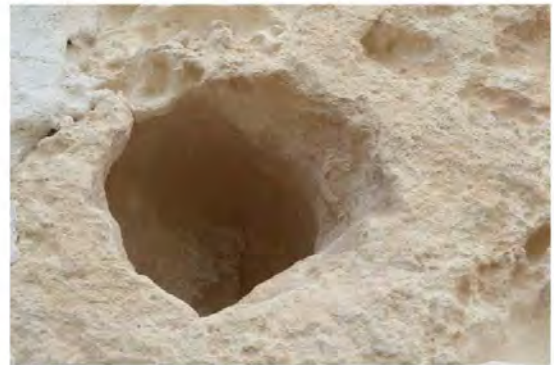
Figure 34: Eroded stone

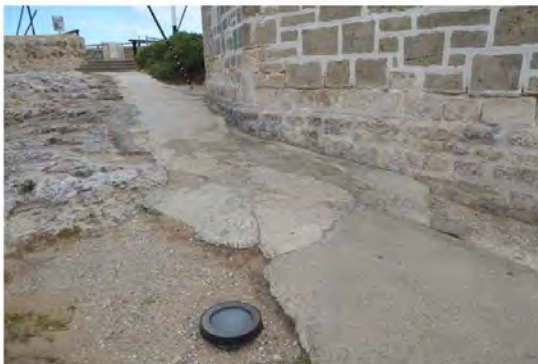
Figure 35: Uneven pathways around Round House

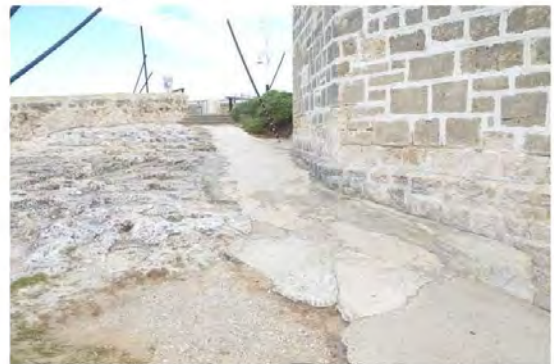
Figure 36: Uneven pathways around Round House

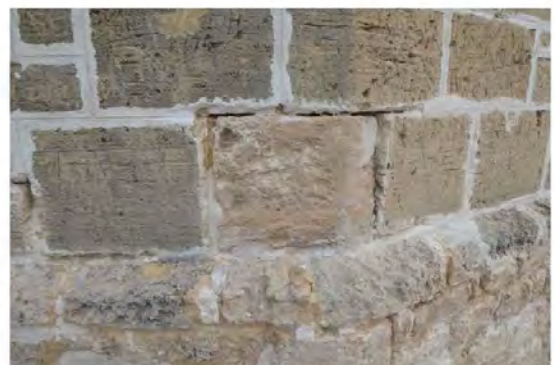
Figure 38: Eroded joints

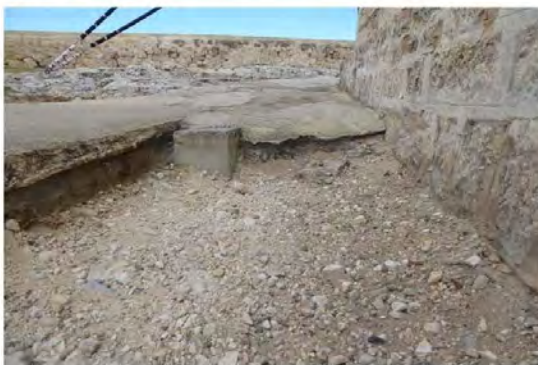
Figure 39: Uneven pathways

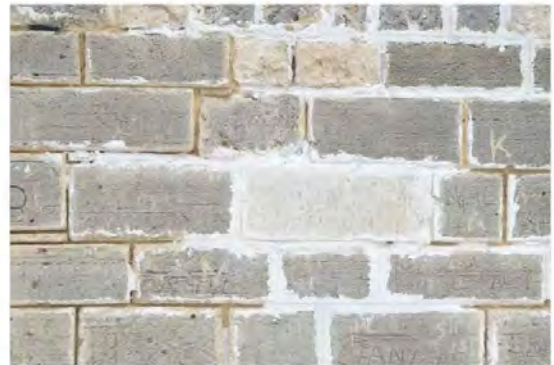
Figure 42: Bad repairs

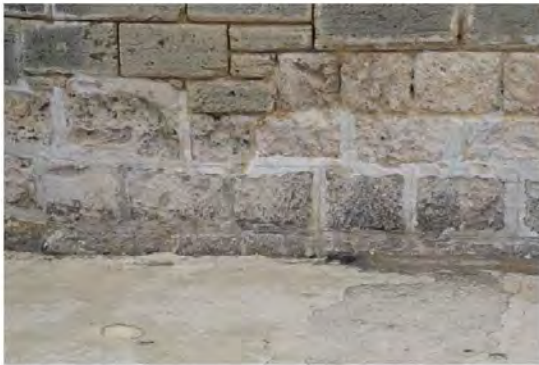
Figure 43: Eroded joints

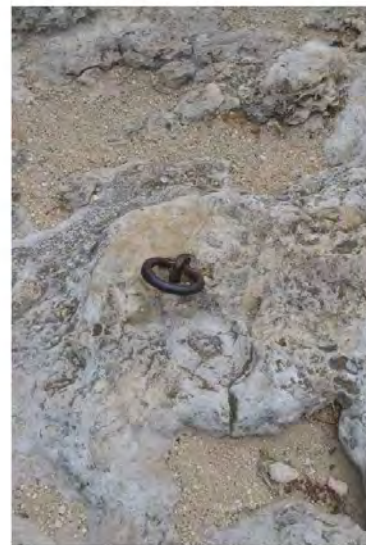
Figure 46: Rope hook in capstone

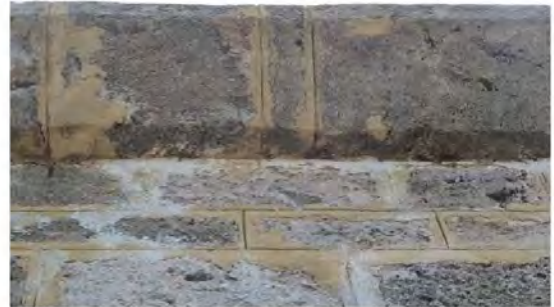
Figure 48: Previous repairs

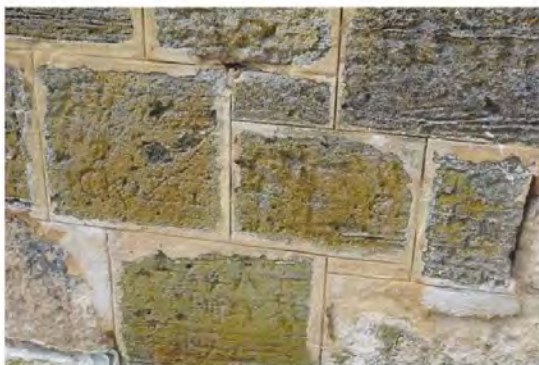
Figure 53: Lichen growth on stones face 7

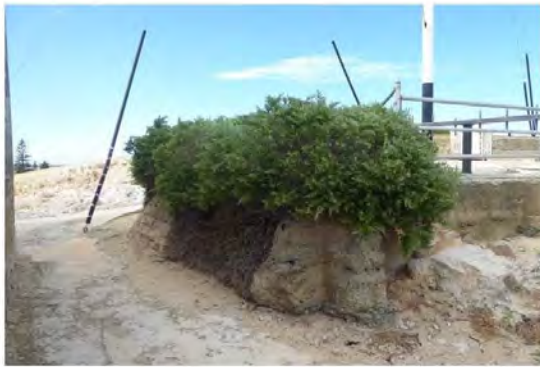
Figure 55: vegetation at rear of Round House

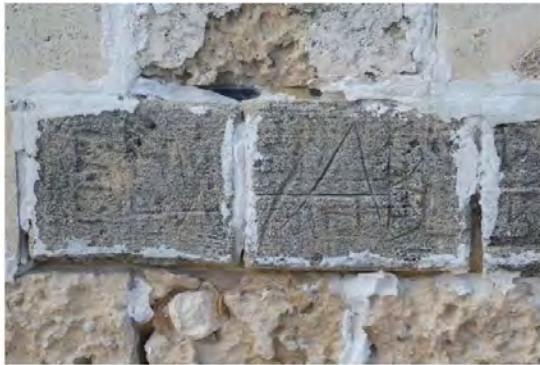
Figure 57: Graffiti on stones

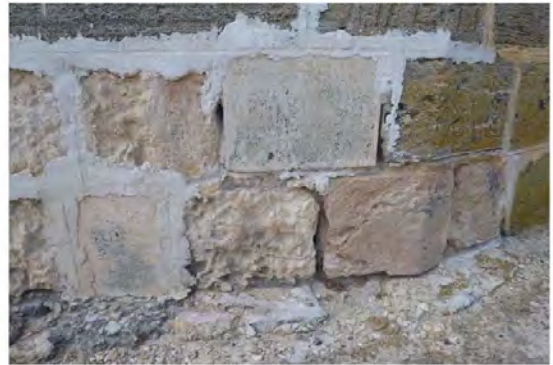
Figure 58: Eroded joints

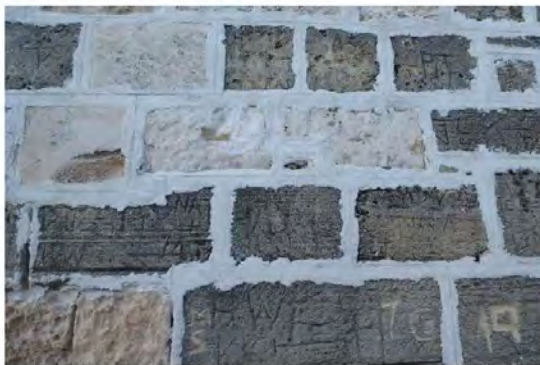
Figure 59: Previous repairs

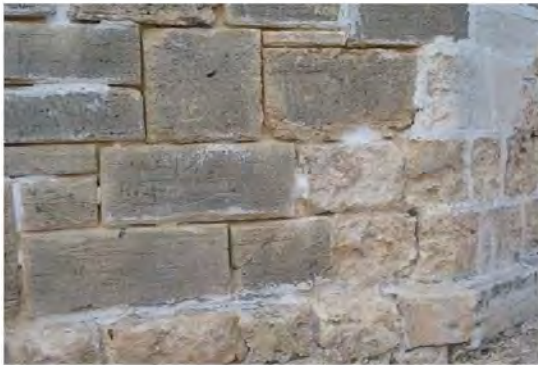
Figure 63: Eroded joints

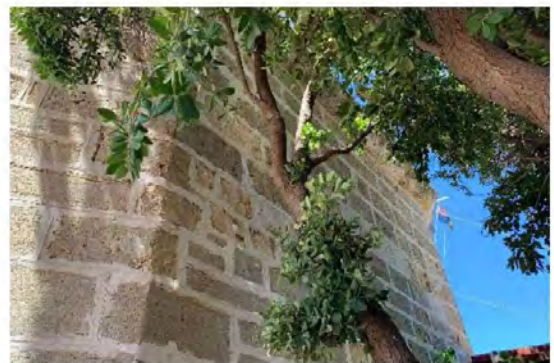
Figure 68: Face 10 proximity of plantings

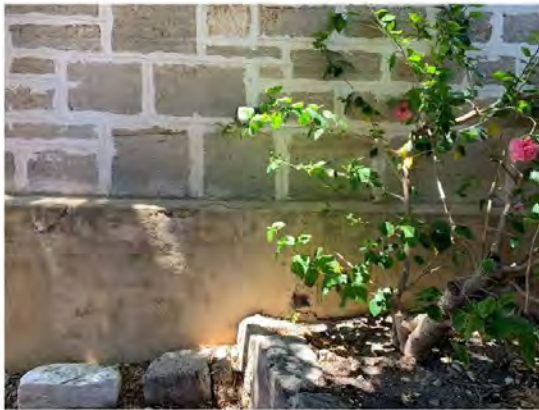
Figure 69: Rendered plinth to face 10

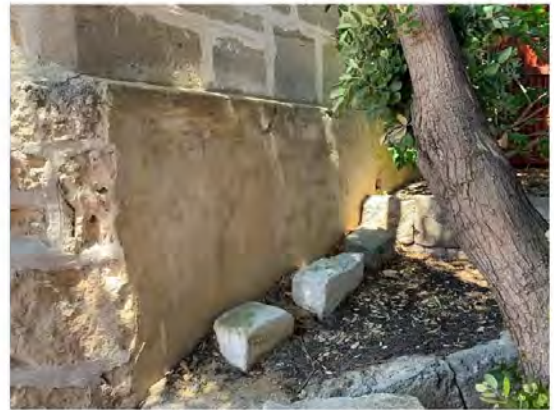
Figure 70: rendered plinth to face 10

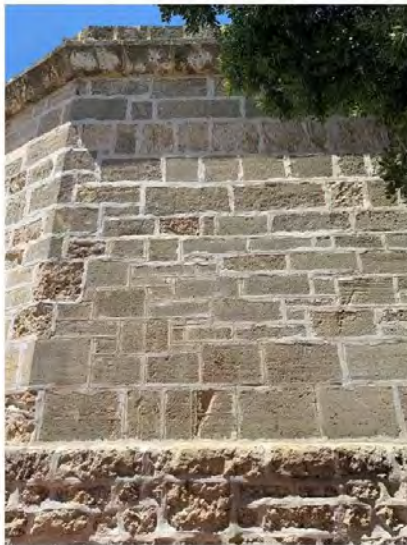
Figure 75: Differences in stone quality face 11

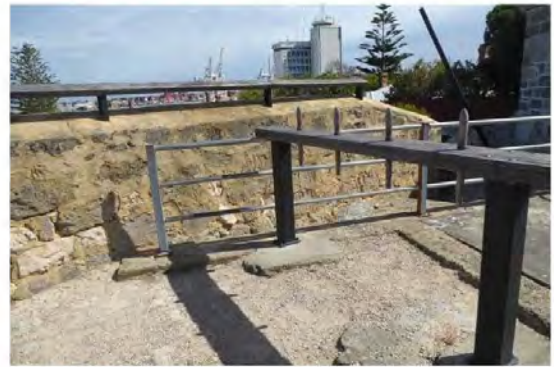
Figure 82: Uneven surface

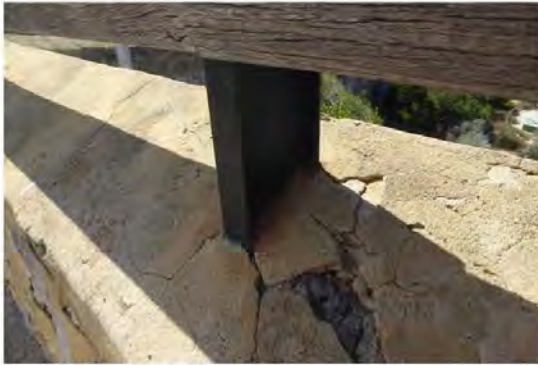
Figure 89: Cracked render

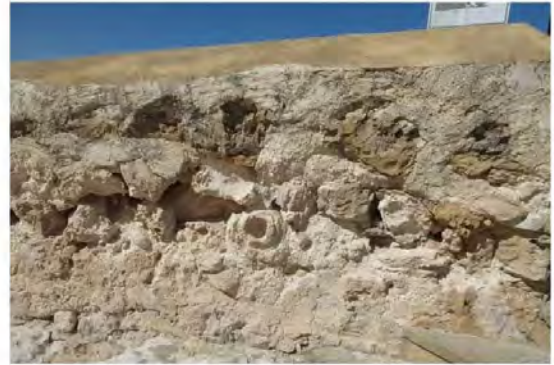
Figure 90: Eroding stones

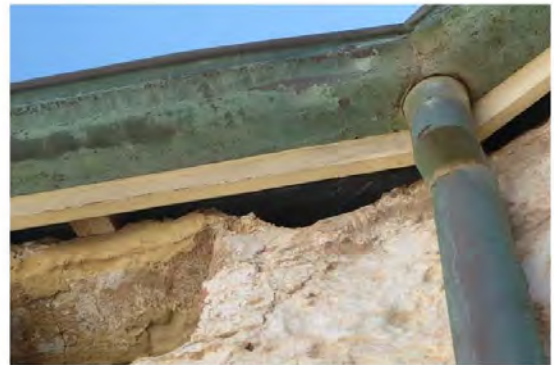
Figure 106: Copper gutters

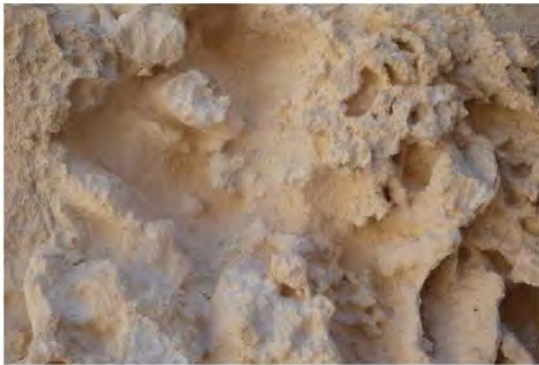
Figure 107: Eroding stones

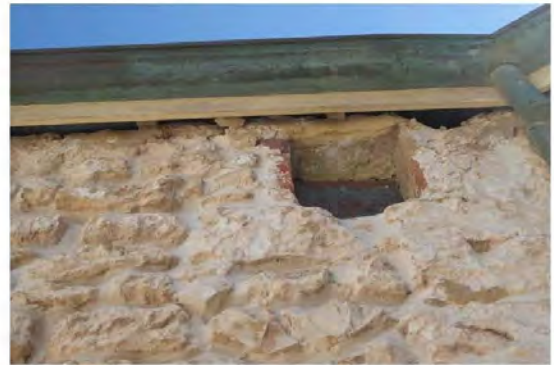
Figure 108: Gutters and vent

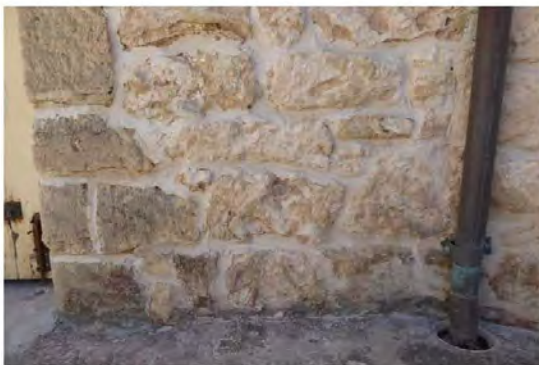
Figure 109: Previous repairs

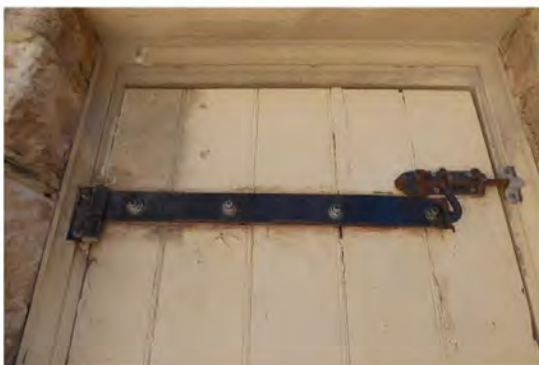
Figure 111: Dirty doors

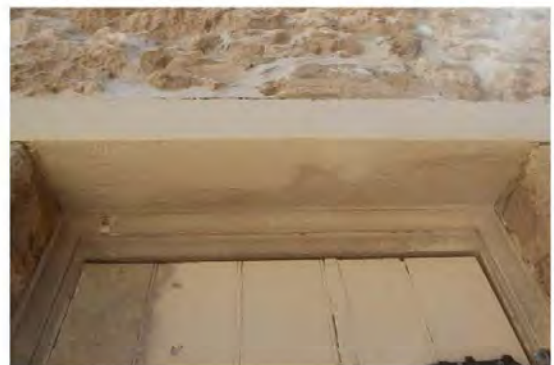
Figure 112: Replacement lintel

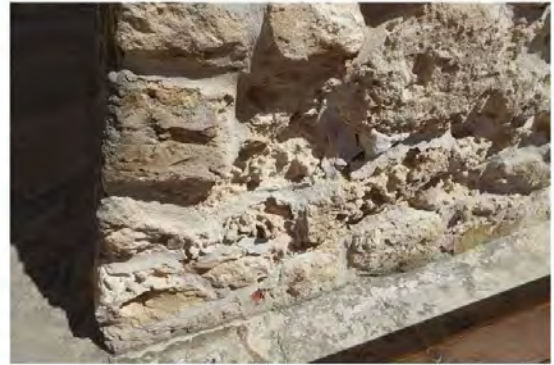
Figure 114: Stone erosion

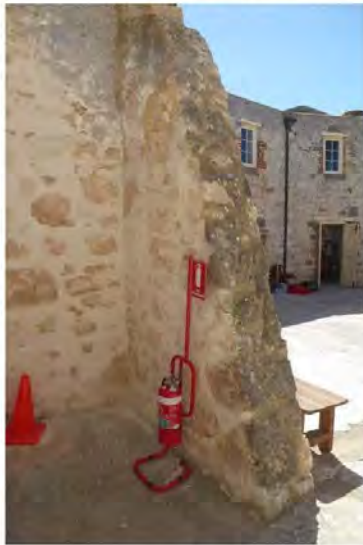
Figure 115: Buttress wals

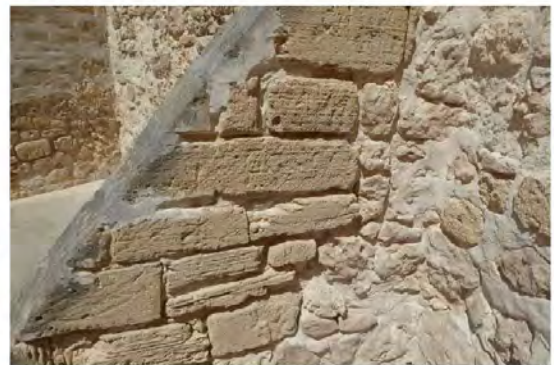
Figure 118: Eroding joints

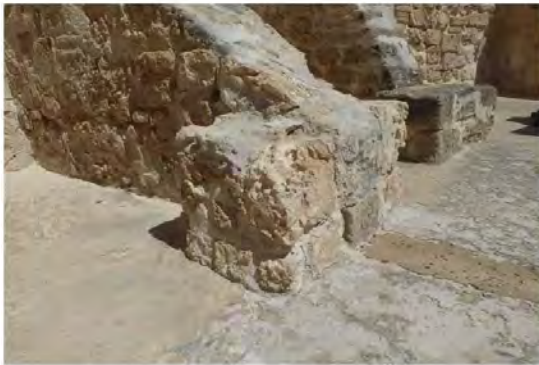
Figure 122: Previous repairs using mortar for stone repairs

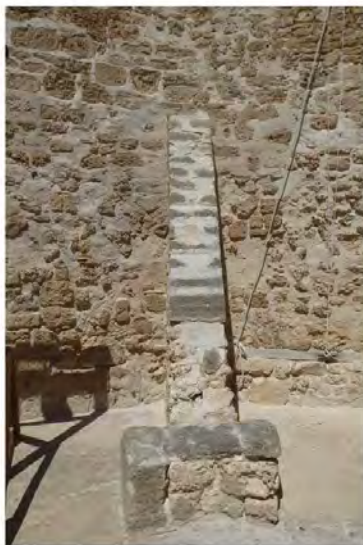
Figure 124: Previous mortar repairs

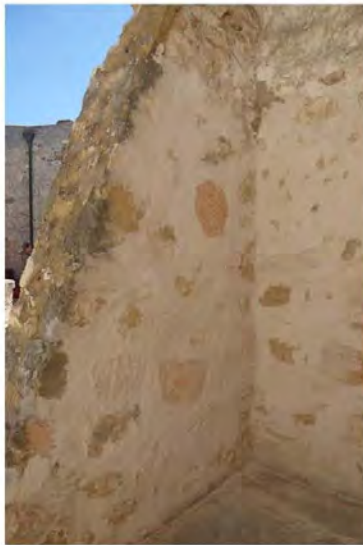
Figure 126: Erosion of stones

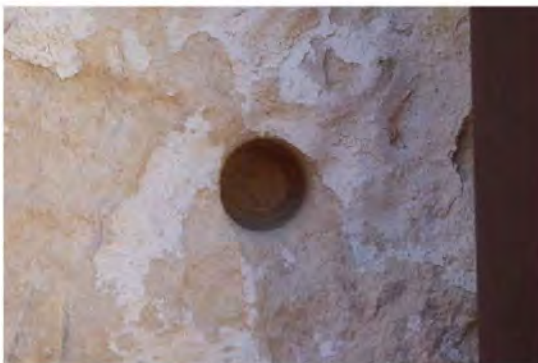
Figure 130: Air vent and replacement gutters

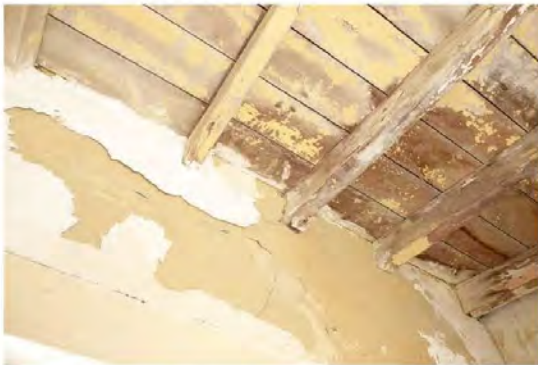
Figure 144: Drummy and patched render

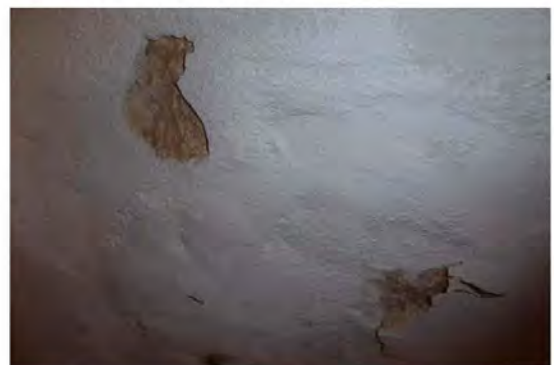
Figure 148: Drummy render

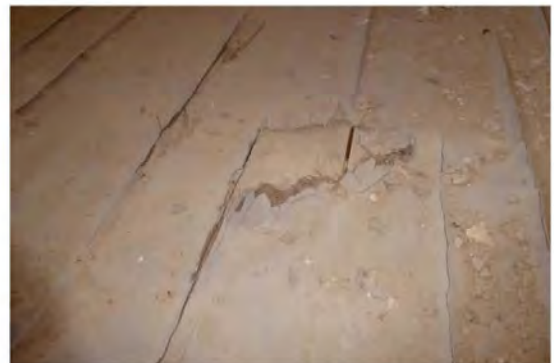
Figure 154: Brittle lino Room 14

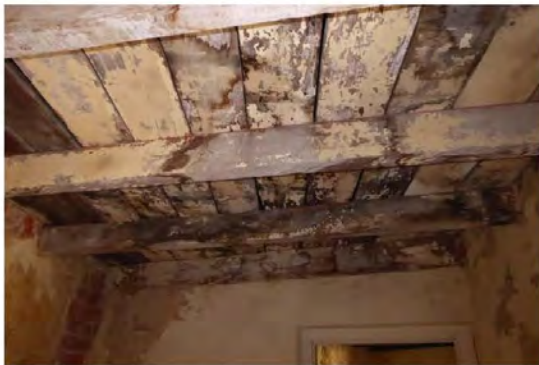
Figure 157: Wearing point to Room 1

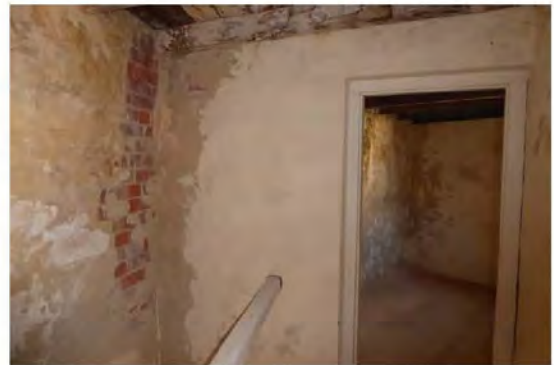
Figure 158: Brick infill

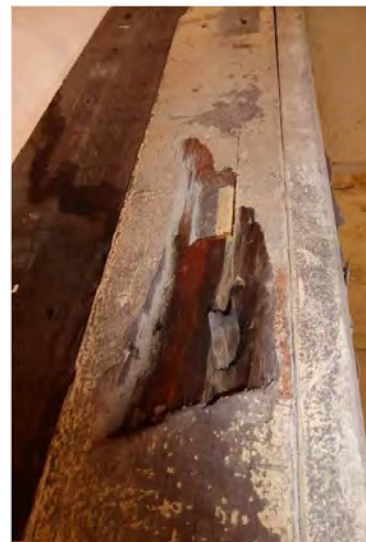
Figure 172: damaged timbers

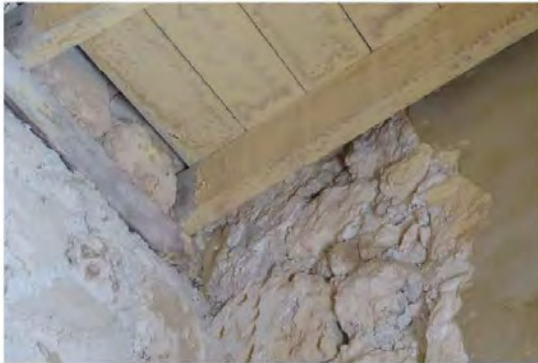
Figure 191: Eroding joints
